# The “King Tiger”

## Vol. II

• Development • Units • Operations •

Wolfgang Schneider

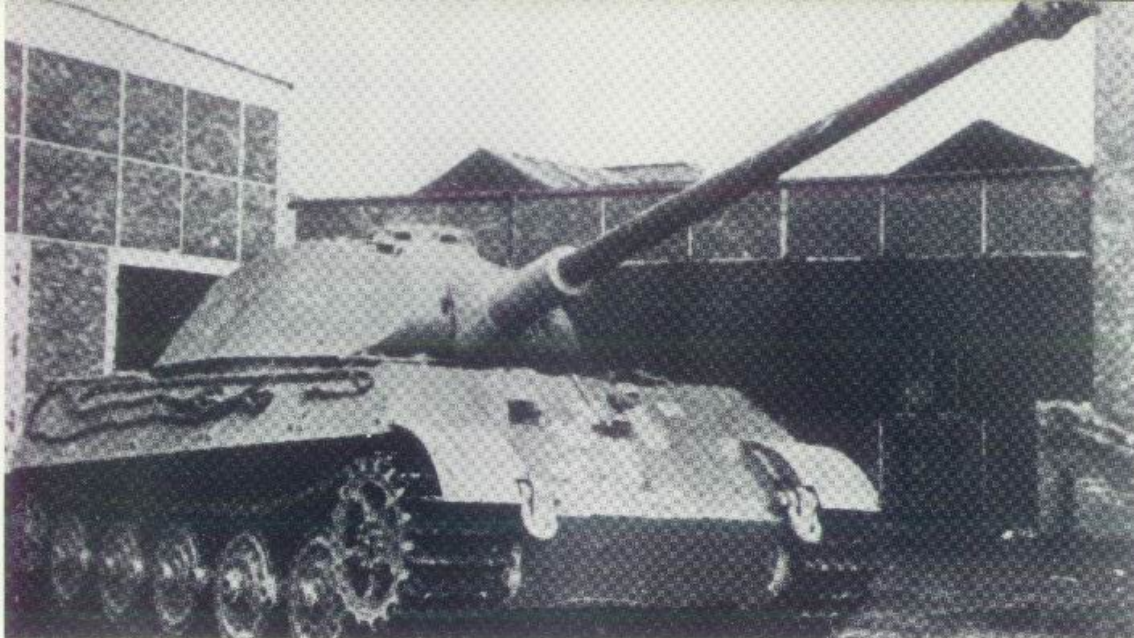
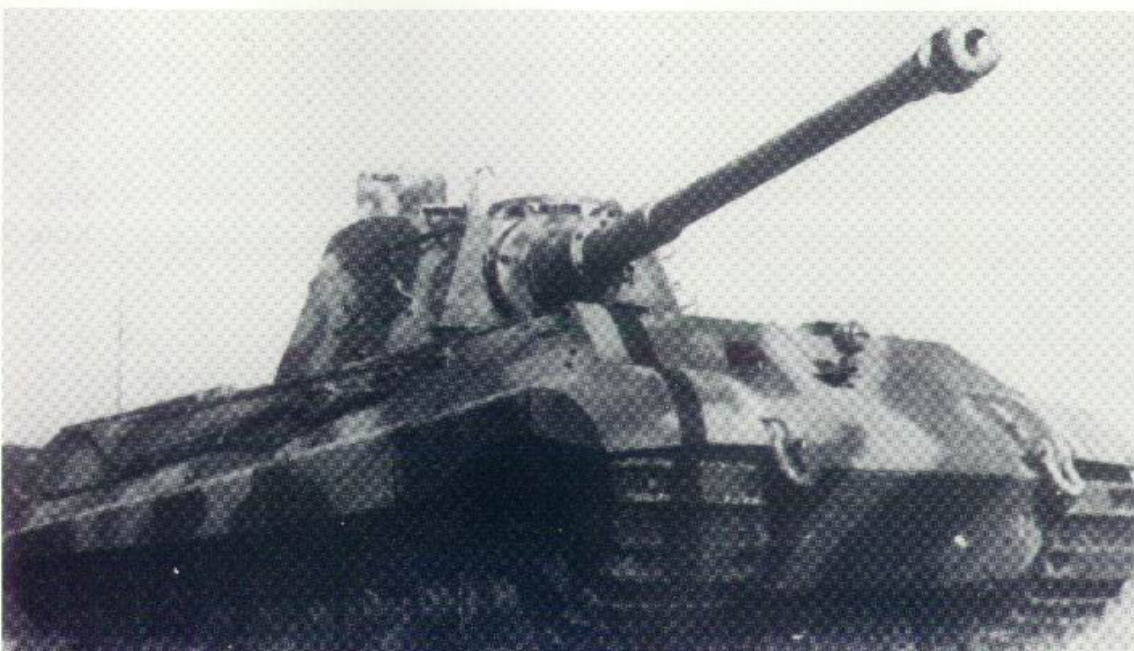
The first fifty King Tigers were equipped with the so-called Porsche turret (above). This was more sharply sloped and had a very rounded front. Its manufacture was very expensive, and it also turned out that the shape essentially trapped shots and caused a particularly great danger to the turret turning circle. Thus Krupp produced a turret that offered greater armor strength and eliminated these problems, as well as being much simpler to produce. With this so-called production turret all subsequent Tiger II tanks were equipped. The two photos offer a comparison of the two types.

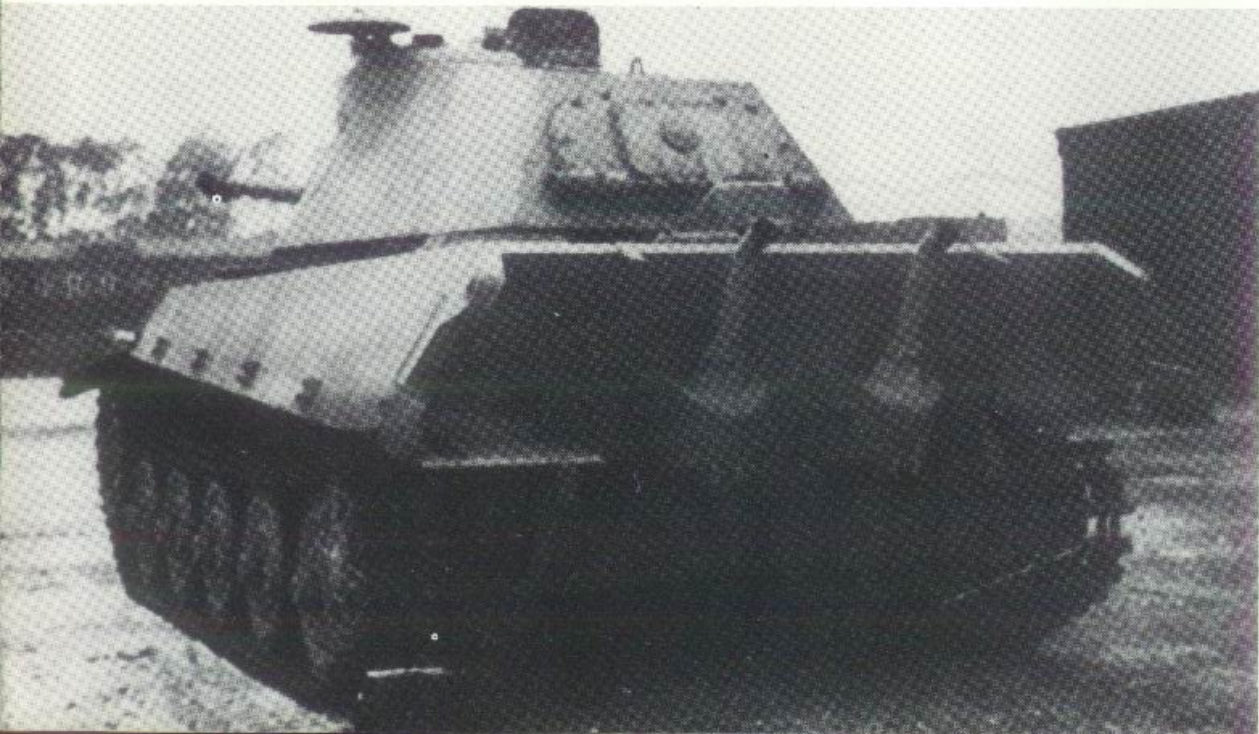
During series production, a number of improvements and armament changes were introduced. One example is the exhaust system. Originally the exhaust pipes were jacketed (above) for sound damping and better heat conduction; later vehicles had open tailpipes.

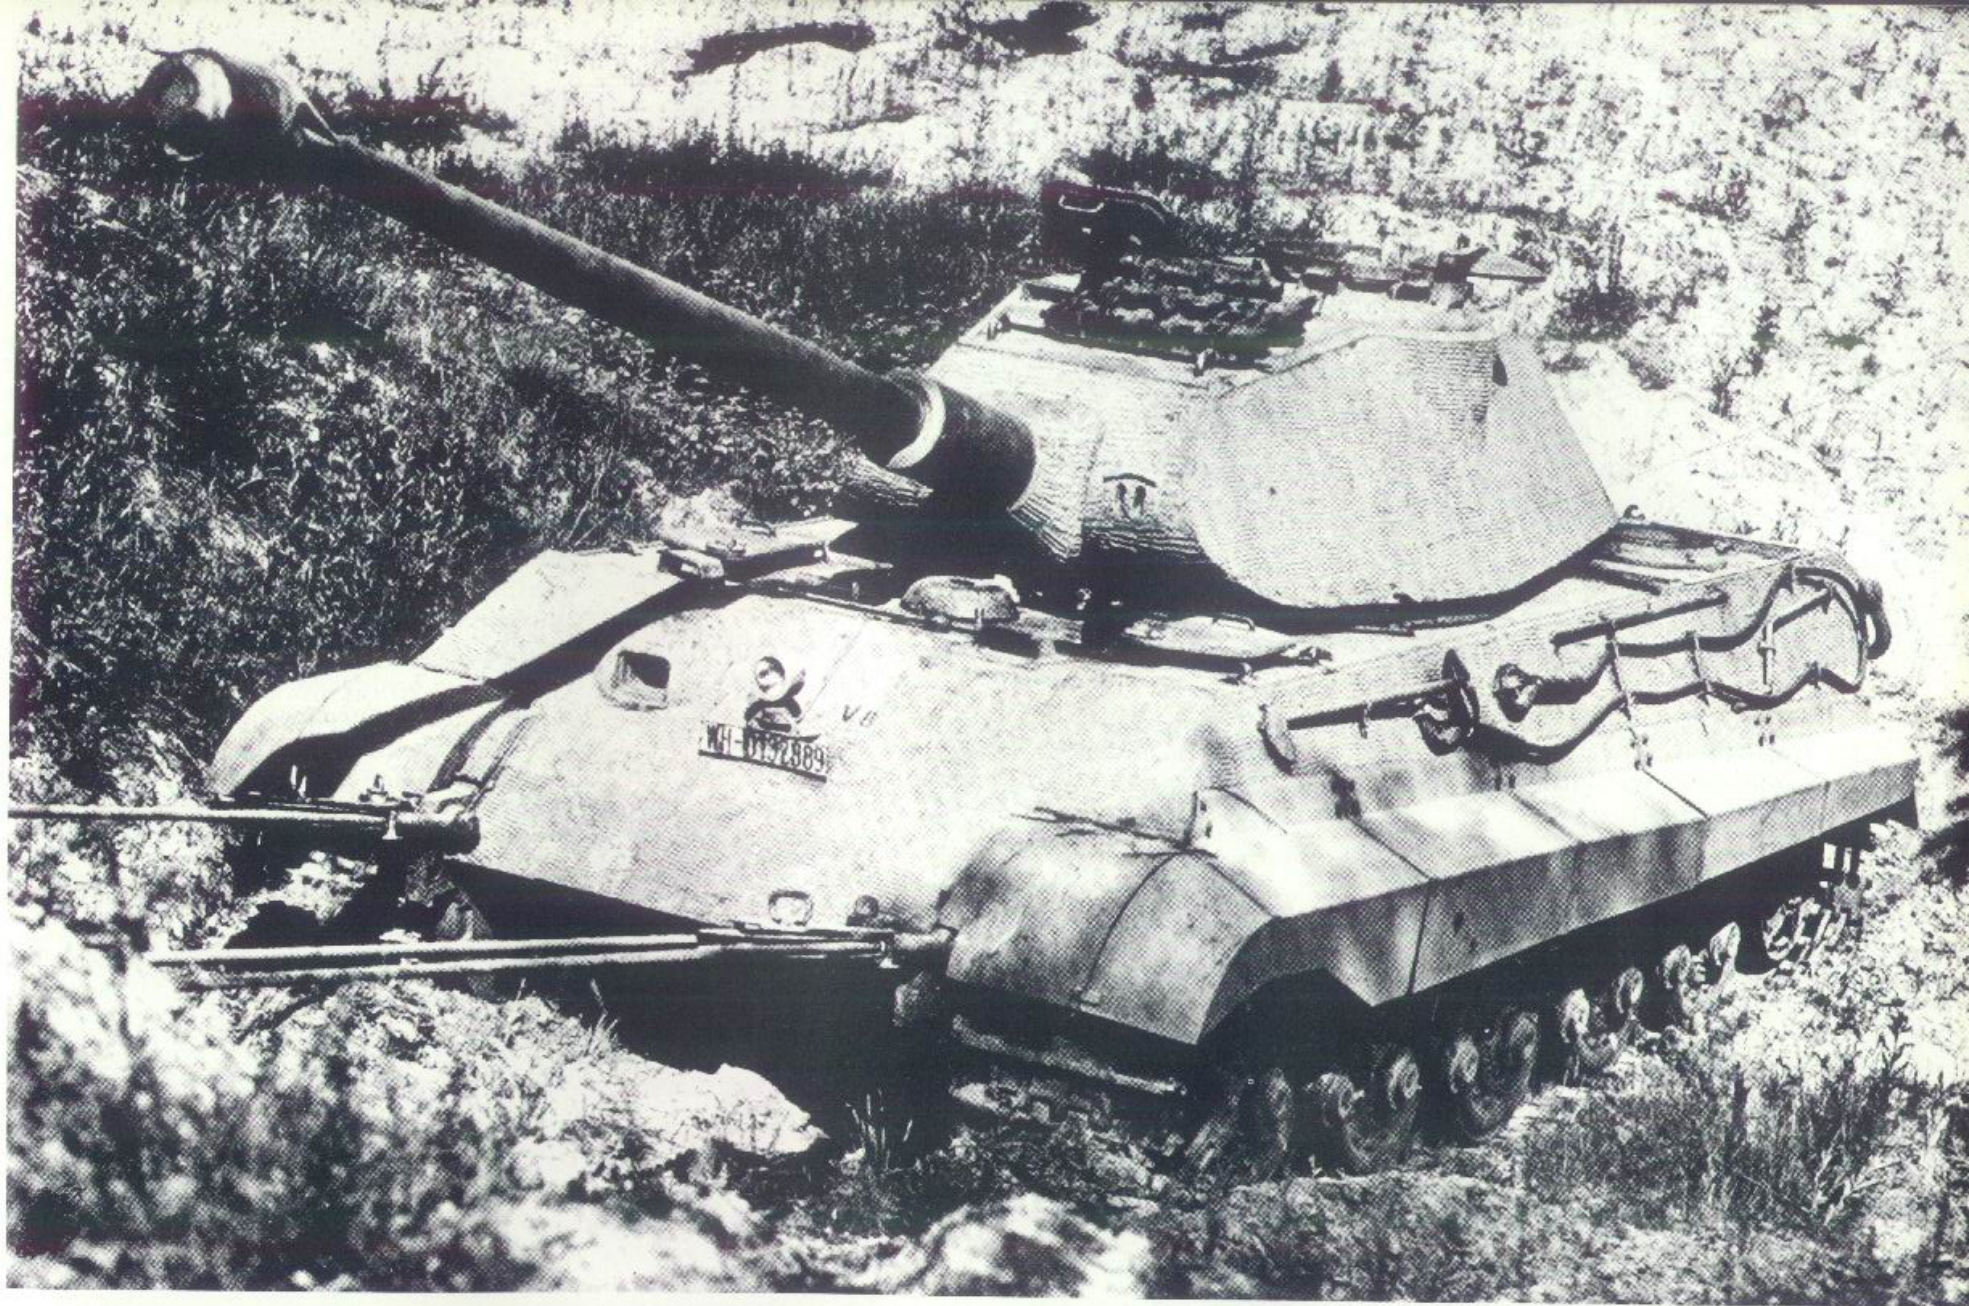
A series of tanks served for testing. This photo shows V8 in a rescue maneuver at Kummersdorf. Notice the number plate — not used in combat — on the bow plate.

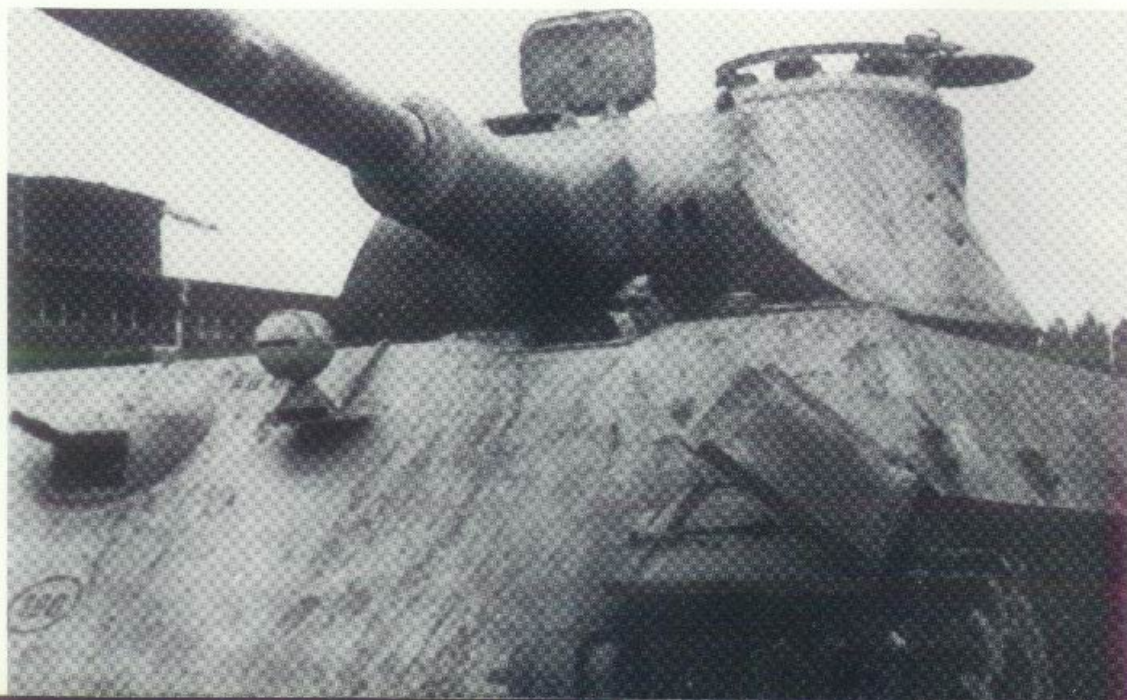
Left:

This photo shows the first production tank (note number 001 on the left towing eye). It is clear to see that the commander's hatch required a bulge on the left side of the turret wall.

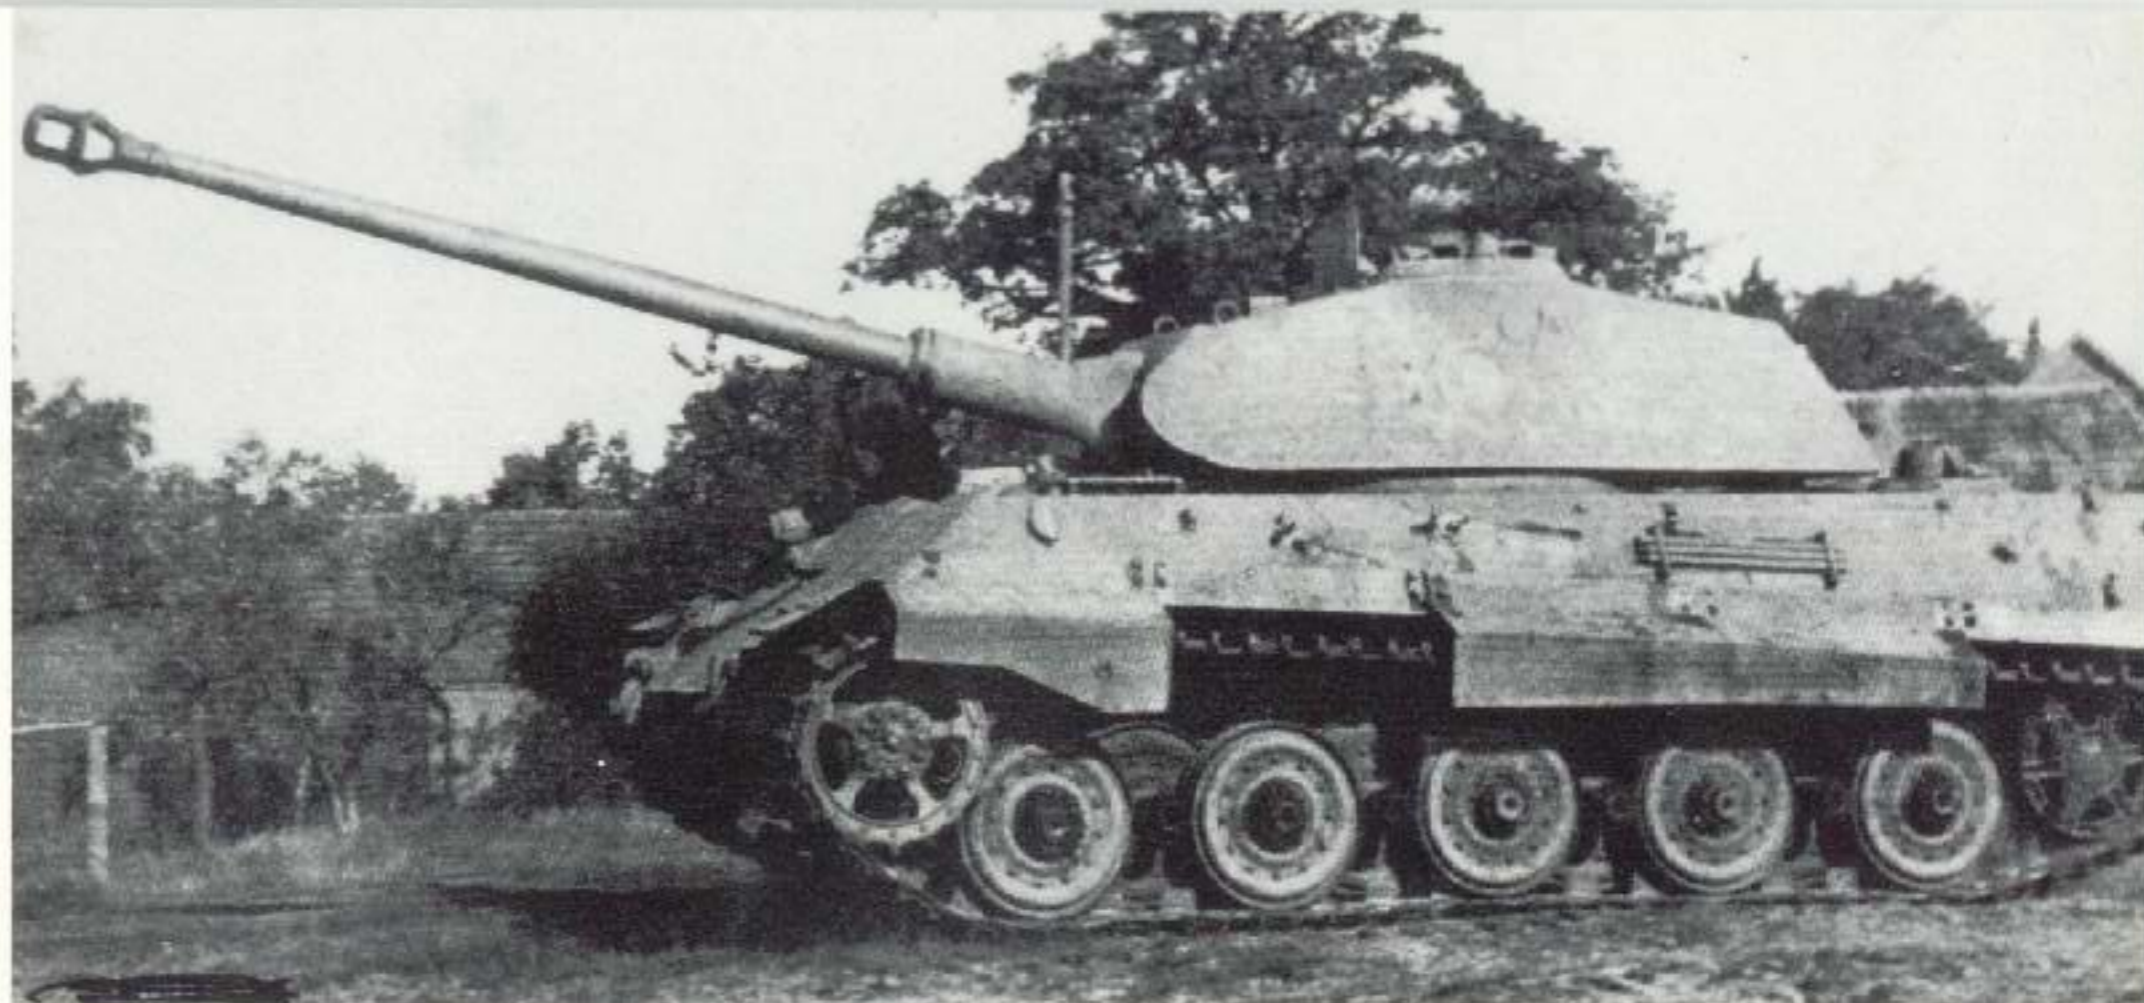
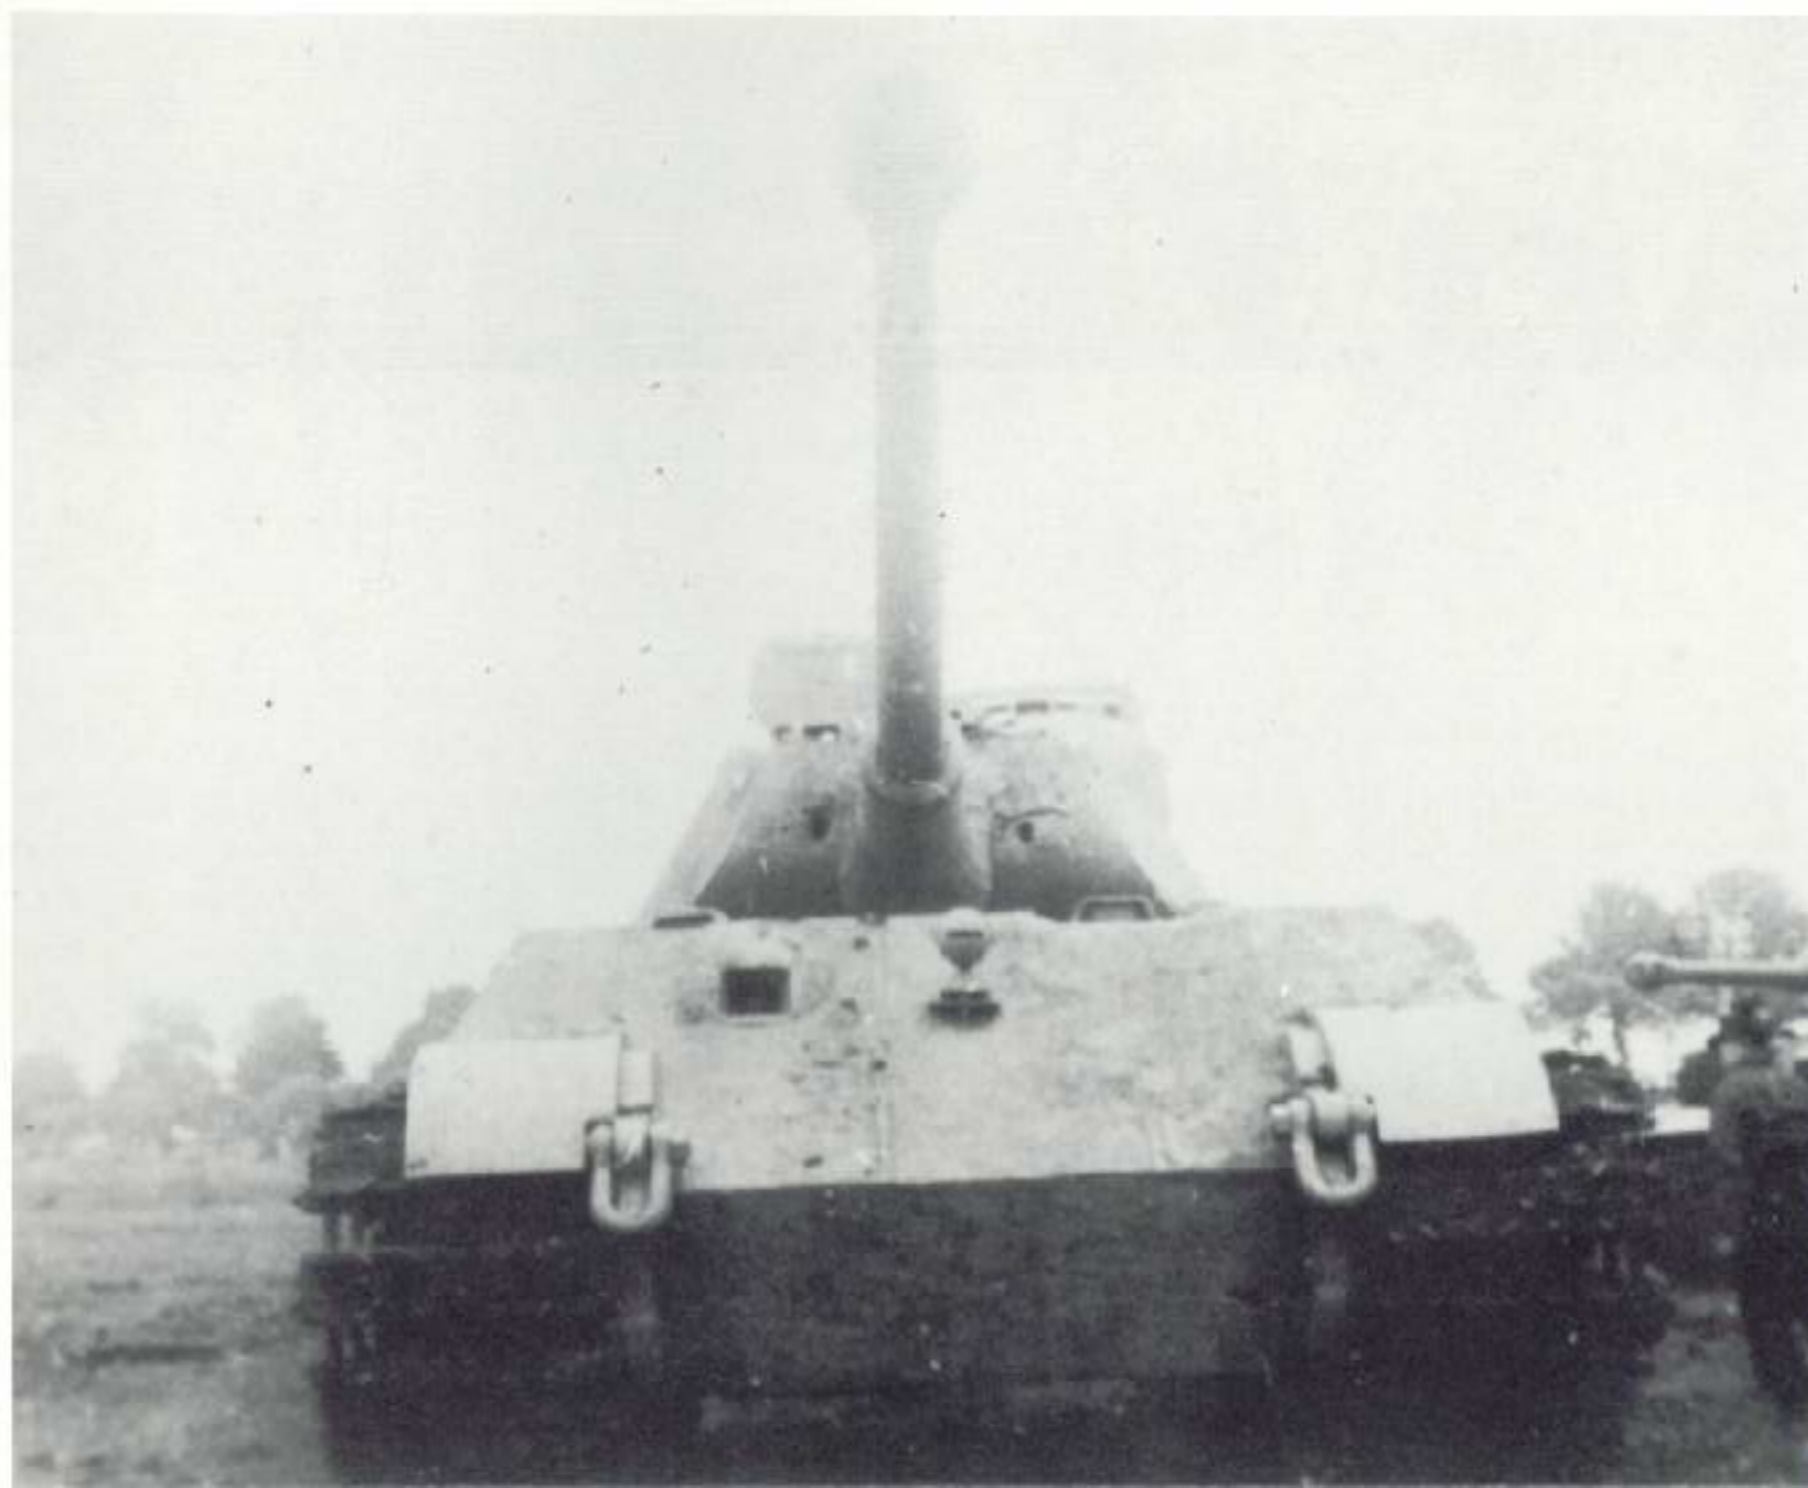
Immediately after the Allied invasion on the Normandy coast of France, the 1st Company of Heavy Panzer Battalion 503 was supplied with the King Tiger. The two photos show one of the tanks from the early production lot with the simple aiming telescope port (later two) at left beside the tank gun, which is still extended in one piece. At the left side of the turret the welded opening of the original ammunition hatch can be seen.

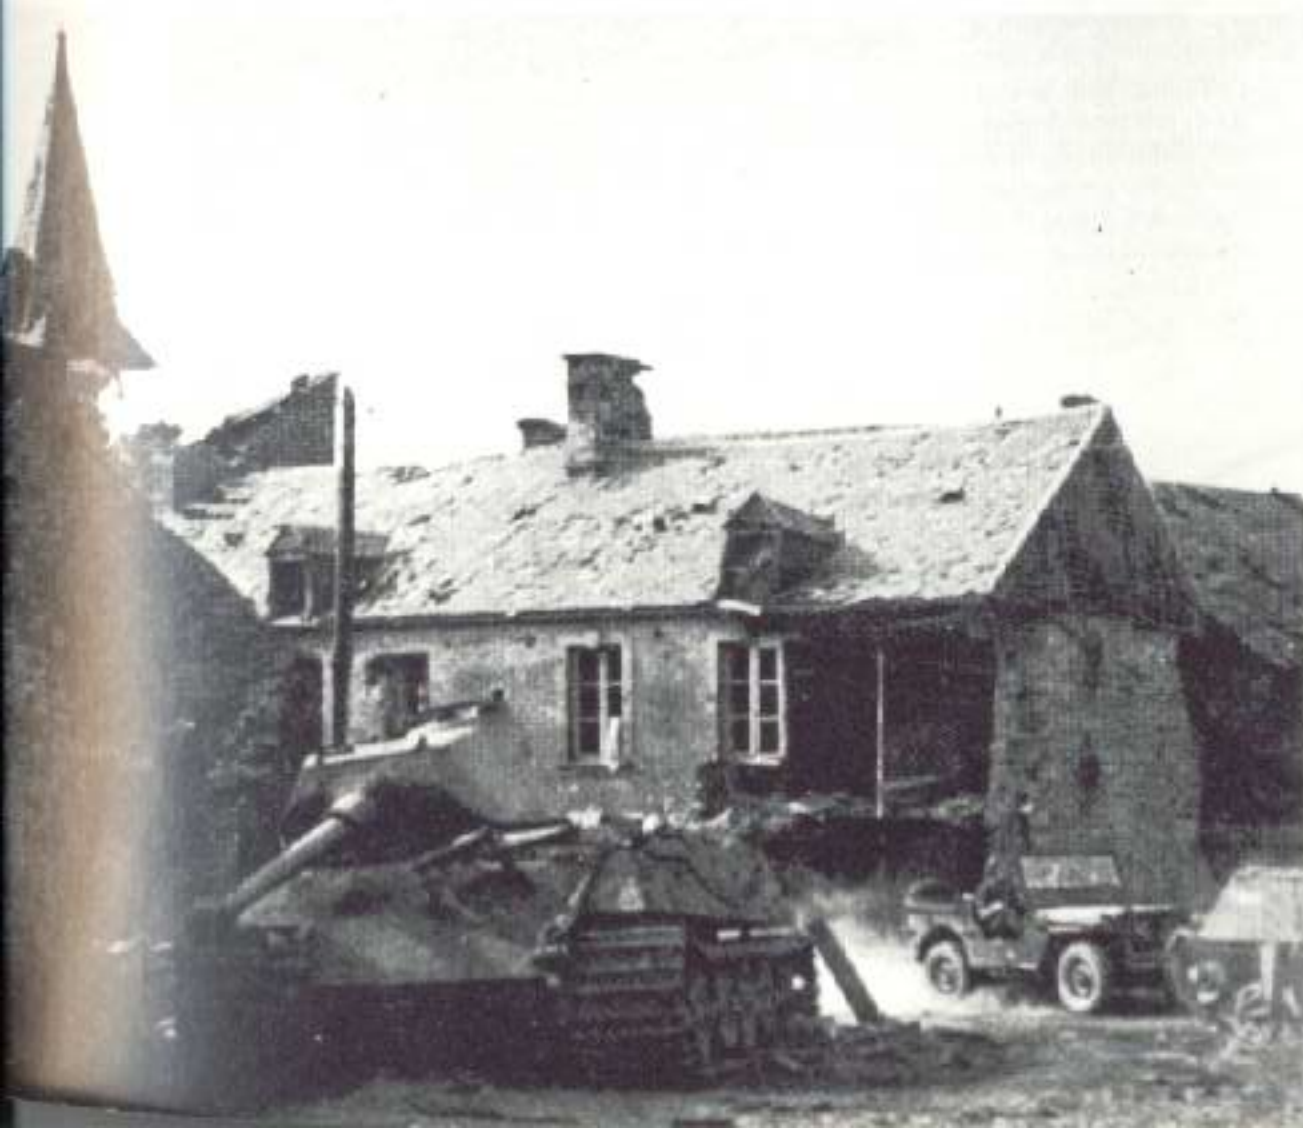
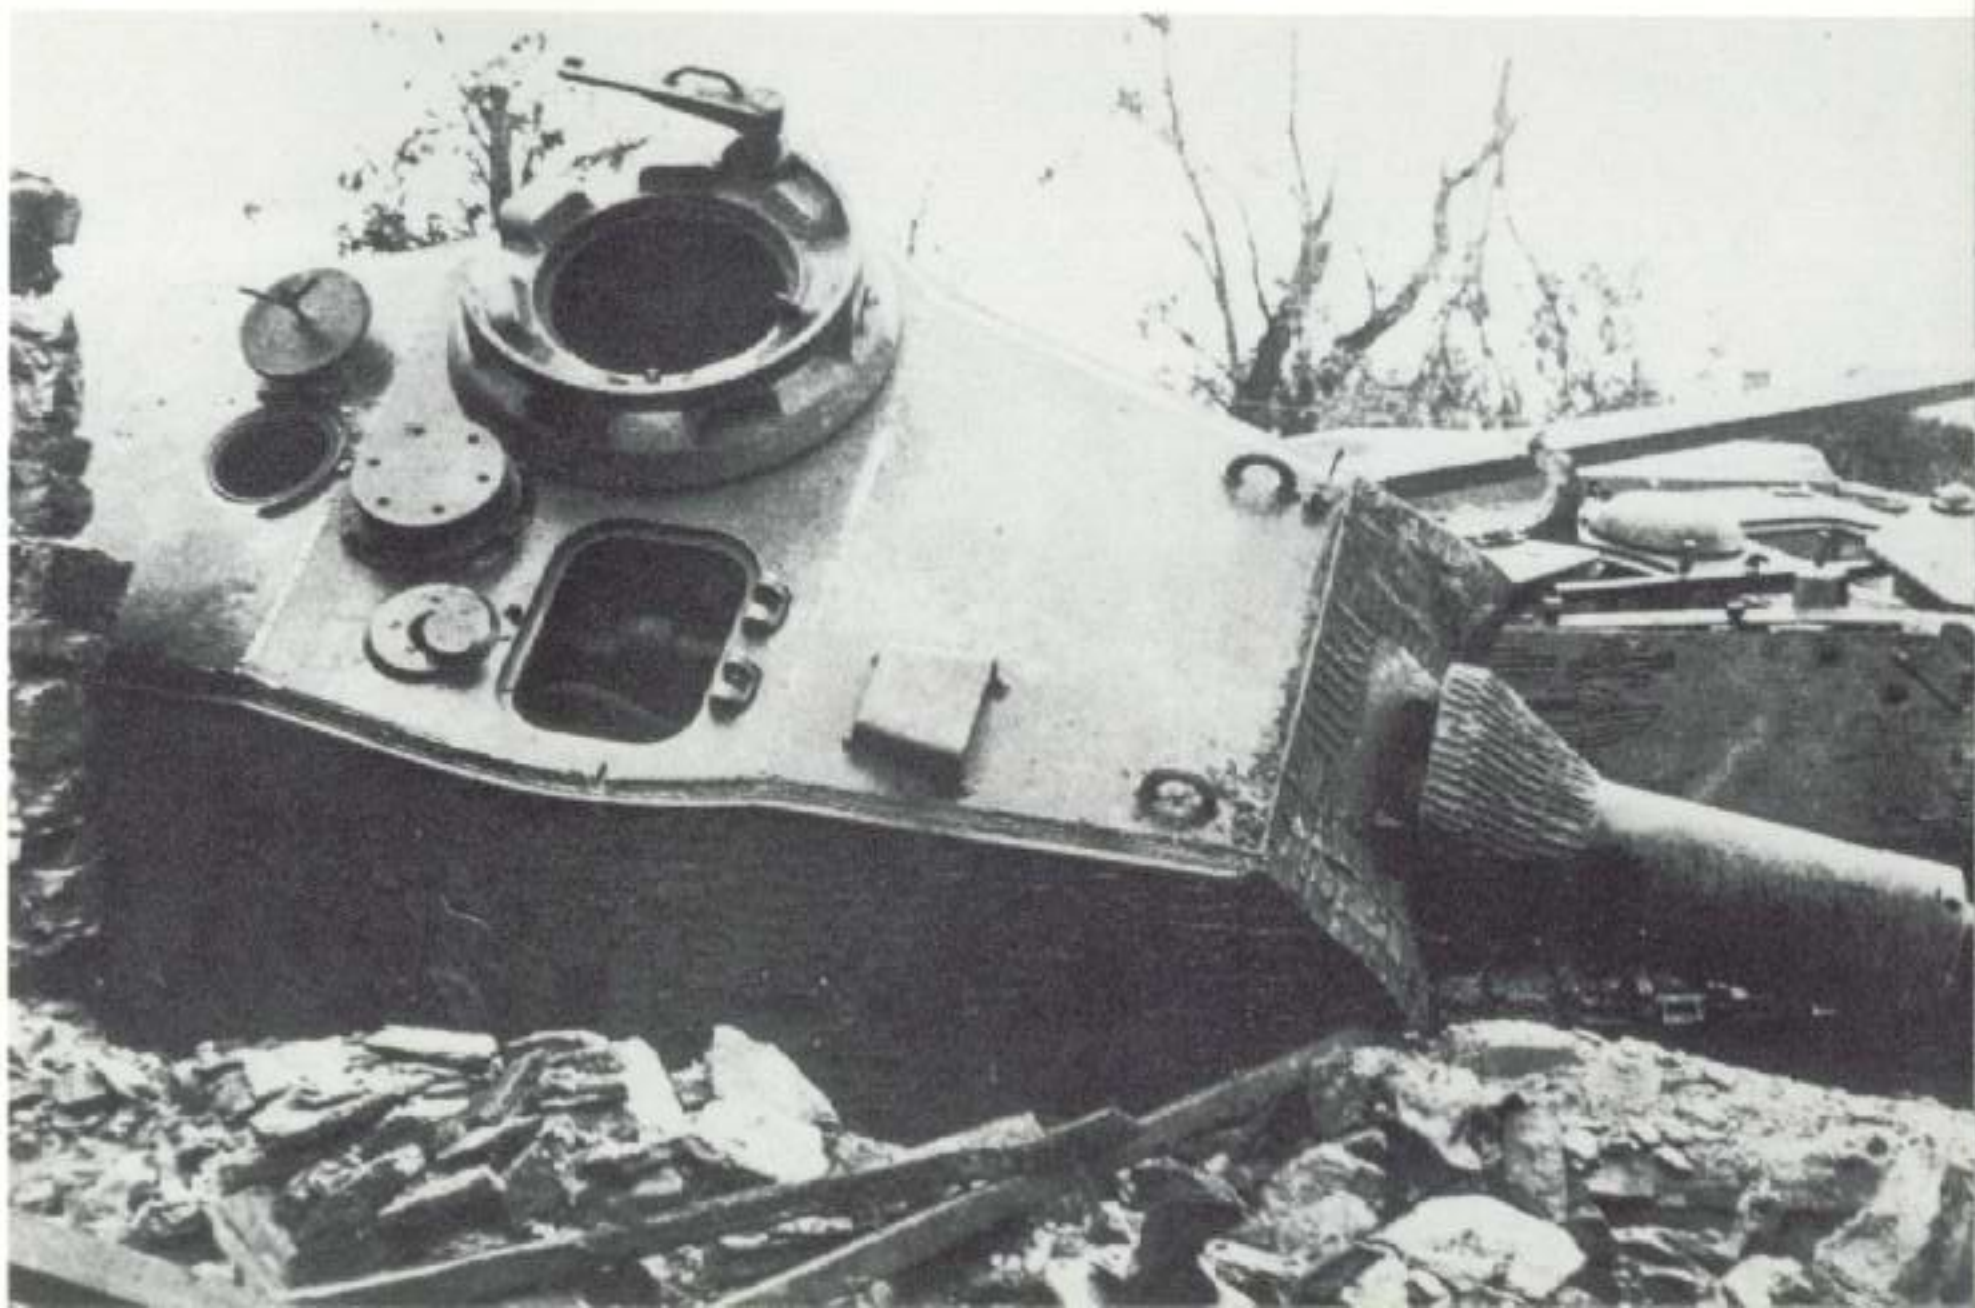
Below and lower right:  
Both photos show a disabled Tiger II in Plessis-Grimoult. In a later attempt to tow it away, the turret fell off to the side (right).

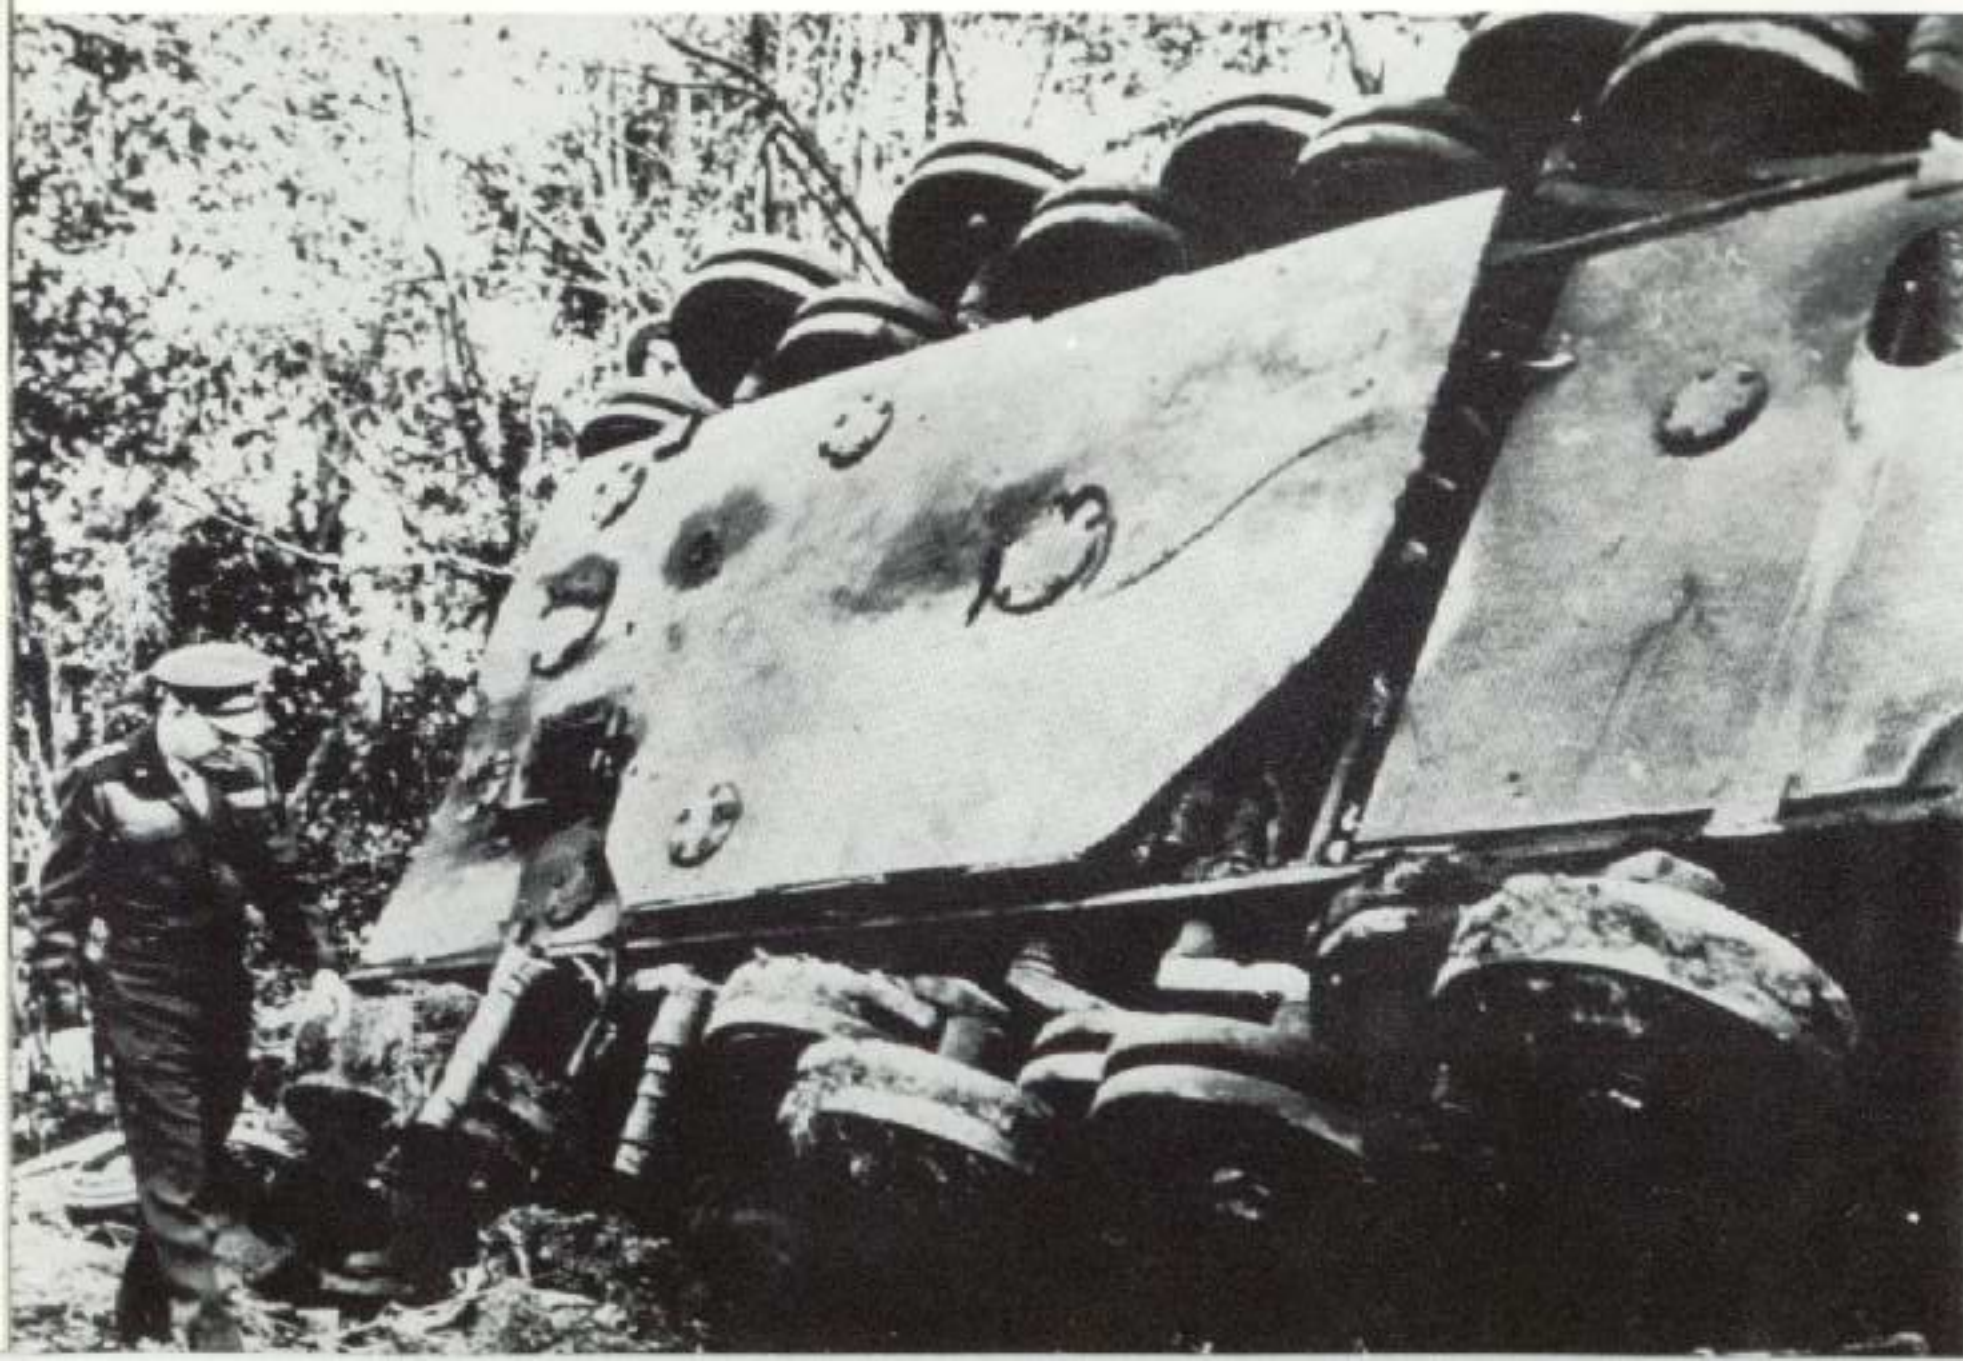
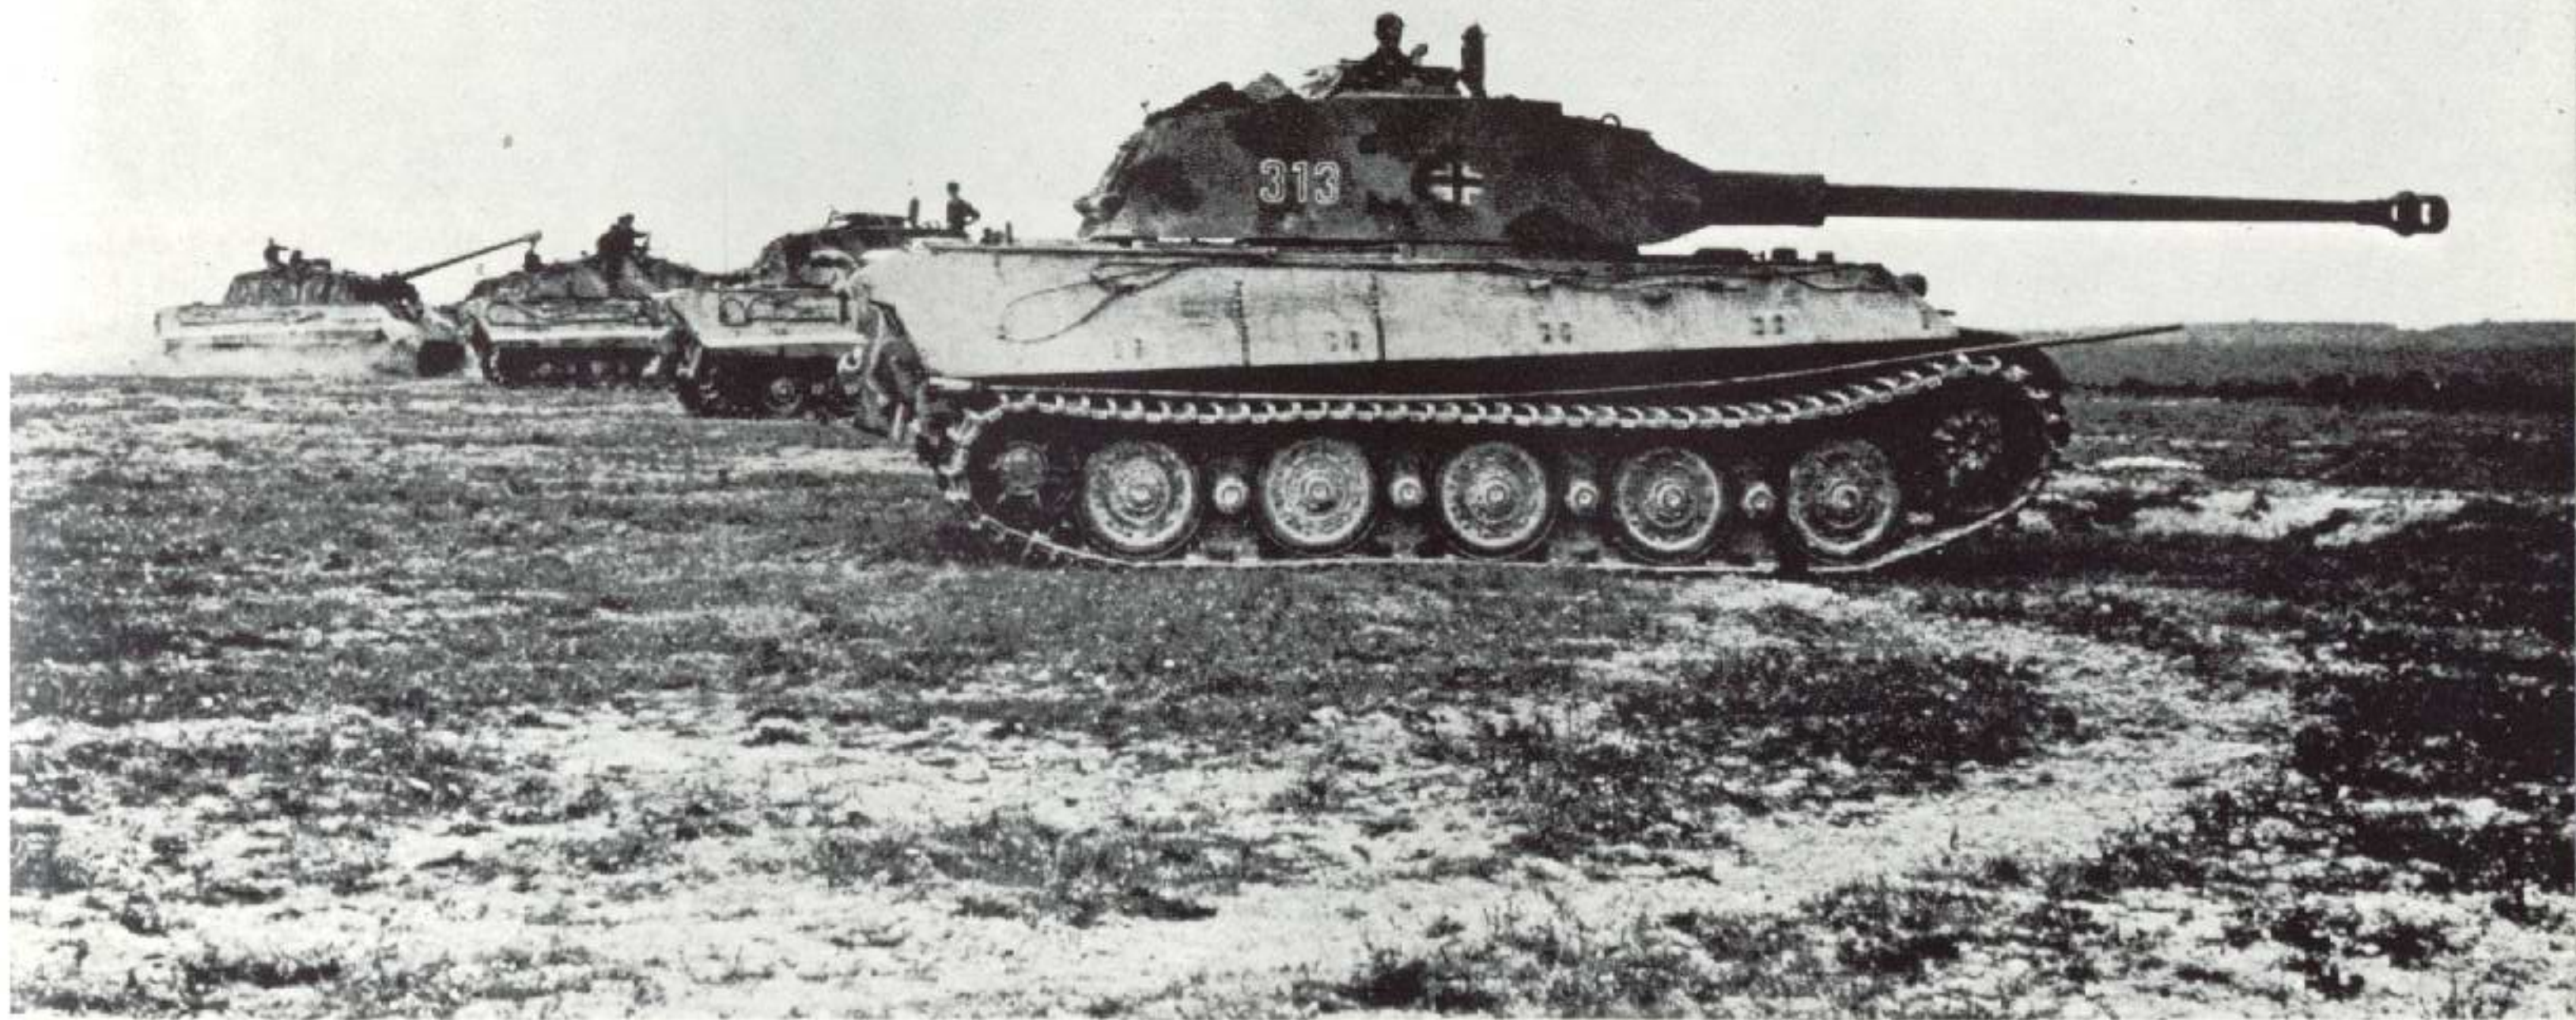
Lower left:  
General Eisenhower examines a capsized "Royal Tiger." The floor of the fighting compartment was bent by an explosion. The arrangement of the servicing openings and the emergency exit hatch at the left front can be seen.

Below:  
This drawing shows all the openings in the base of the Tiger II.

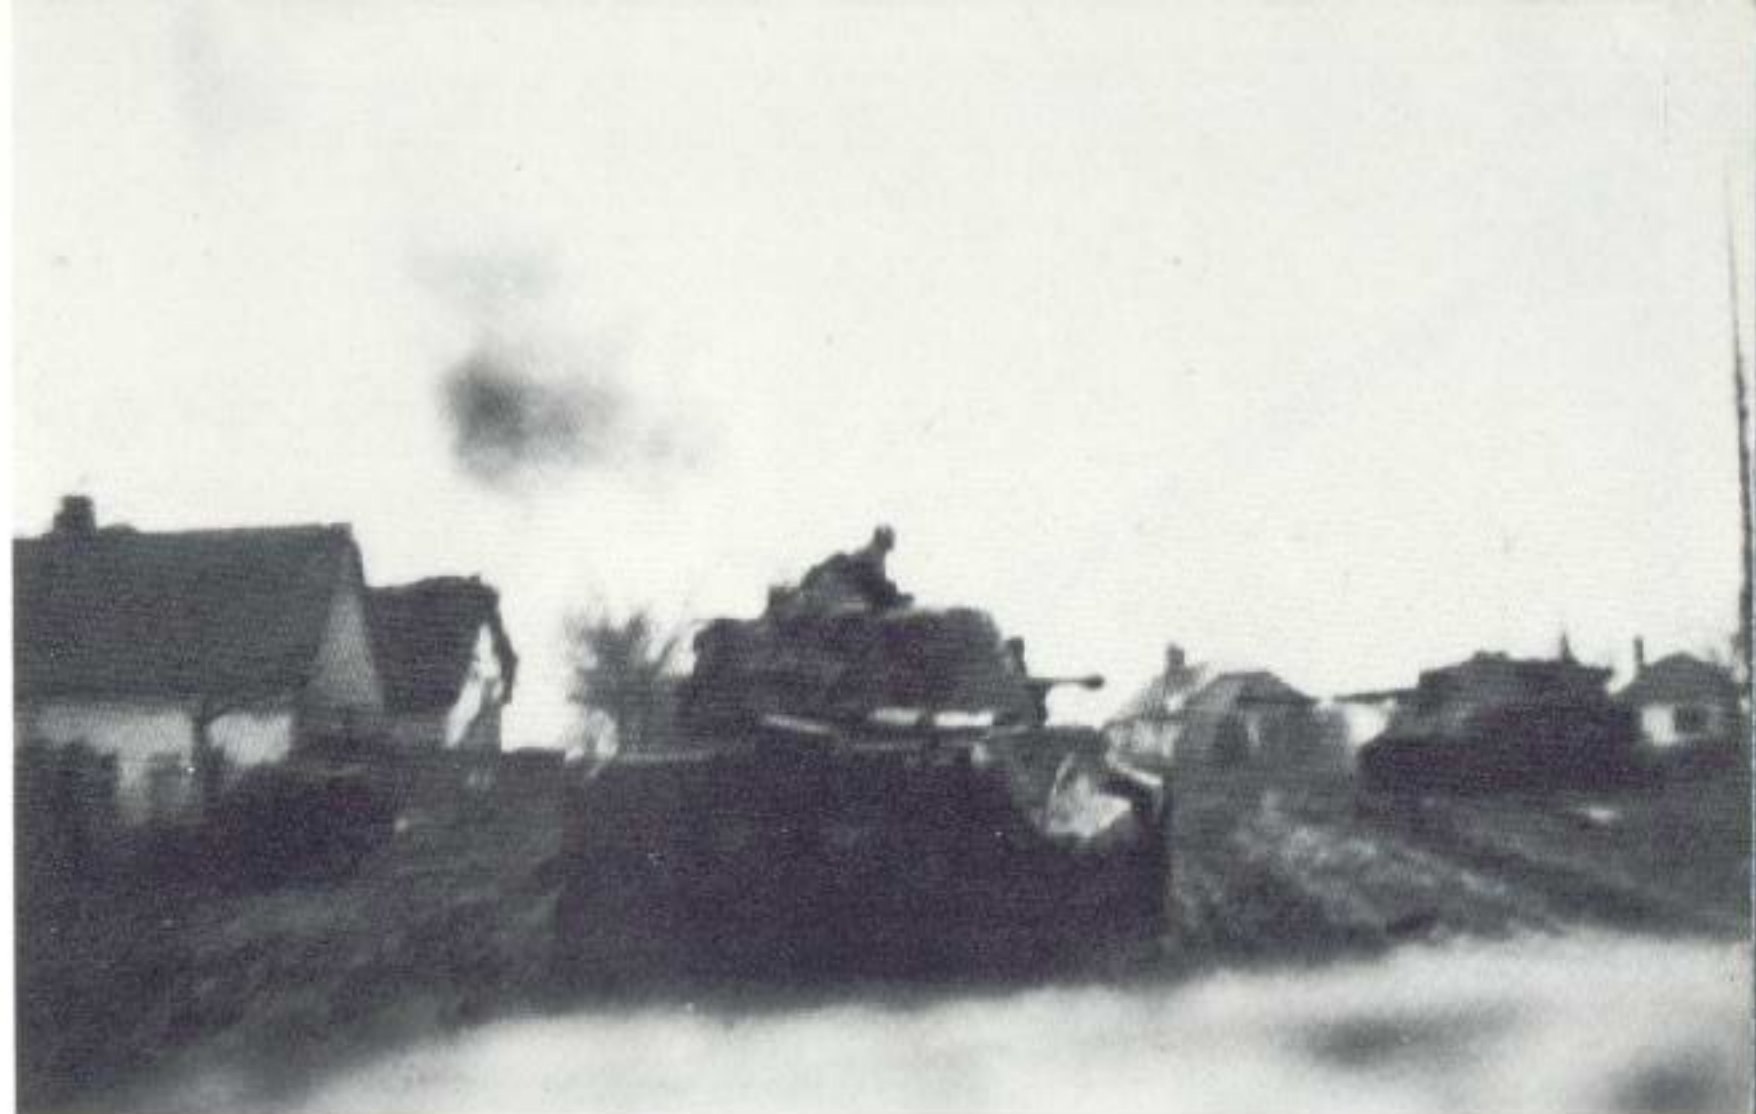
An antitank gun on the left flank that had not been silenced hit Tank 124 at the shortest range. The following tanks guard the crew as they abandon the tank.
