# The “King Tiger”

## Vol. II

• Development • Units • Operations •

Wolfgang Schneider

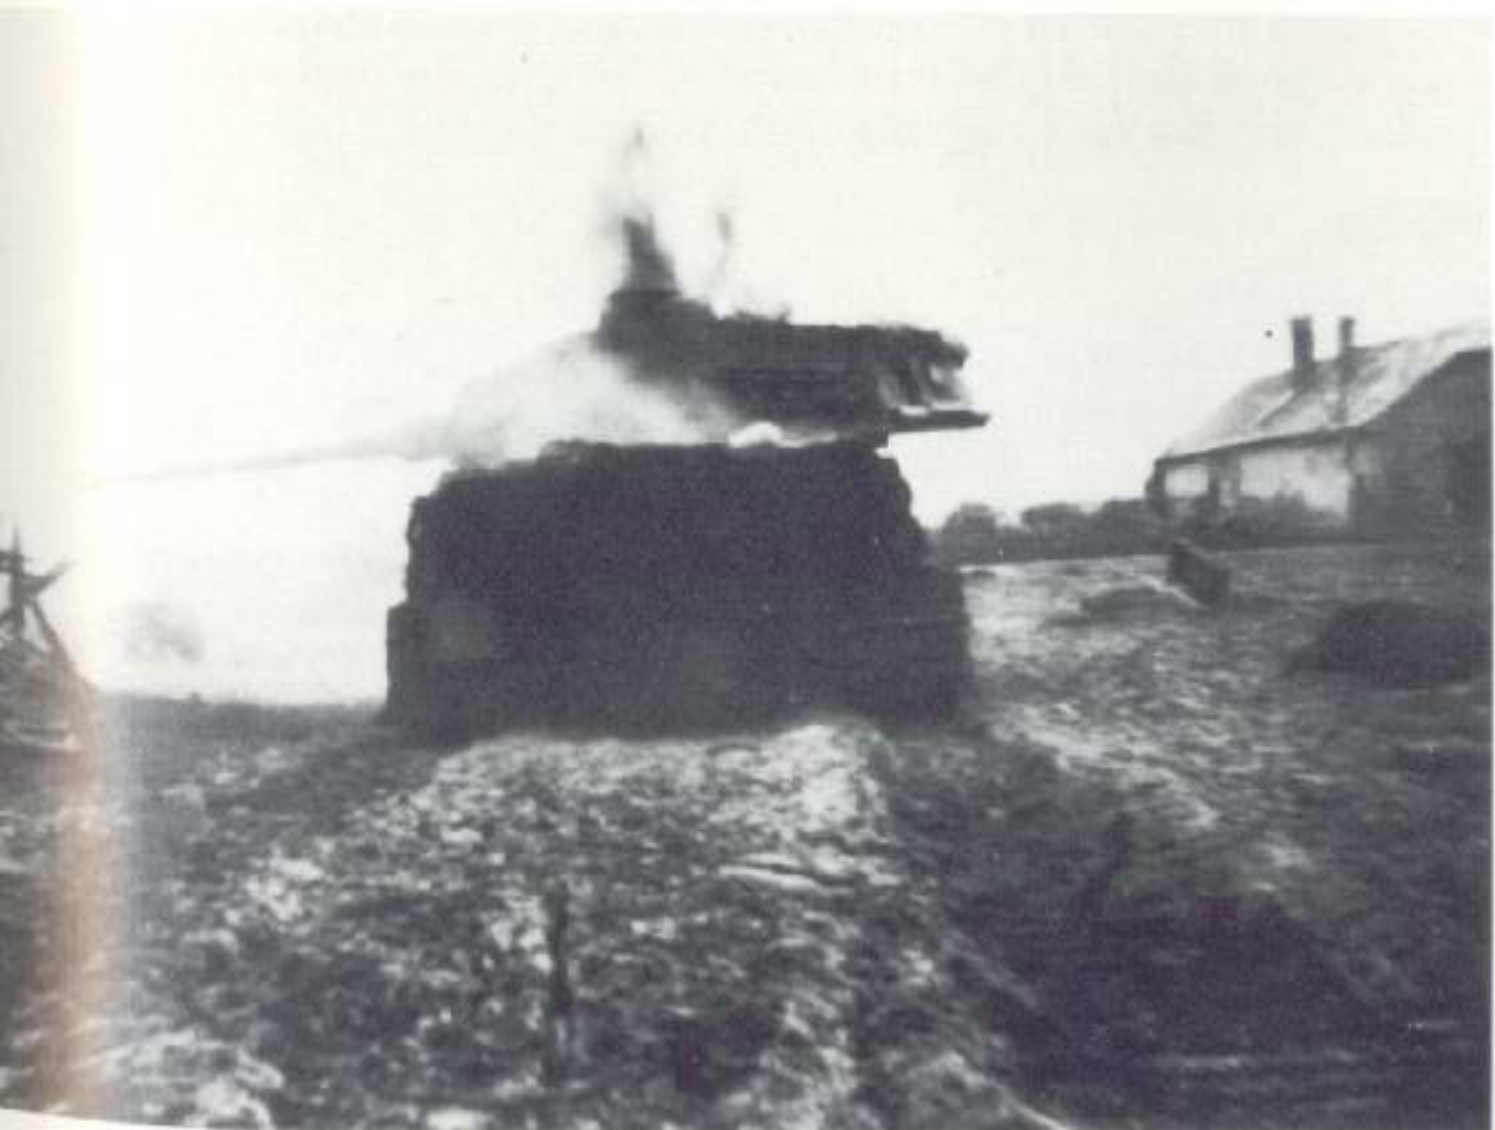
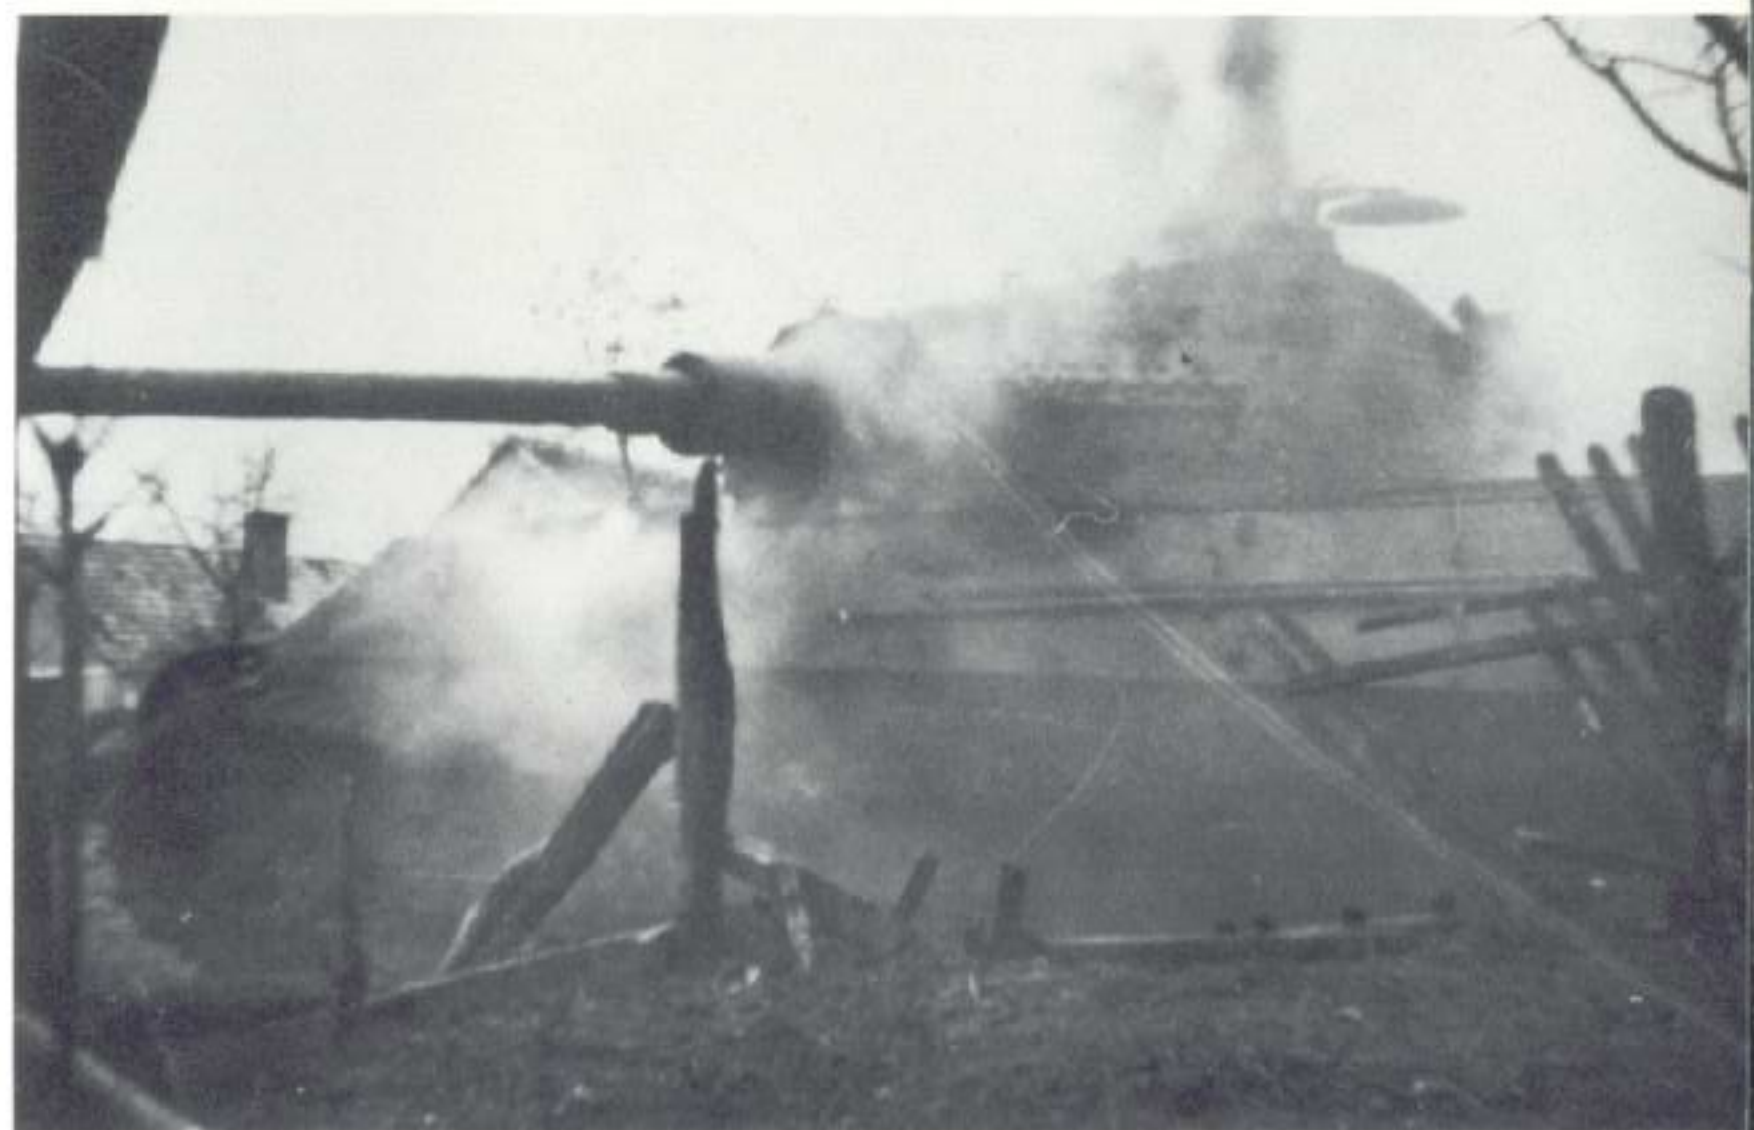
After the village has been taken, the extent of the loss becomes clear. The close-up photo shows the burning tank which suffered a hull penetration at the left front. The driver and radioman lost their lives.

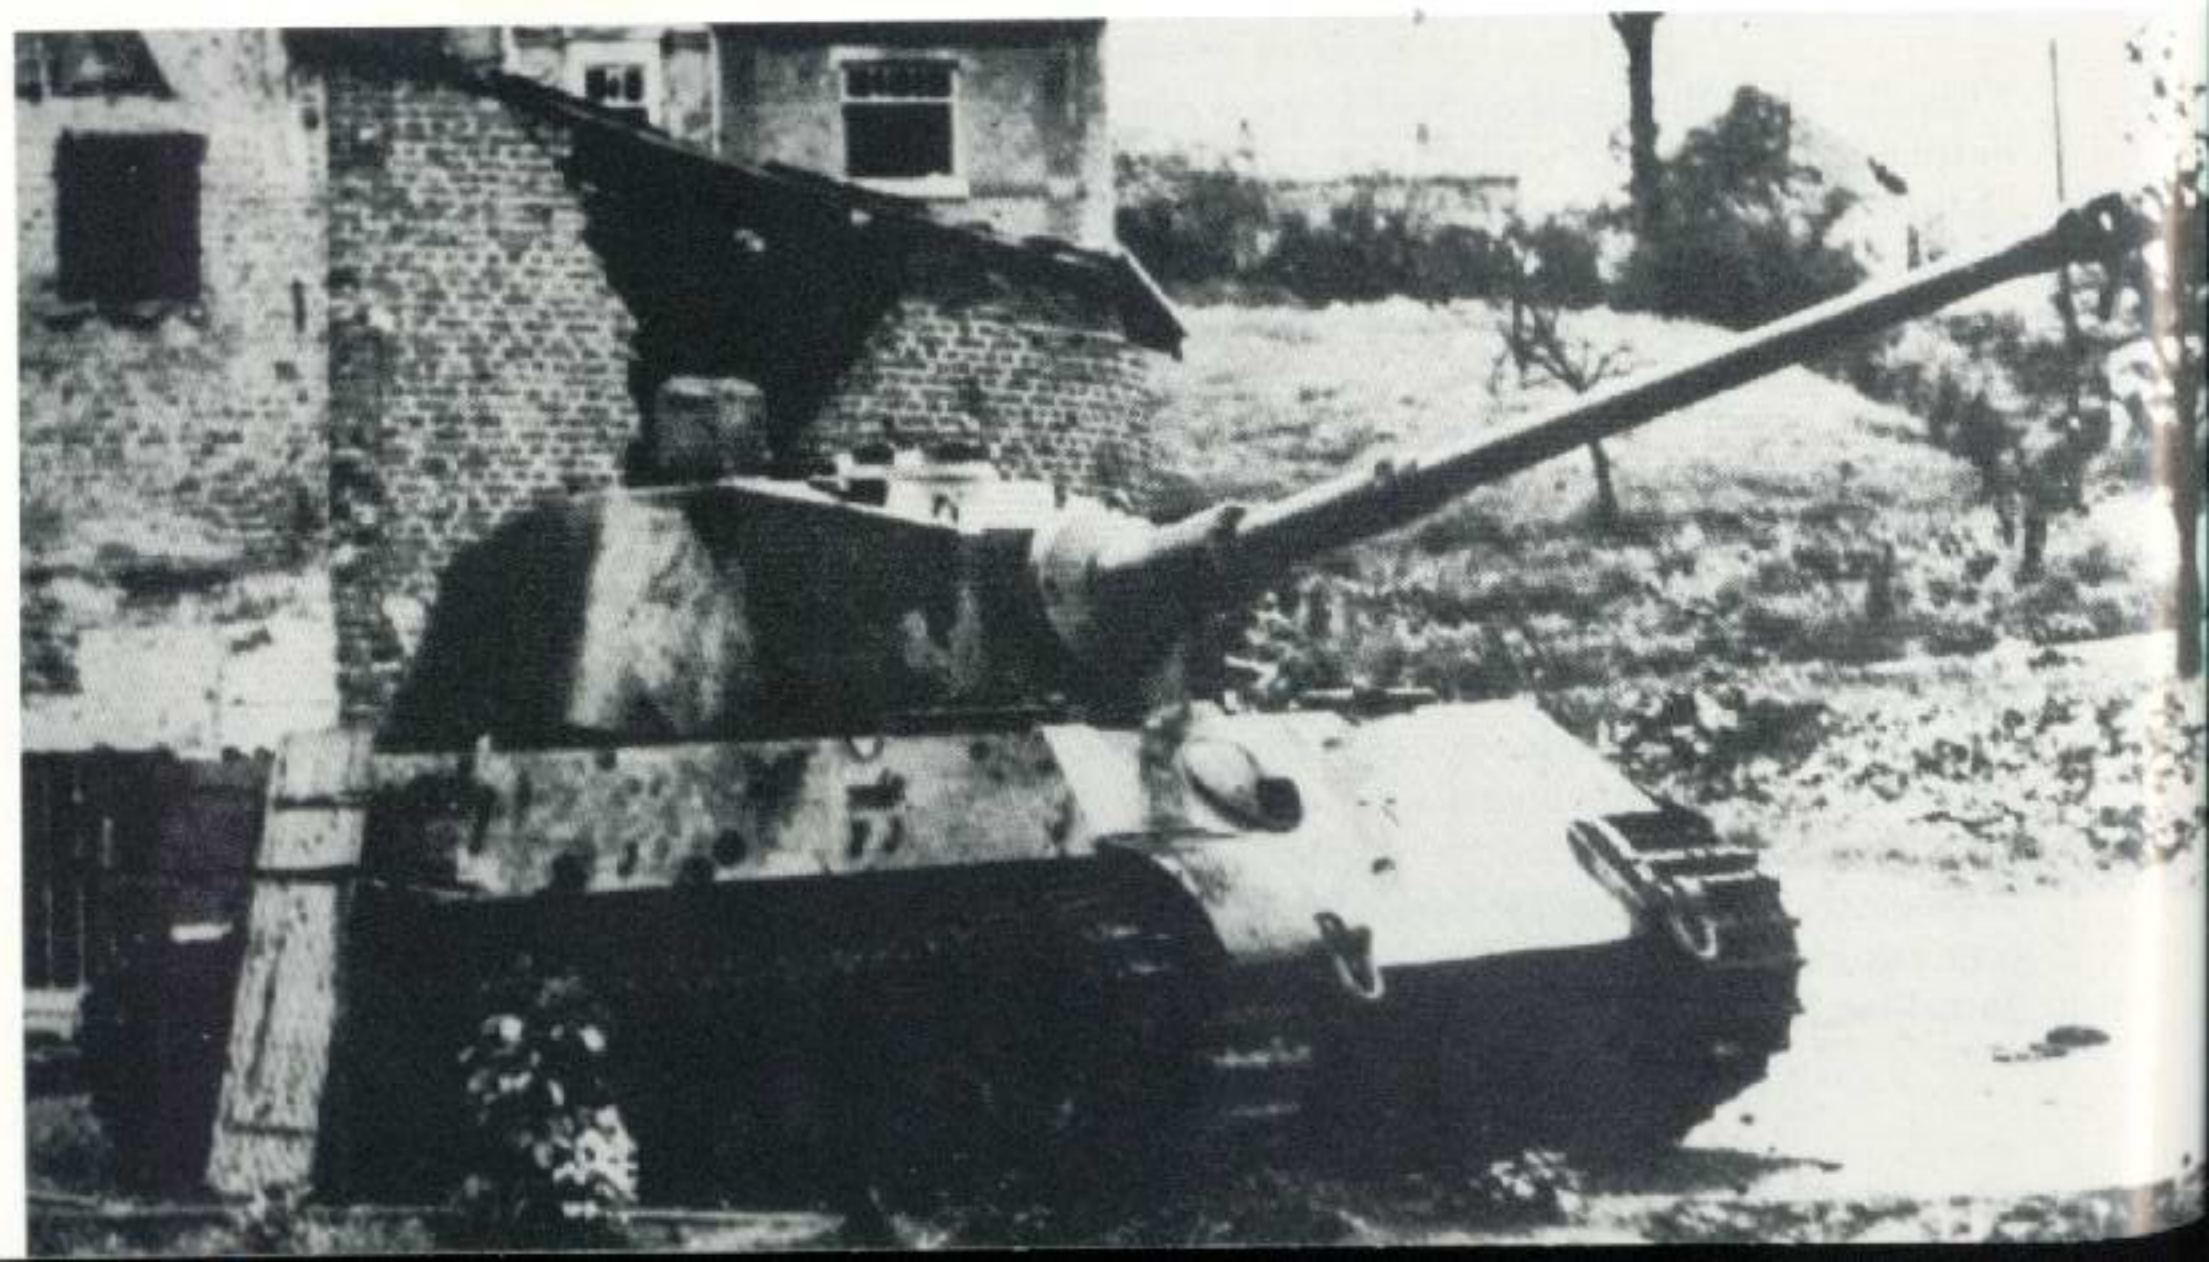
There was daily fighting around the turning point of Stavelot. Tank 222 was hit on the left side of the hull while advancing toward the Ablève Bridge and had to be abandoned.

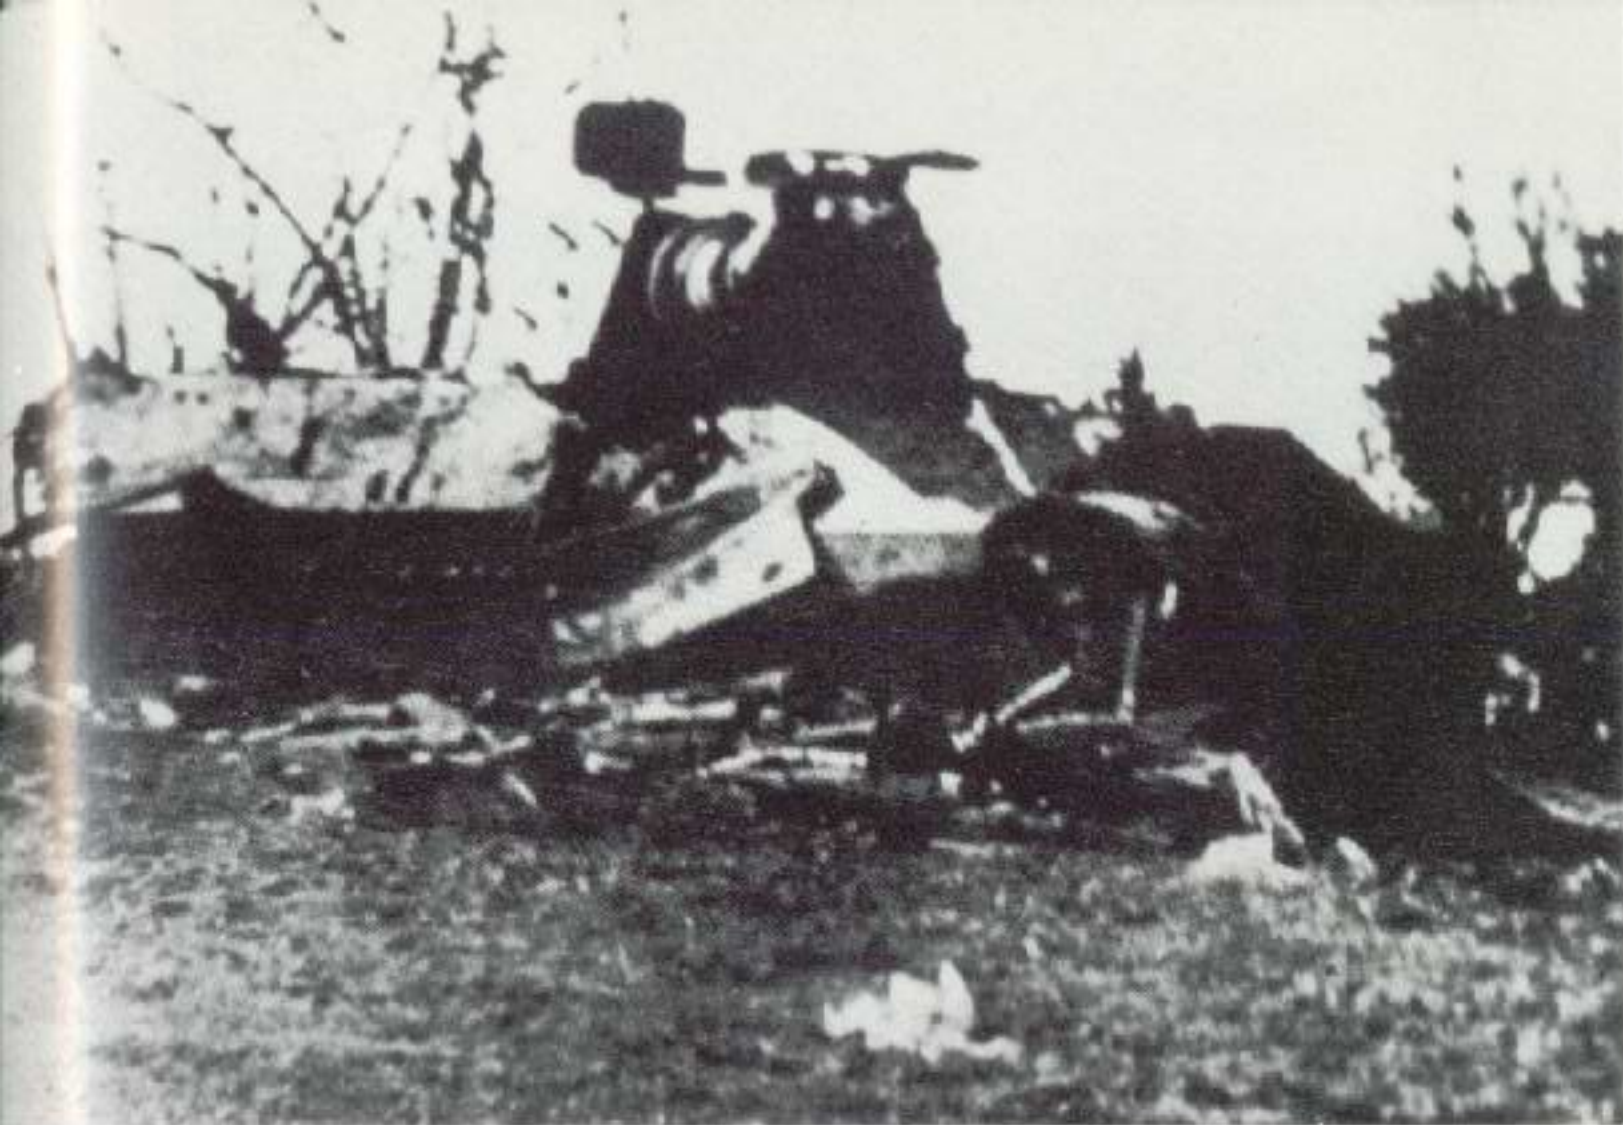
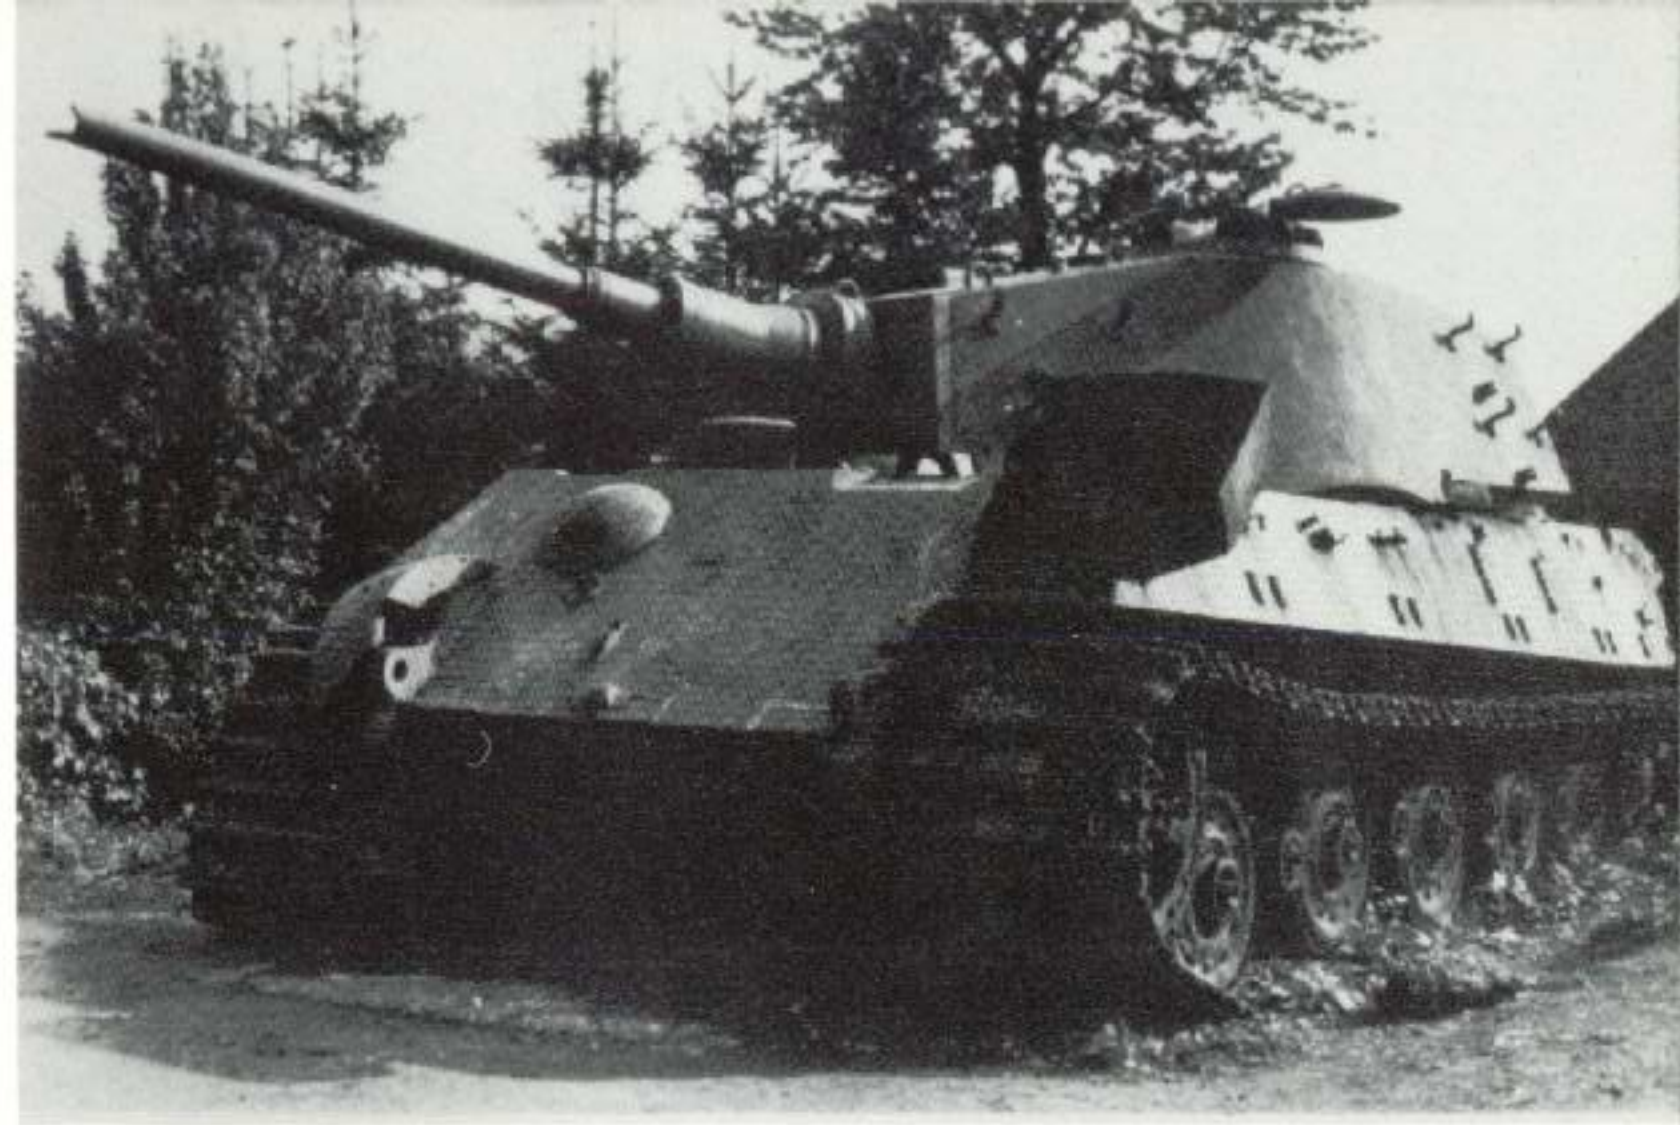
A tank of the 3rd Company threw its right track on Route 33 near Intersection K 22 (1200 meters before La Gleize) and could not be made mobile. Several days later, American soldiers inspected the tank and set off a hand grenade in the turret.

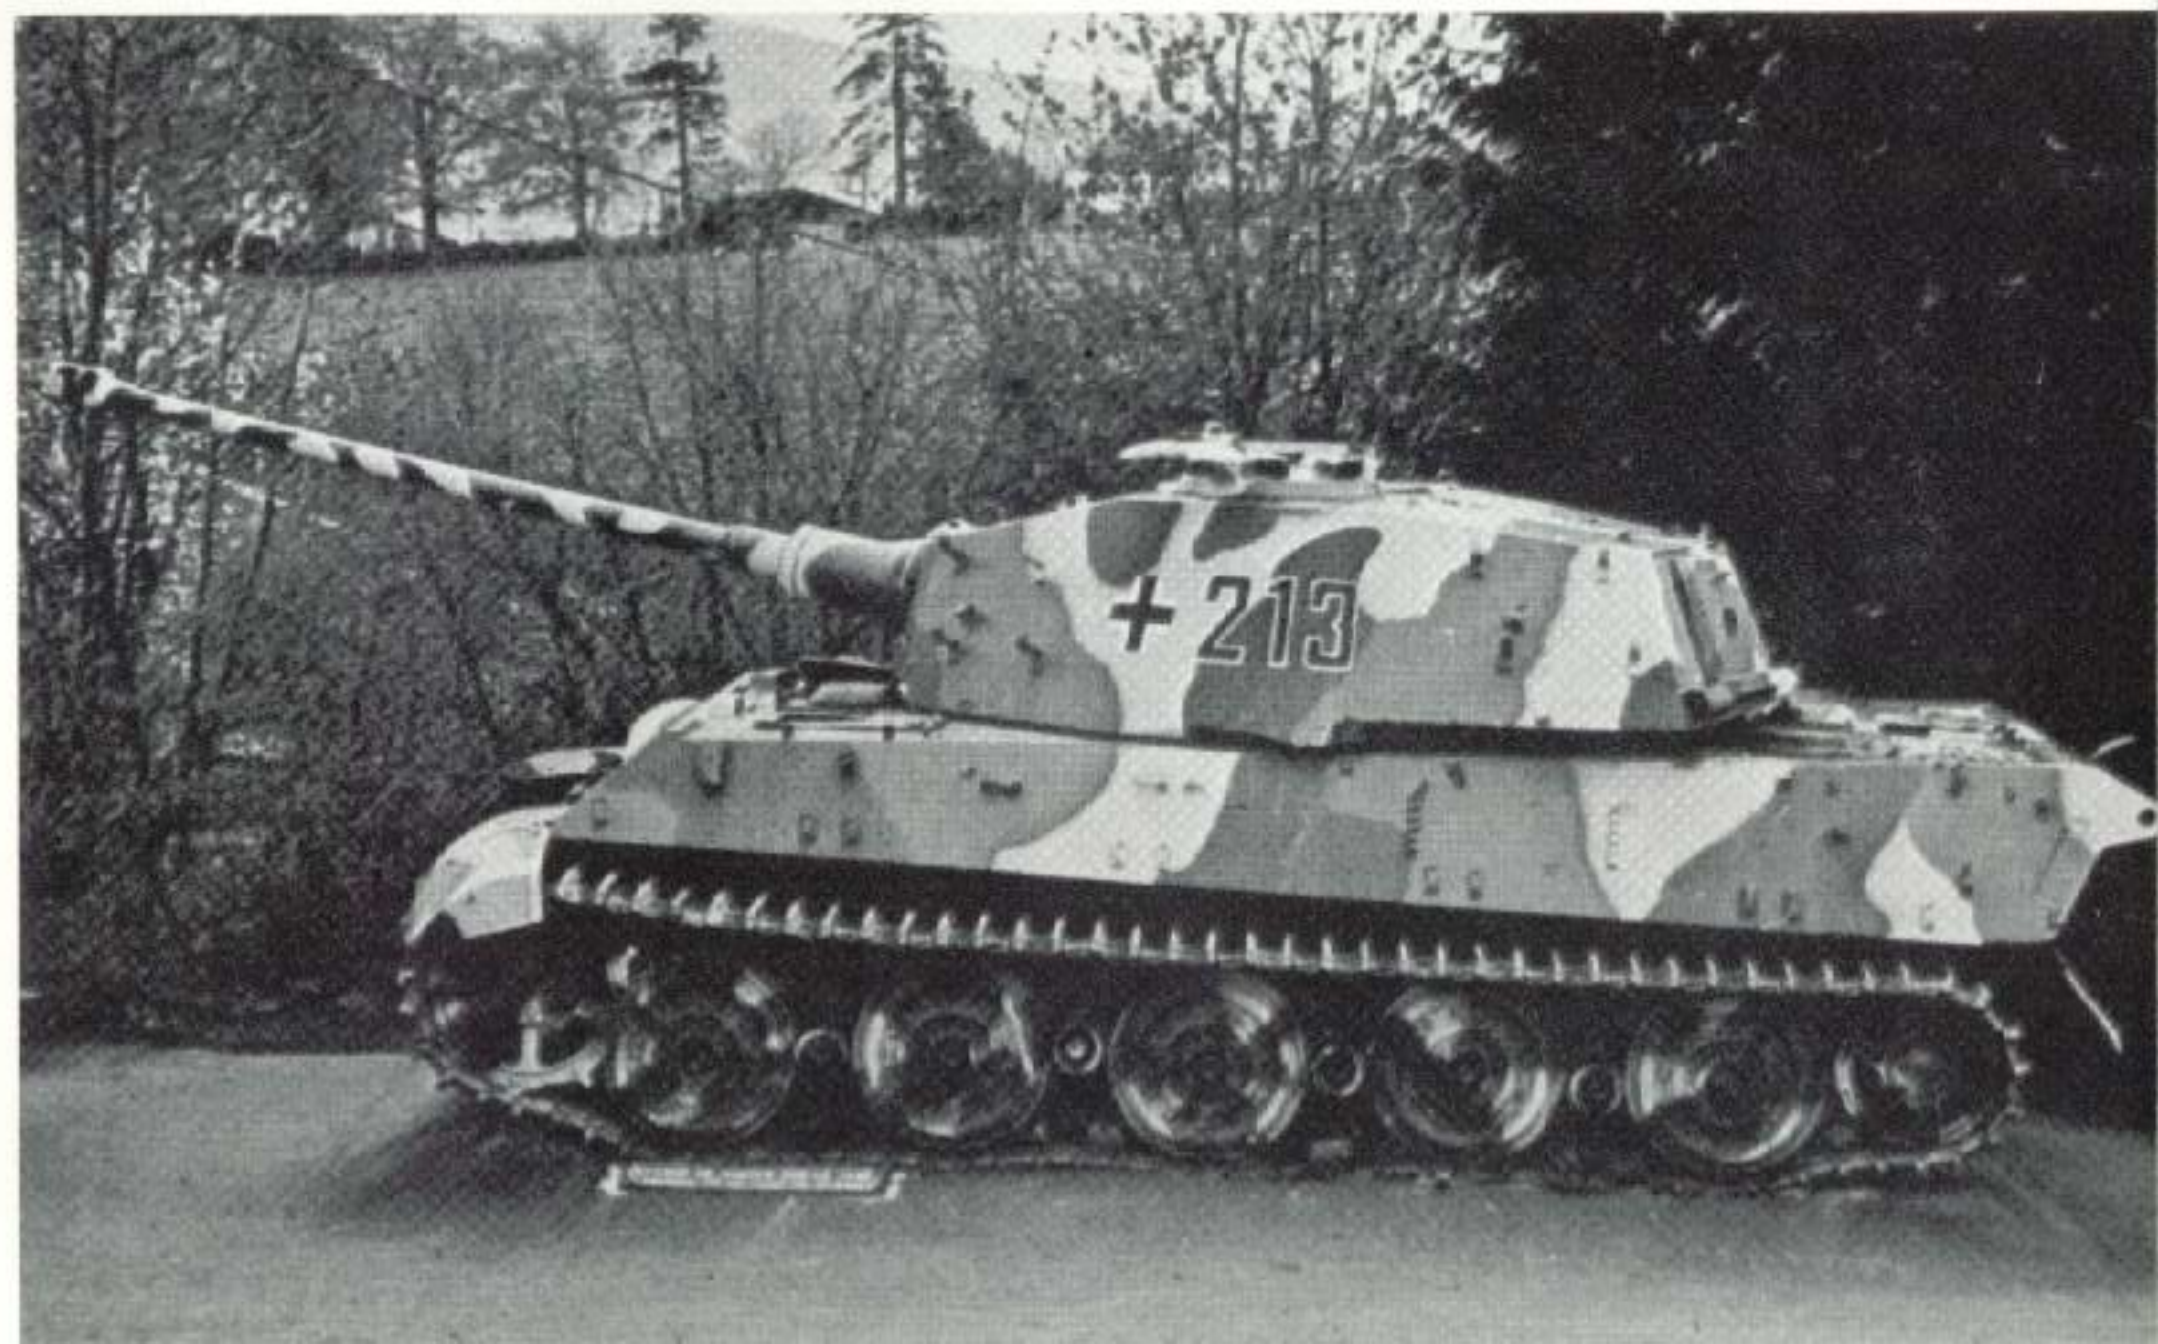
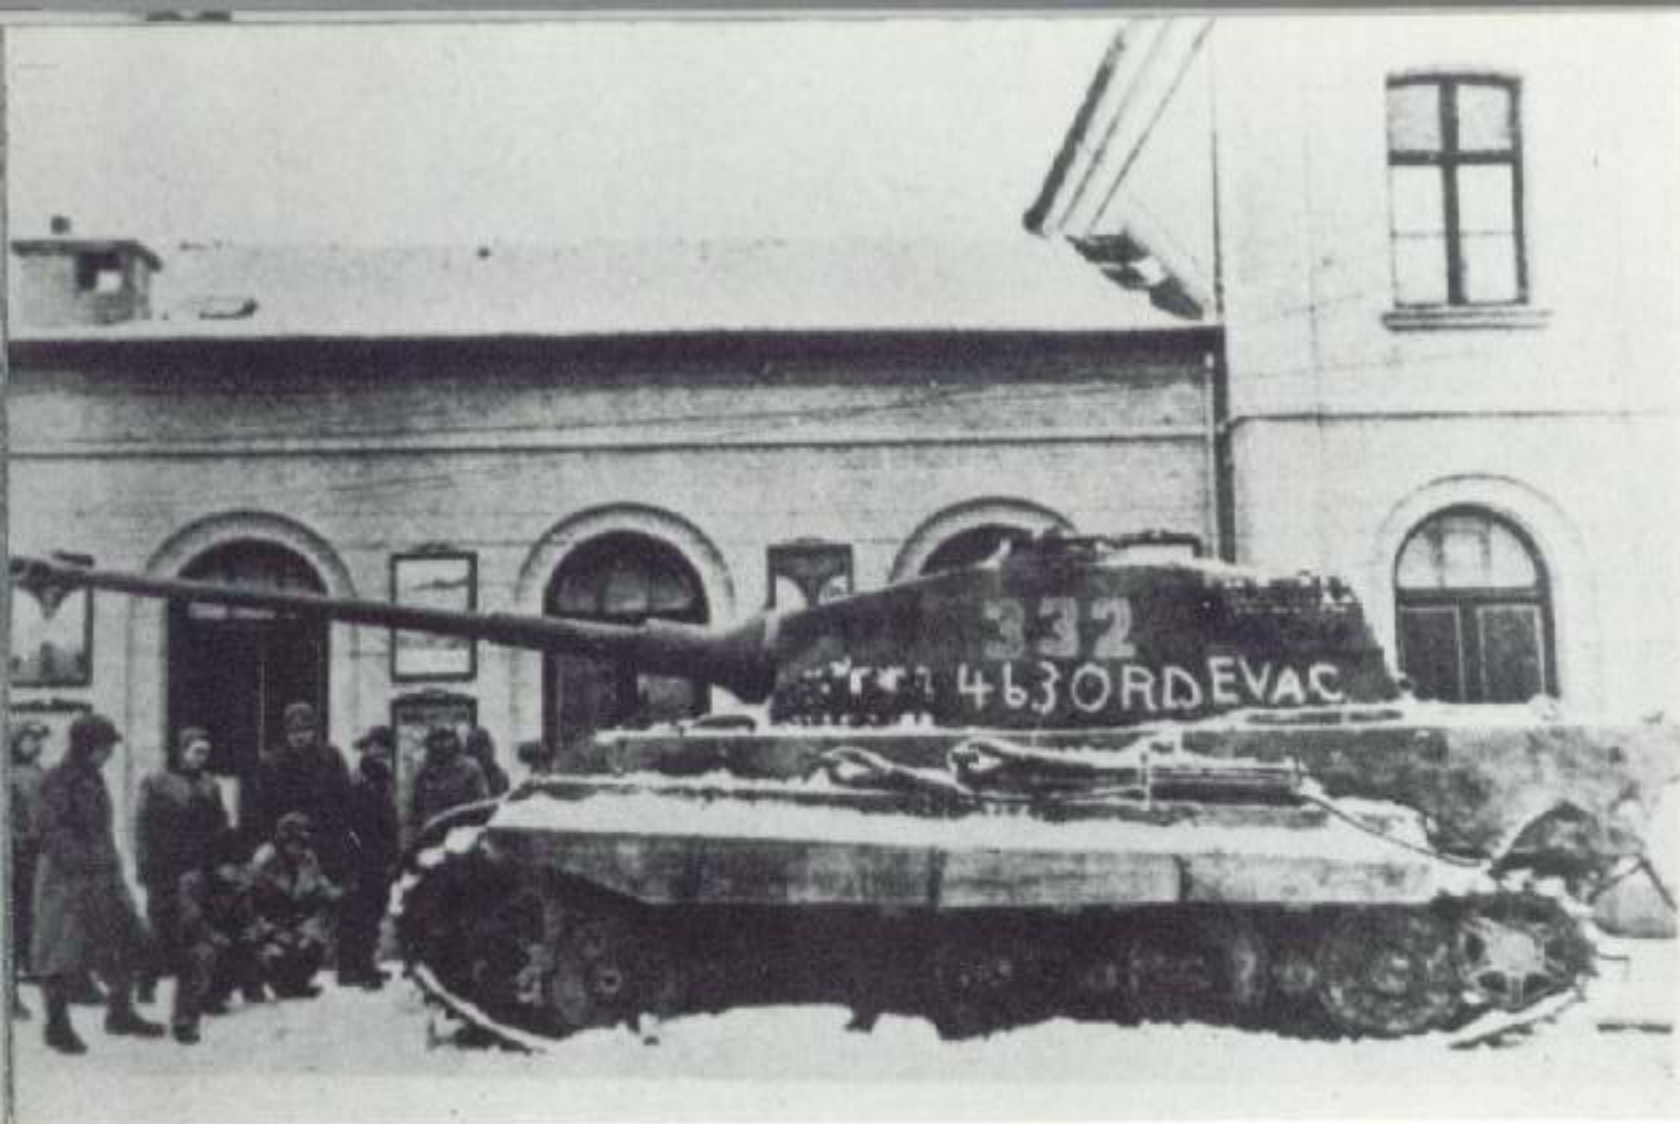
The other tank, No. 213, rusted away until July 1945, when at the people's request the Americans towed it to the village square (upper right). From there it was moved by the Belgian Army to its showplace above the church in August of 1951. In 1975 it was given a non-authentic camouflage paint job (right). Only in 1981 was it given a more accurate one.

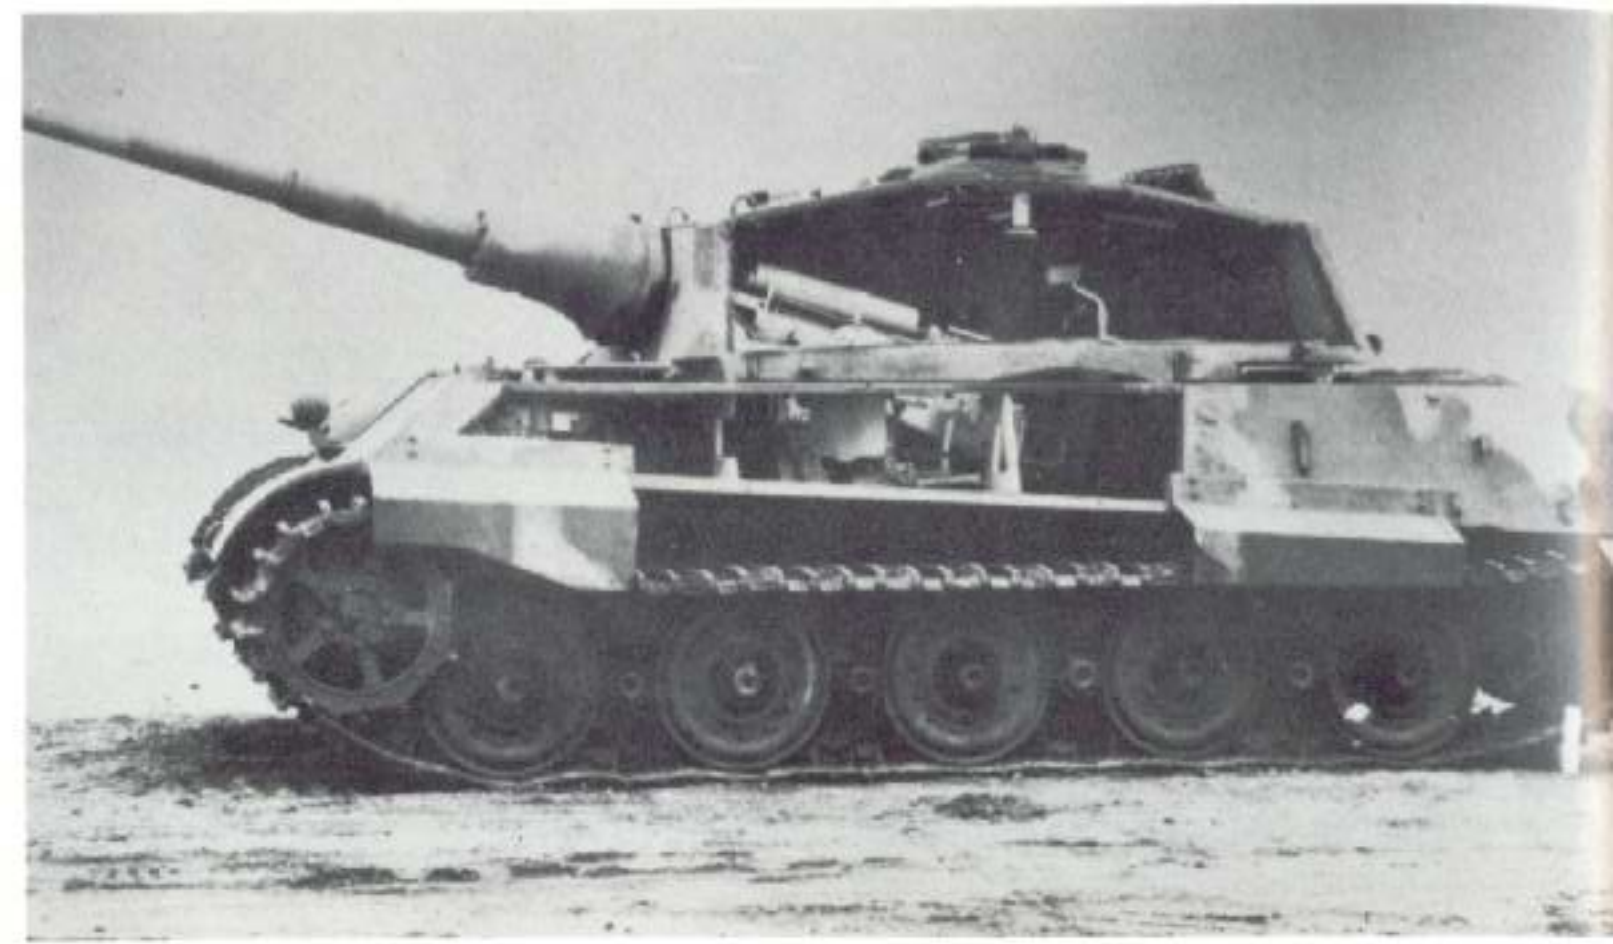
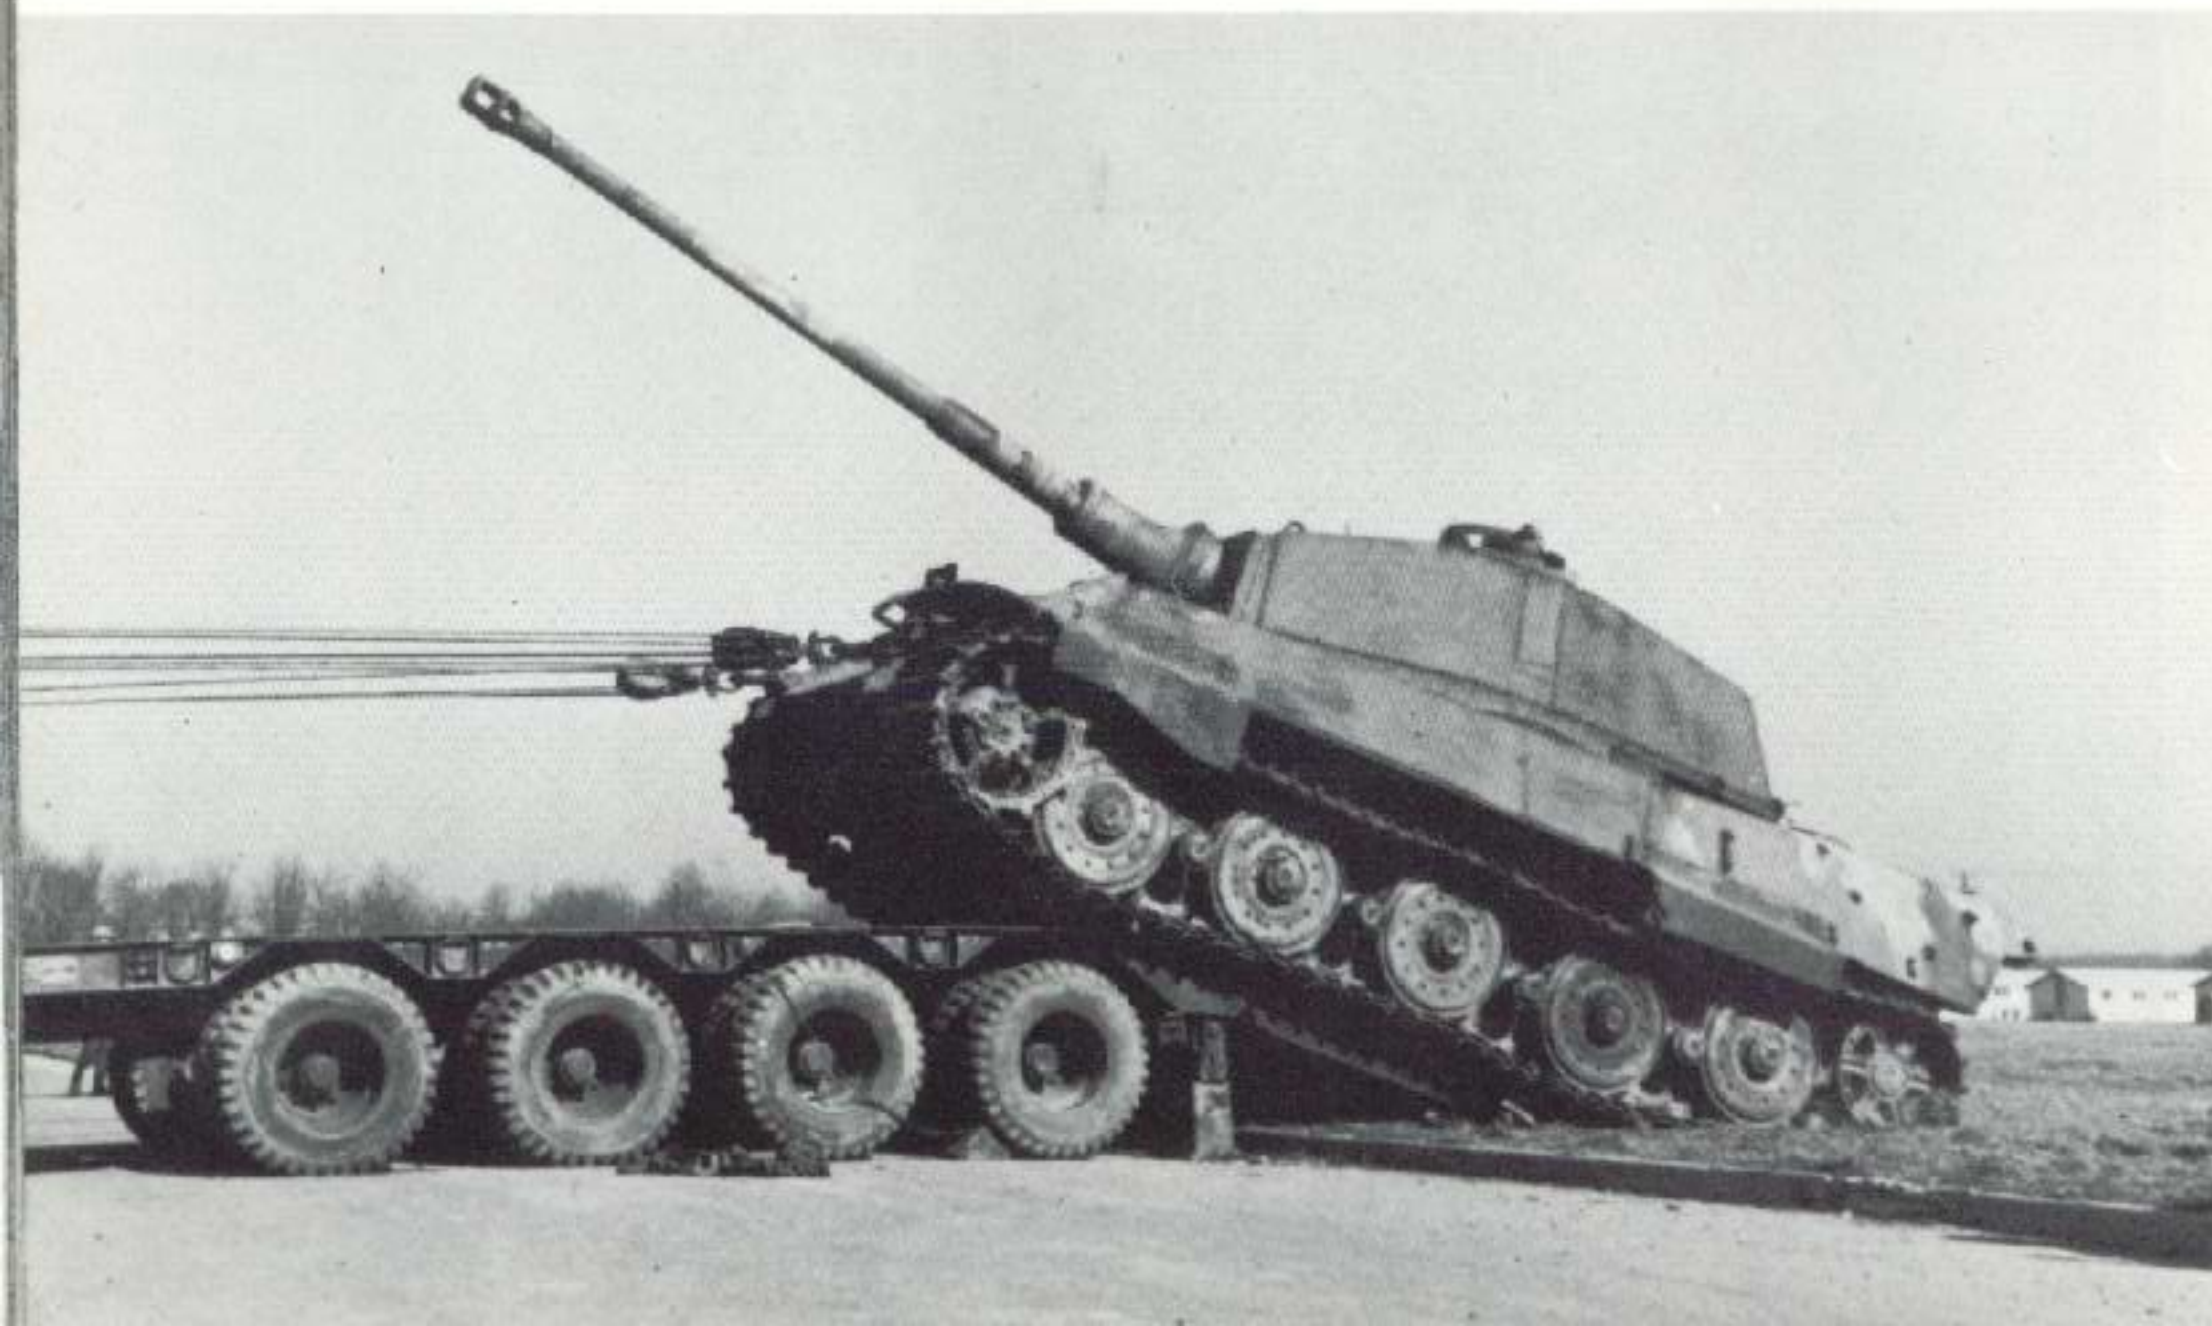
Tiger 332 was abandoned by its crew near Petit Coe and transported to Spa by rail by the 463rd Ordnance Evacuation Company (upper left). From there on it was taken to Antwerp and shipped to the U.S.A., where it was examined thoroughly at the Aberdeen Proving Ground (left). After the openings were closed, it was displayed (unfortunately with an inaccurate paint job).

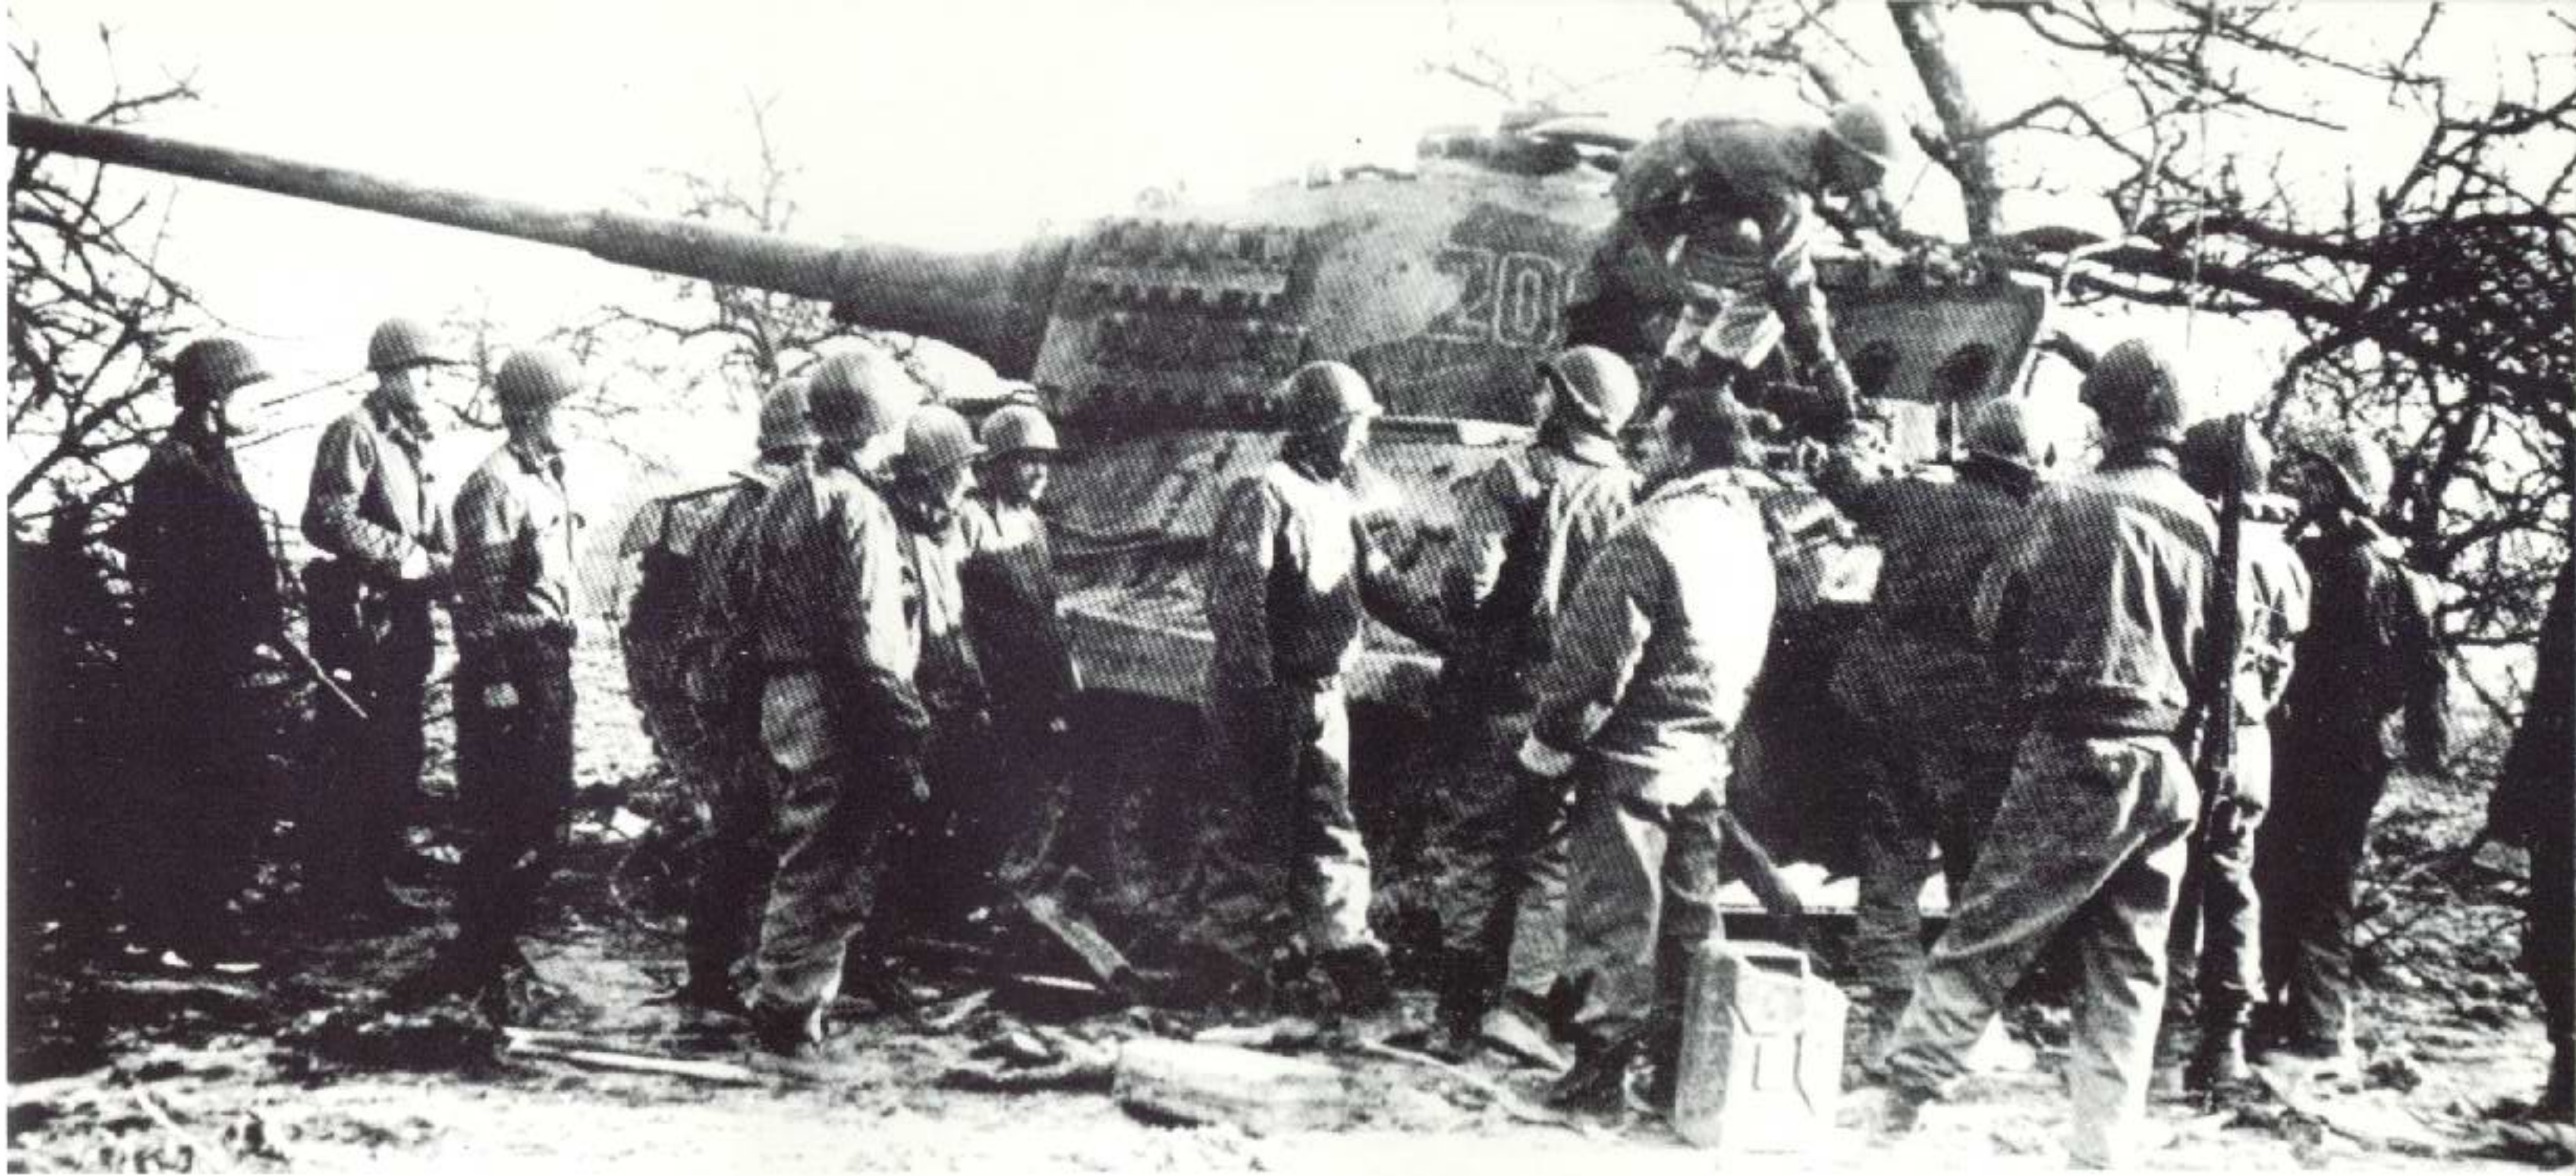
Tiger 204 was stranded in a field without fuel. After being refueled, the tank was driven three kilometers in the direction of the Roanne-Coo railroad station by US soldiers. But it gave up the ghost on an upgrade and stayed there for weeks, an obstacle to traffic, before it was pushed down the slope.
