# The “King Tiger”

## Vol. II

• Development • Units • Operations •

Wolfgang Schneider

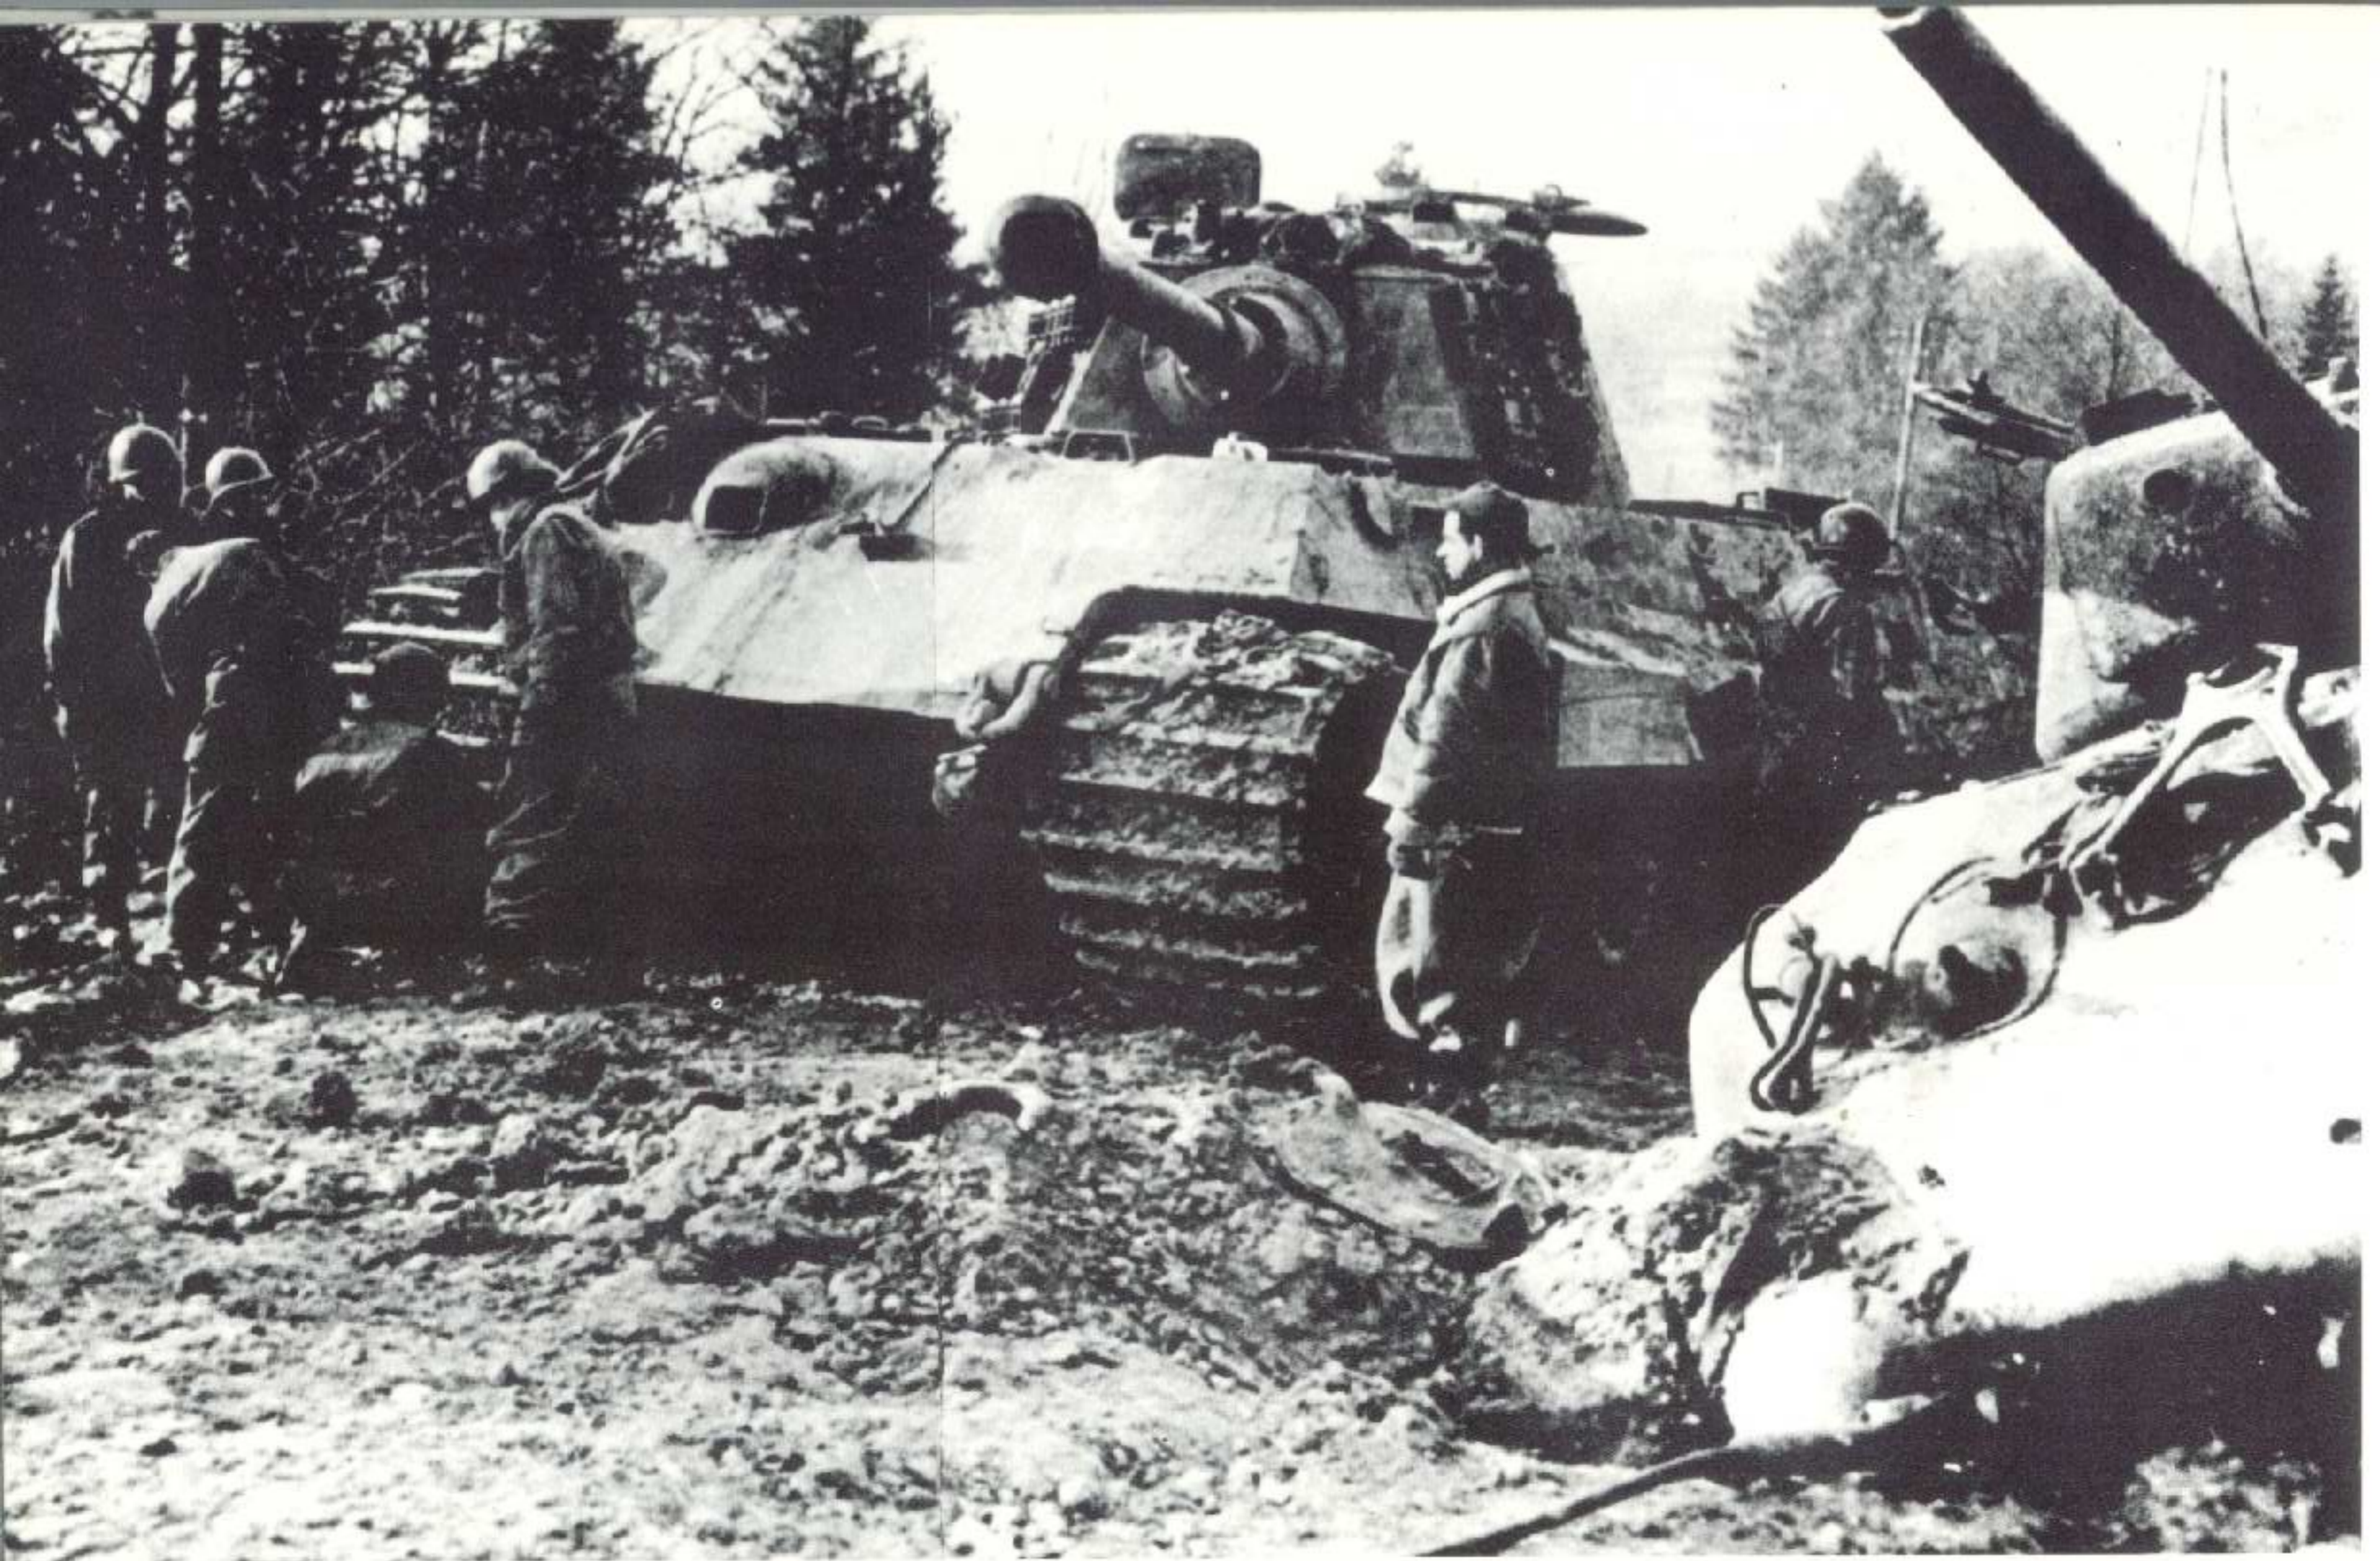
North of La Gleize, Tiger 334 was used to secure Route 33 in the direction of Borgoumont. It slowed up the leading American tanks but was hit in its right running gear. At right is the wreck of a destroyed M 4 A 1 (76) tank. To clear the road, it was pushed into the ditch along the road once the tracks were detached.

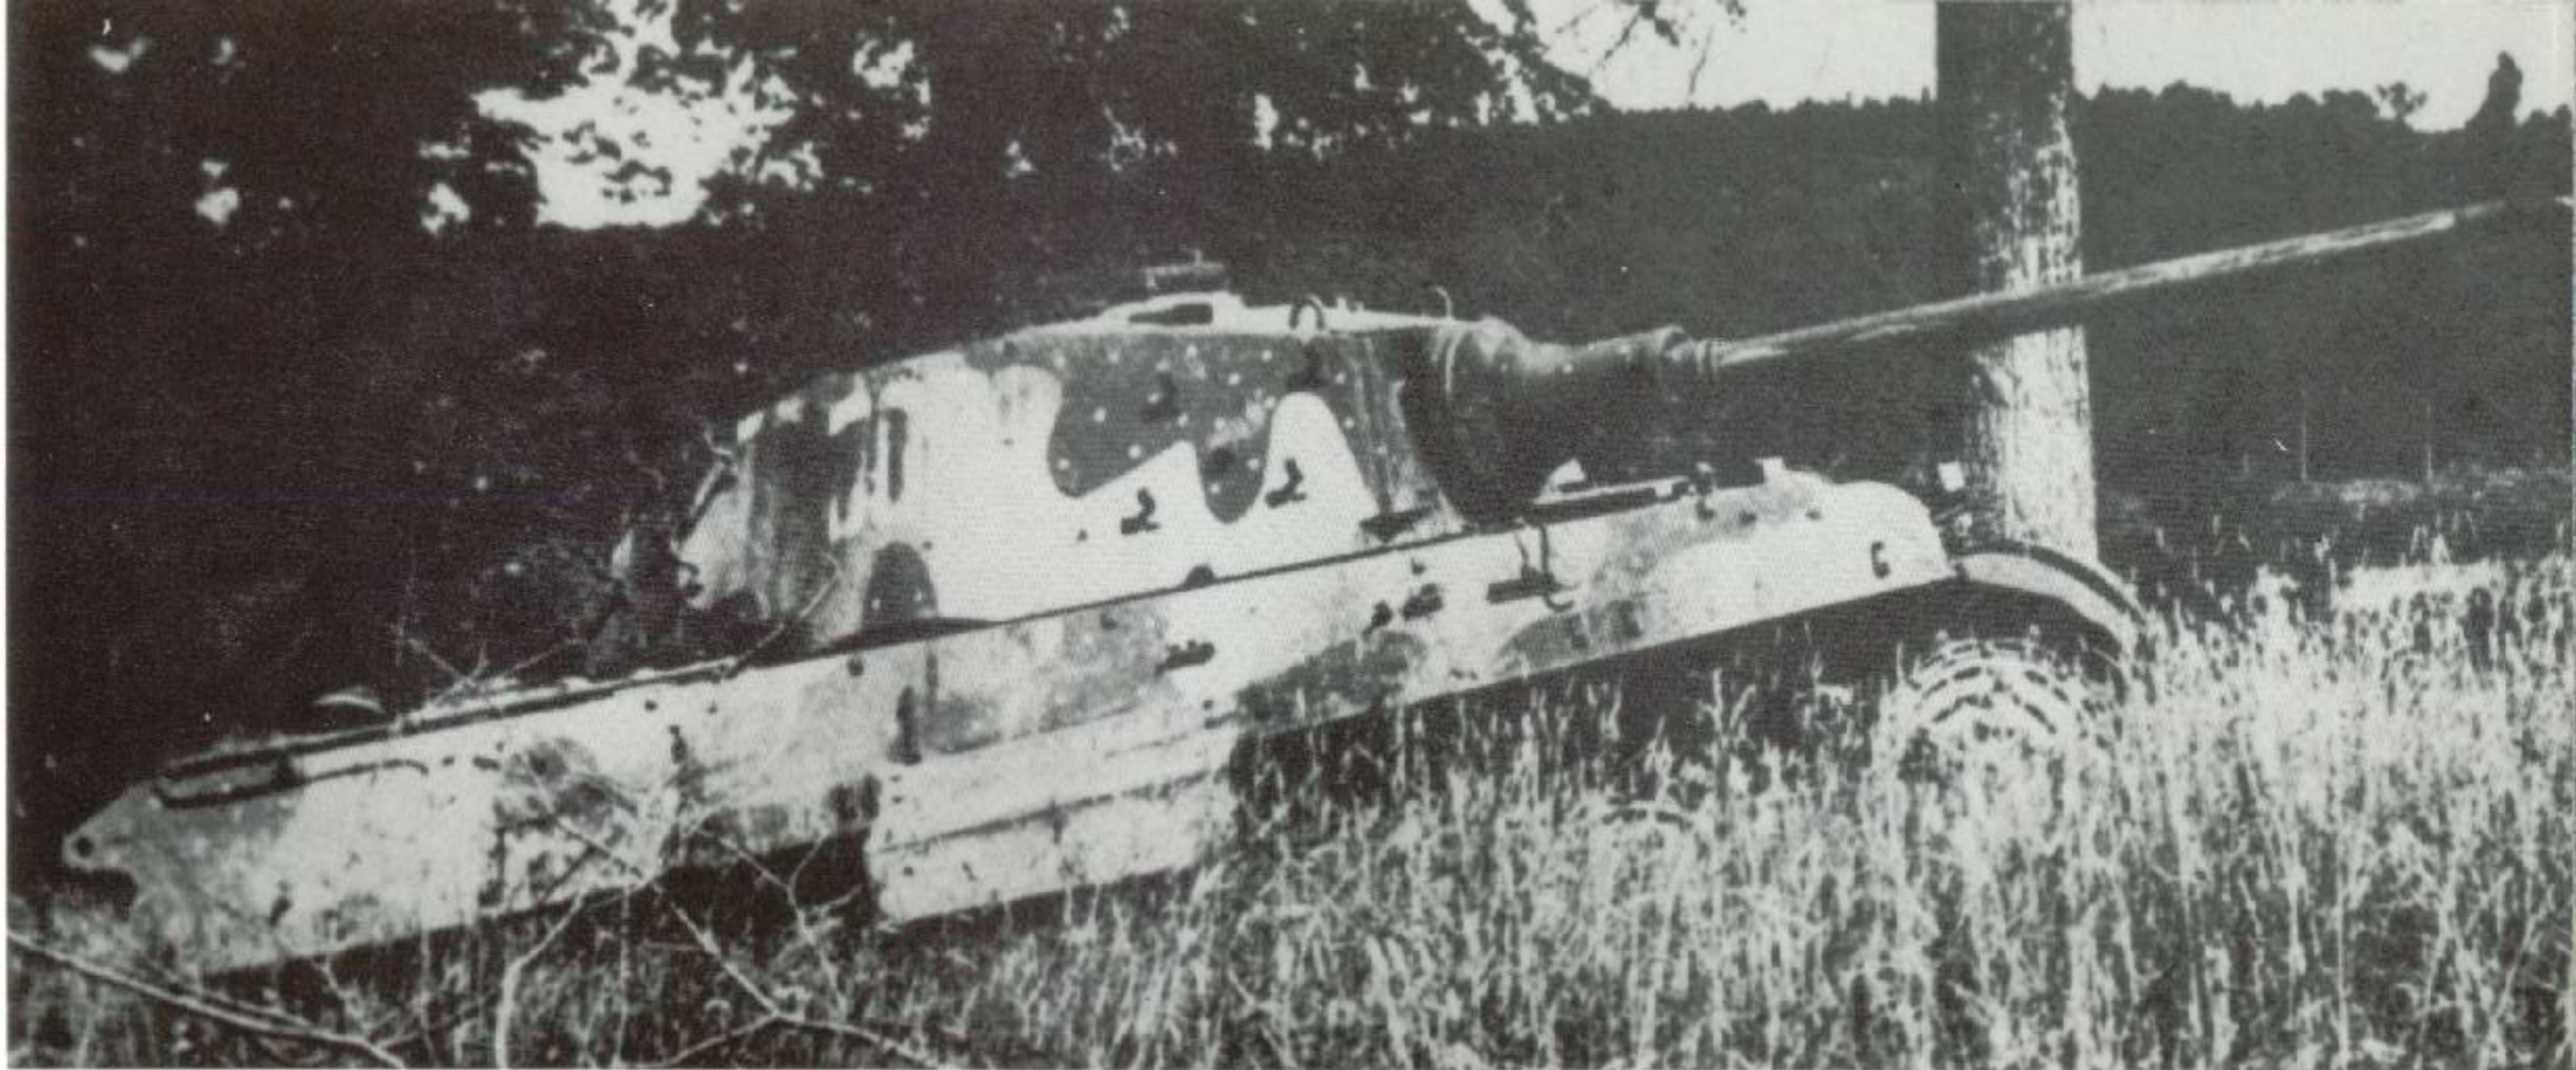
Above:  
Beyond Stavelot Tank 003, also seen in the Tondorf photos (page 34), was hit in the running gear. Before the crew abandoned it, they blew the muzzle brake so that the cannon would not move forward again after its last shot.

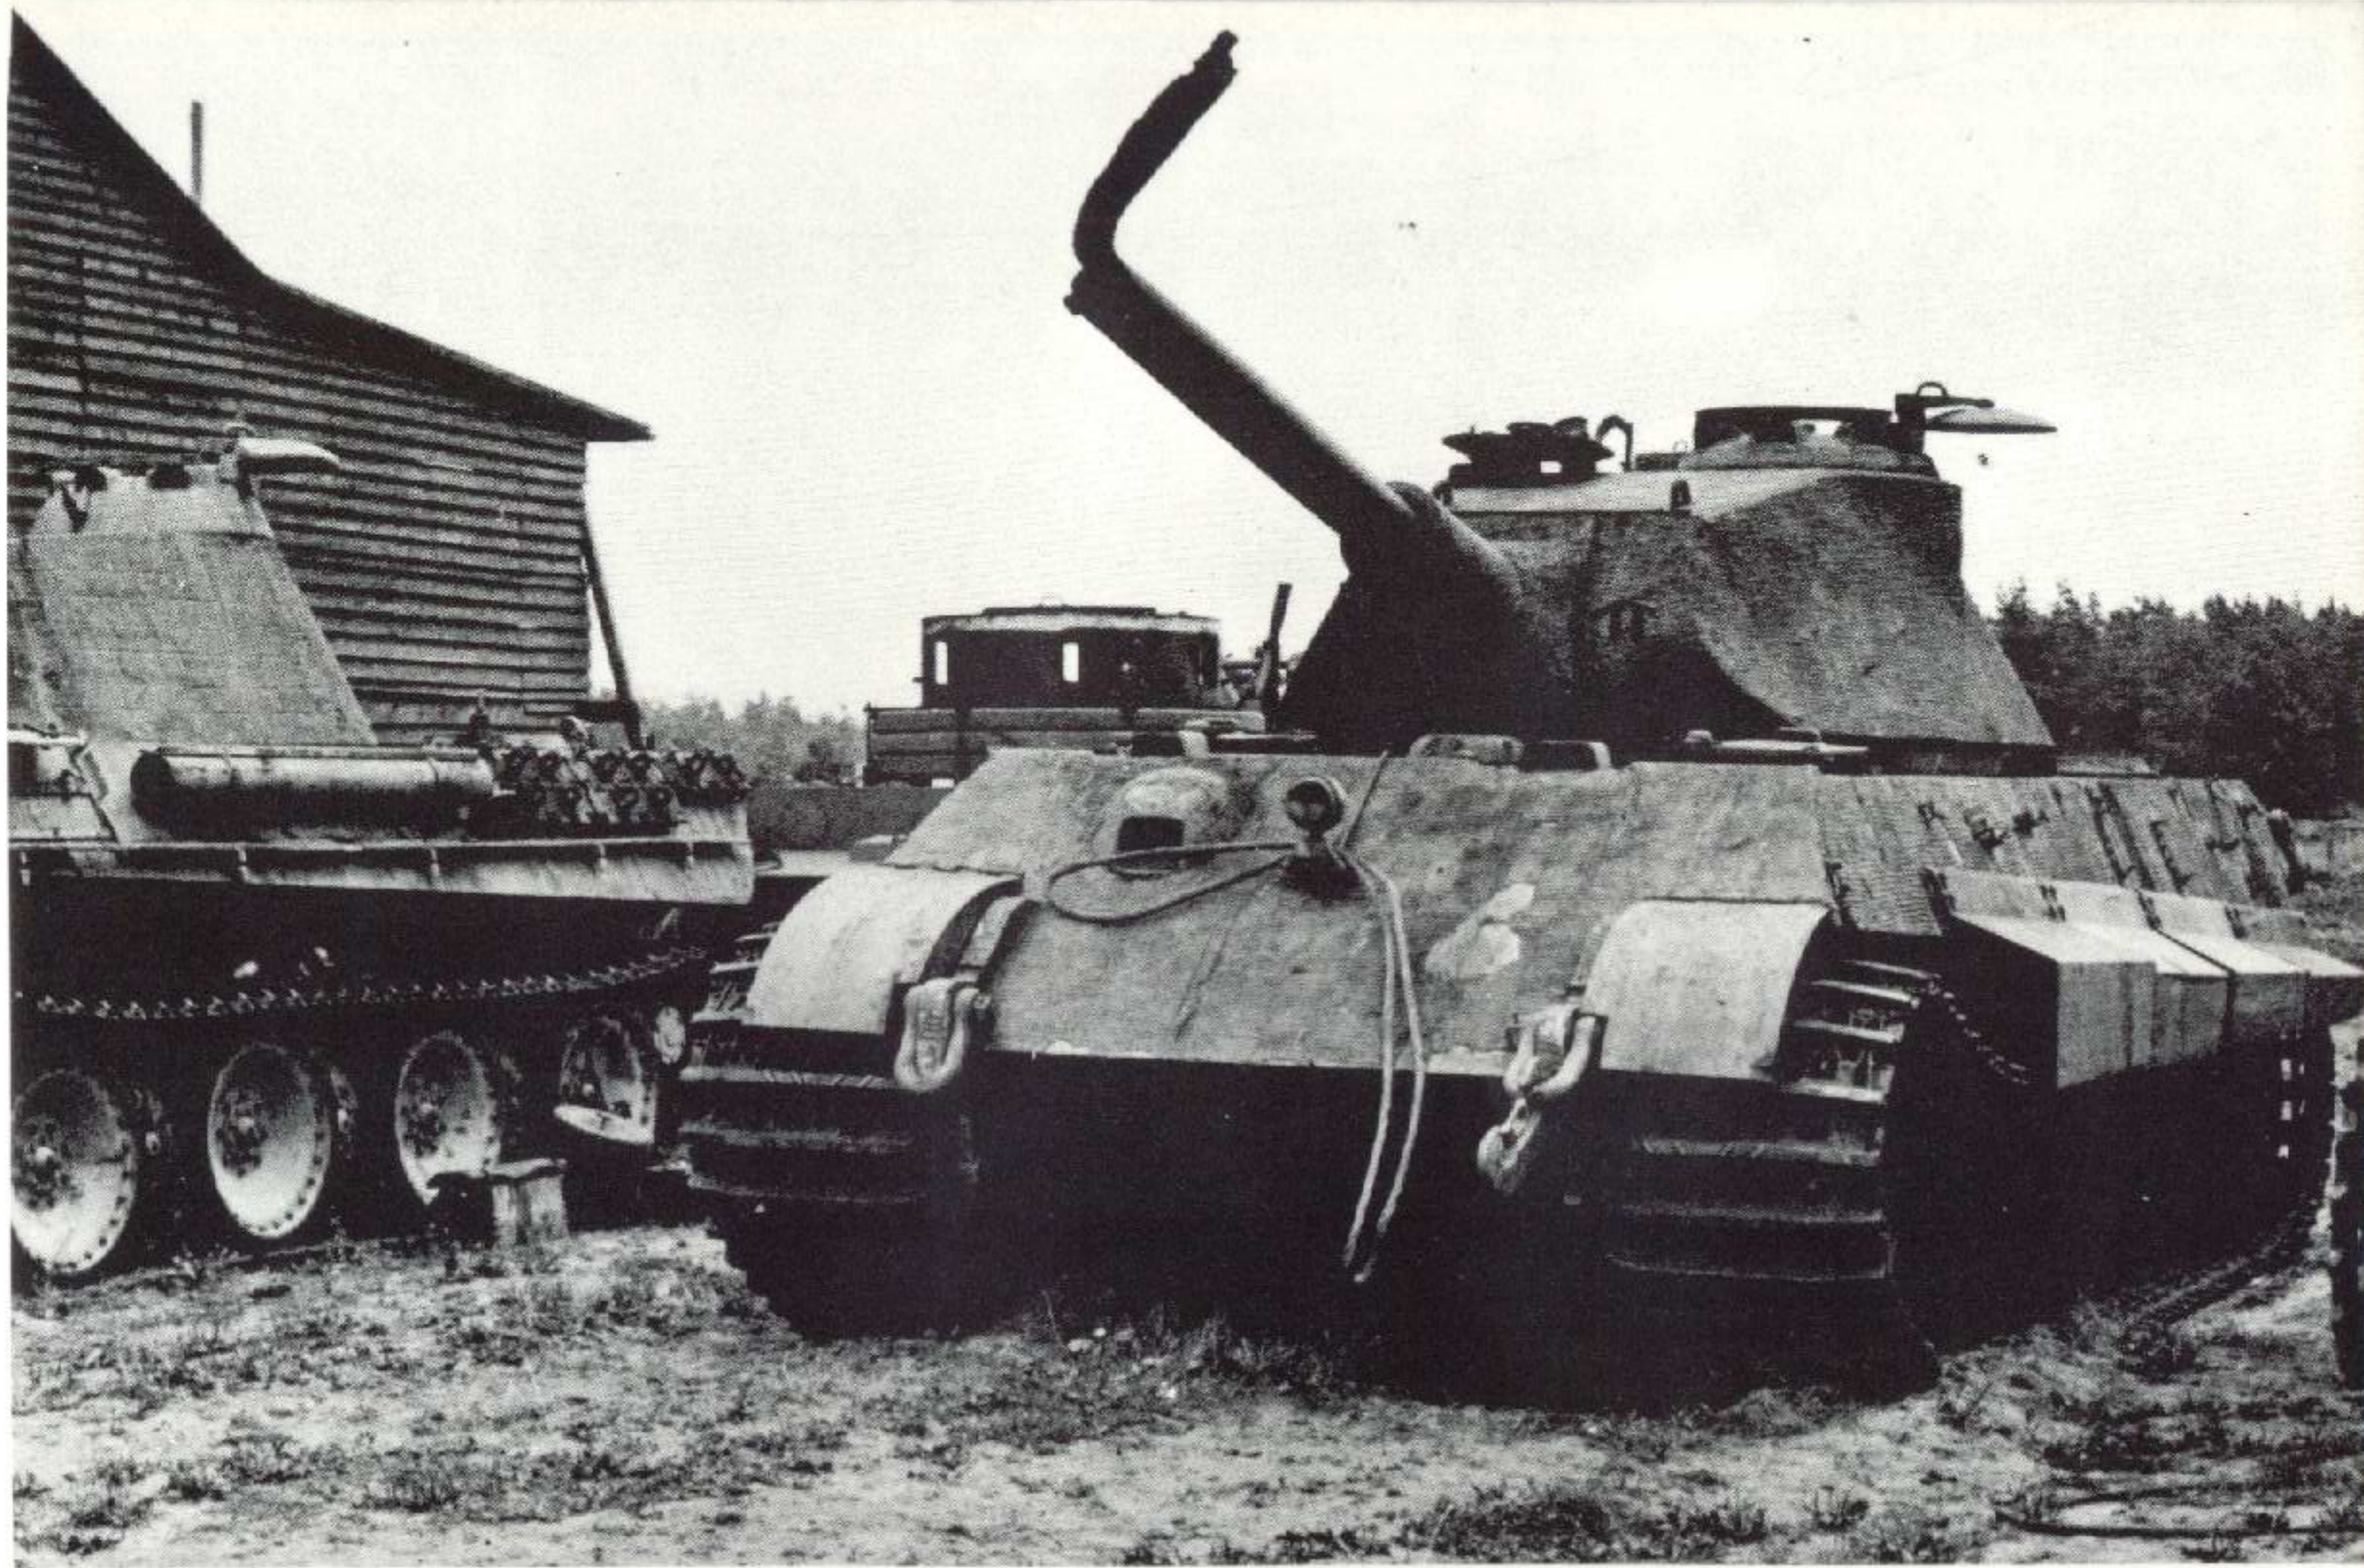
The end: Made useless by barrel damage, this abandoned Tiger (with Porsche turret) waits to be scrapped on the grounds of Tank Unit 500 in Paderborn. To the right of the tank is a Panther V tank, and diagonally behind it the turret weight used on the VK 4501 (H) can be seen.

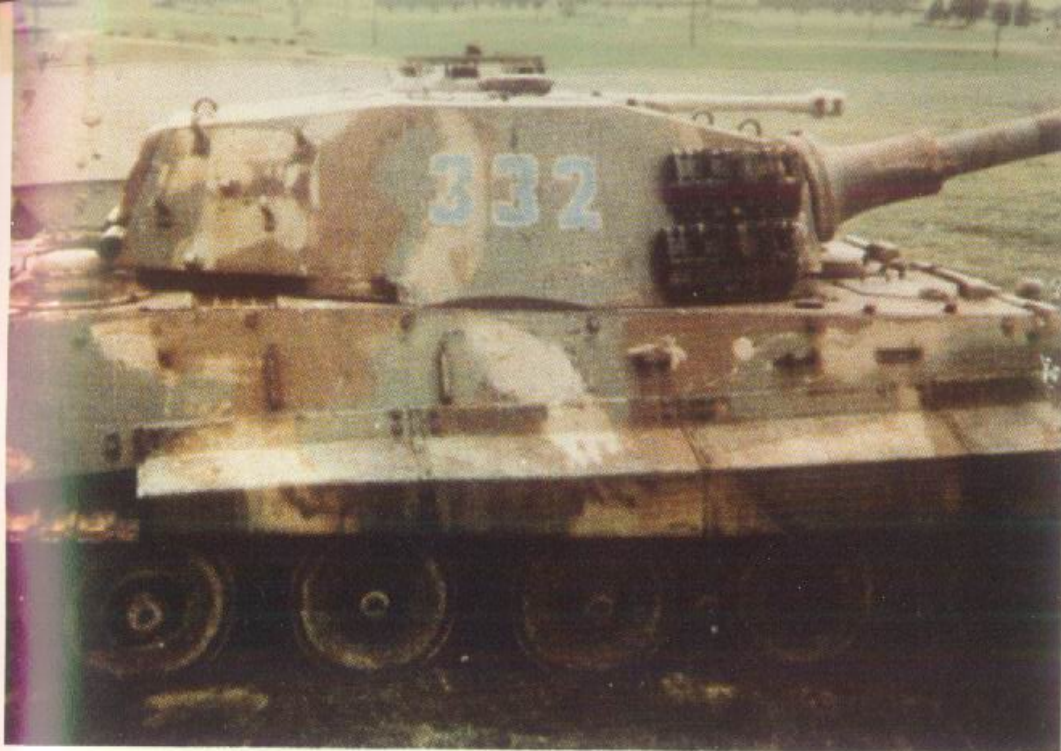
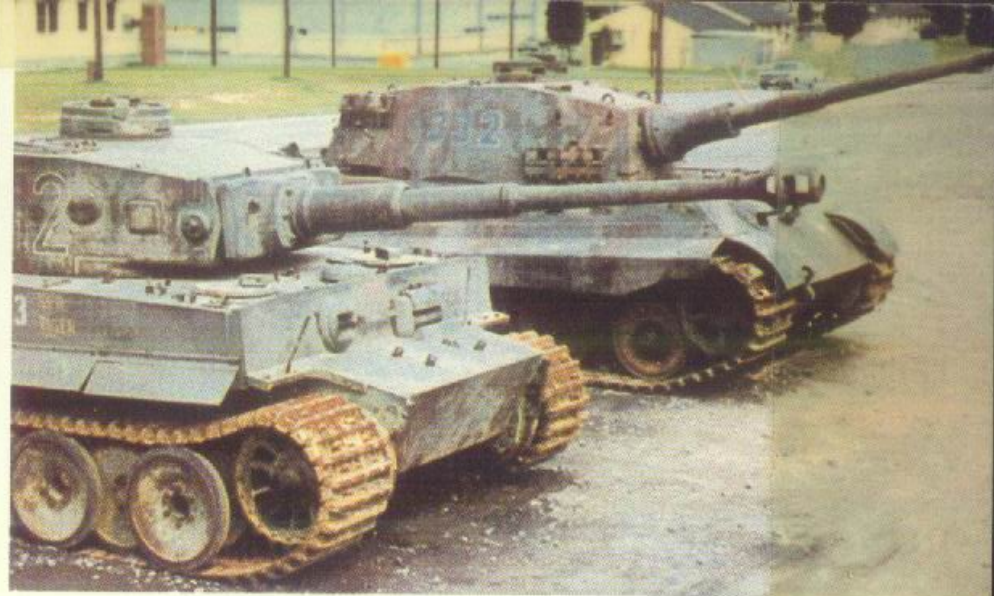
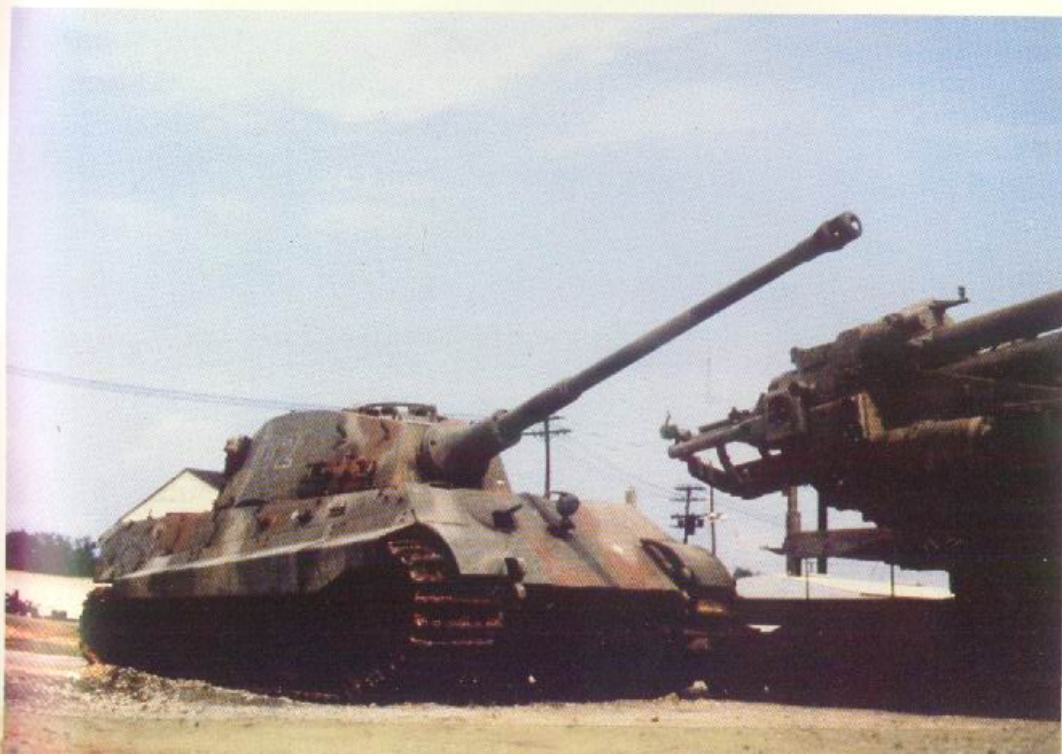
These three rare photos were taken shortly after the war (upper left) or in the early 1950s and show the tanks at the Aberdeen Proving Grounds in the United States in their original condition, with blue turret numbers. On the forward hull sides and at left on the bow plate is the emblem of Heavy Panzer Unit 506 (a white cross on a round red background). Later it was painted very incorrectly (below).

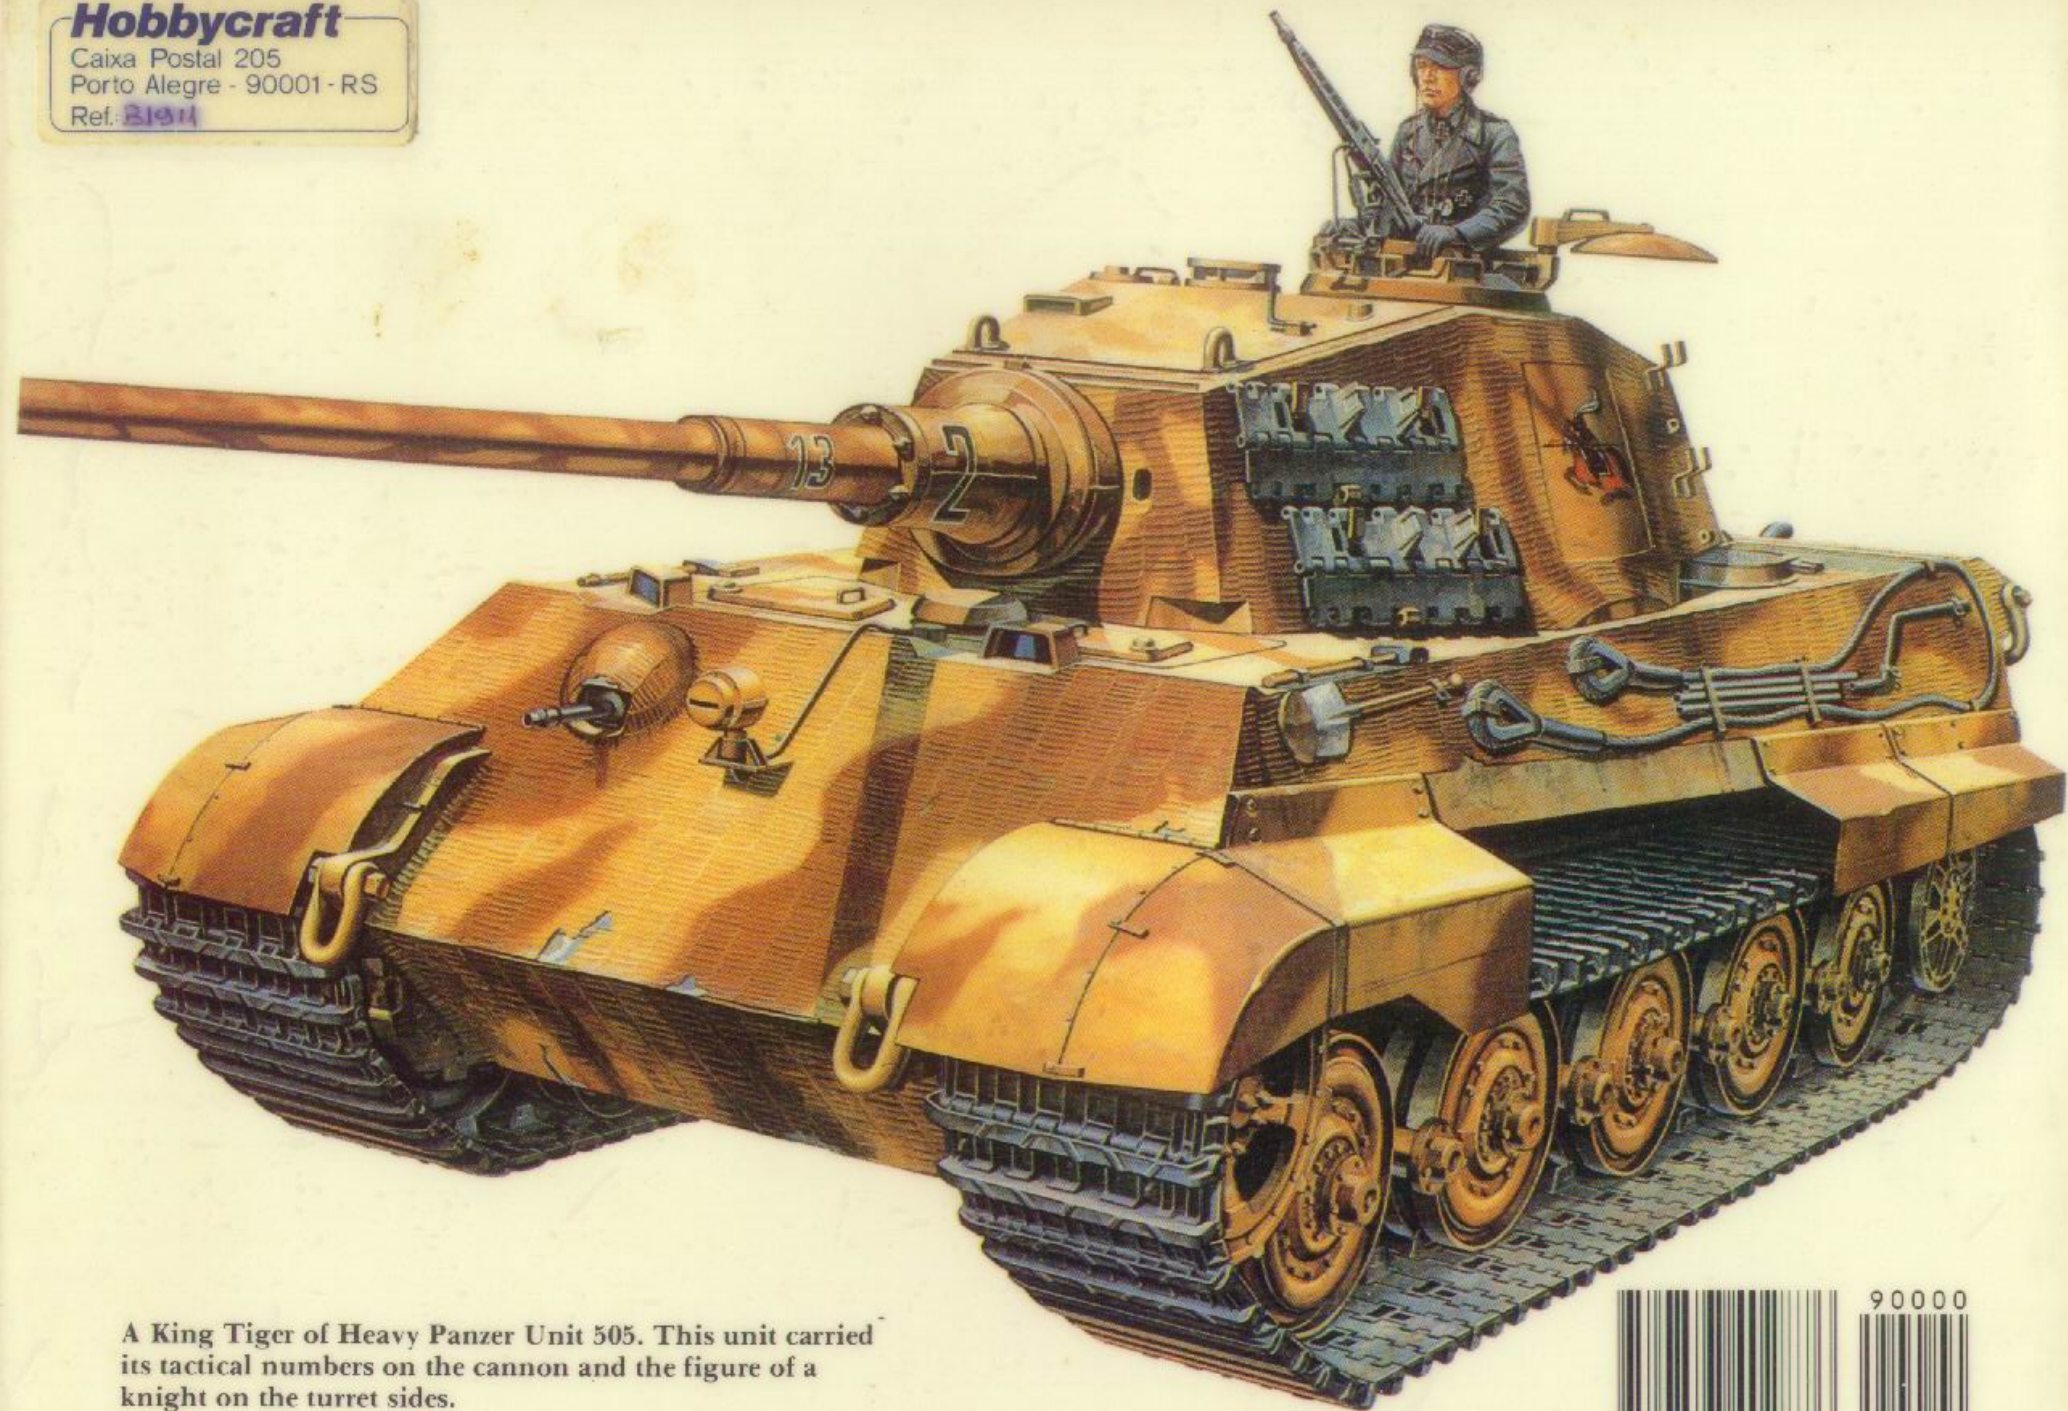
A King Tiger of Heavy Panzer Unit 505. This unit carried its tactical numbers on the cannon and the figure of a knight on the turret sides.
