# The Battle of the Bulge

Steven Zaloga

# Introduction

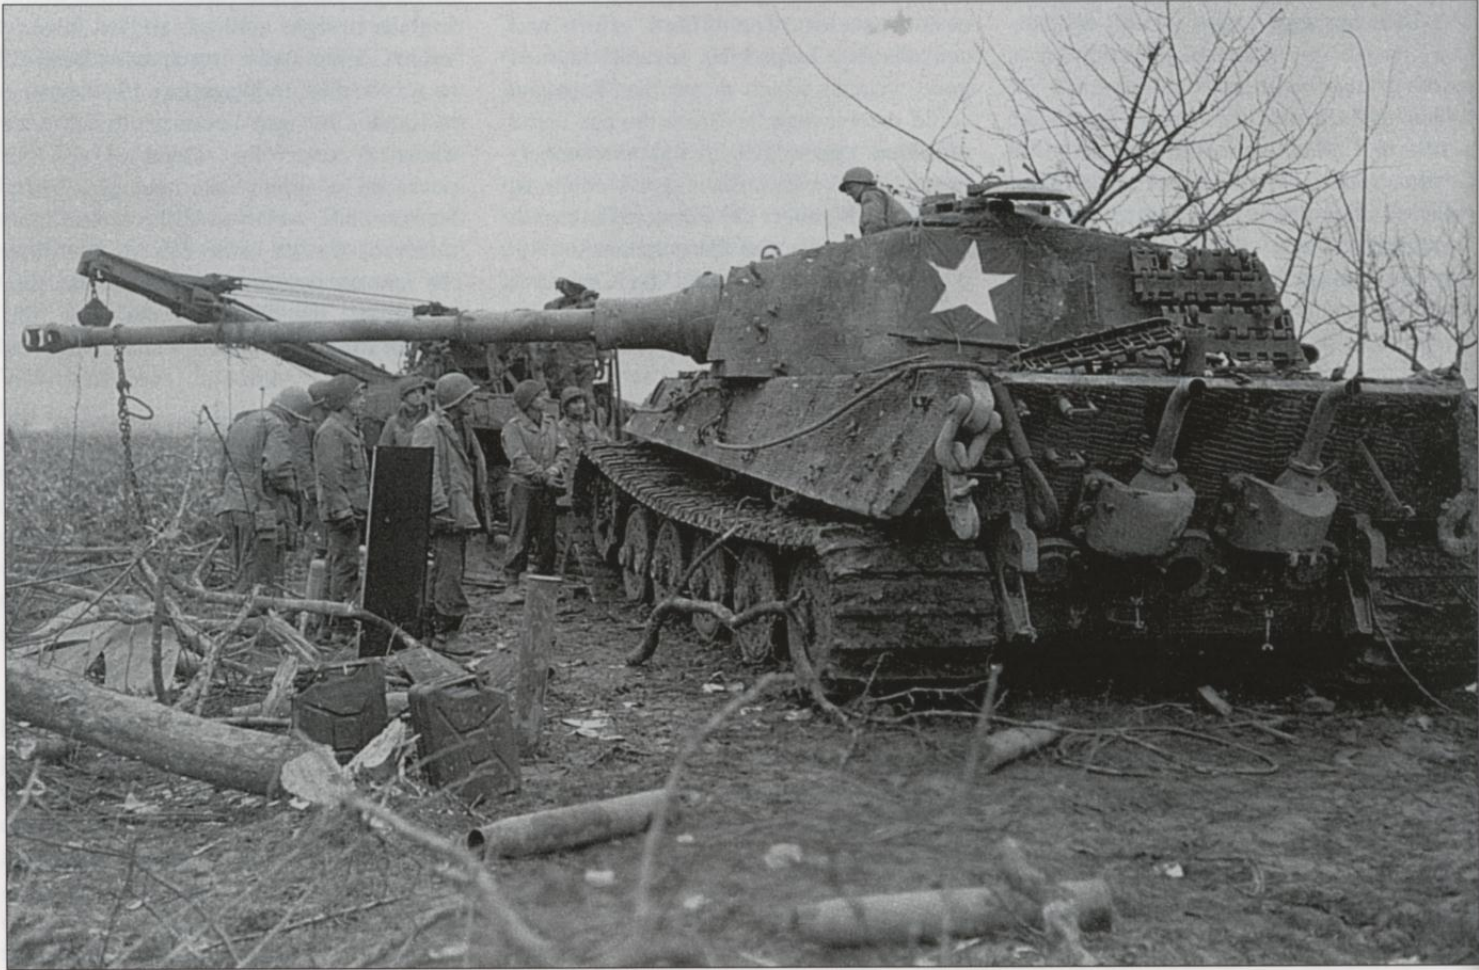
In anticipation of the Ardennes fighting, German panzer units were brought up to near full strength. The s.Pz.Abt. 506 was rebuilt, but lost this tank, tactical number 2-11 near Geronsweiller on 15 December, a day before the start of the Ardennes offensive. It was recovered by the US 129th Ordnance Battalion as seen here.

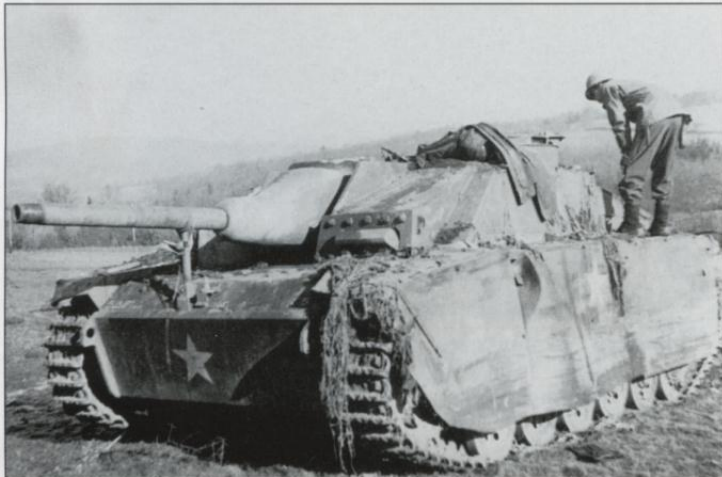
Besides the Panther tanks, five StuG III assault guns were converted for Panzer Brigade 150. Since they bore no resemblance at all to any US vehicle, their camouflage seems rather odd. The muzzle brake was removed, and side skirts added. This one was abandoned near the Baugnez crossroads, site of the infamous Malmédy massacre.

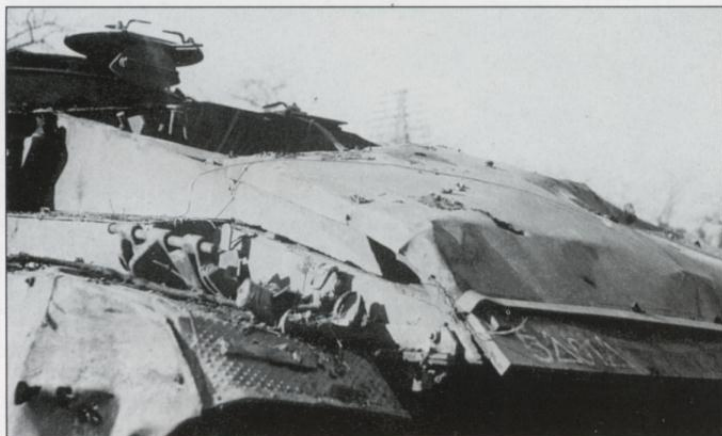
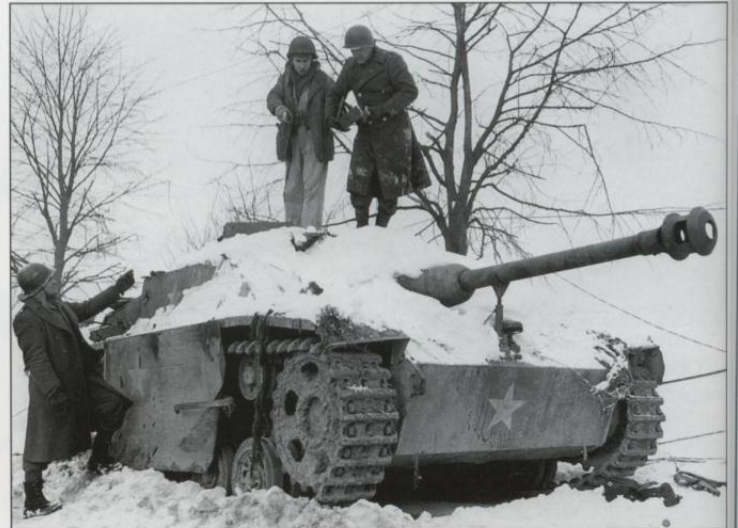
This StuG III of Panzer Brigade 150 was abandoned and booby trapped following the failed attack on Malmédy. Here, some troops from the 291st Combat Engineer Battalion are attempting to remove the booby-traps. Mud has obscured the tactical markings on the vehicle, but the false US stars are still plainly evident.

For unknown reasons, a false engine deck was added to the StuG III conversions. In the lower left corner, the false bumper codes are evident, identifying the vehicle as belonging to the 5th Armored Division, which was not in the Ardennes at the time!

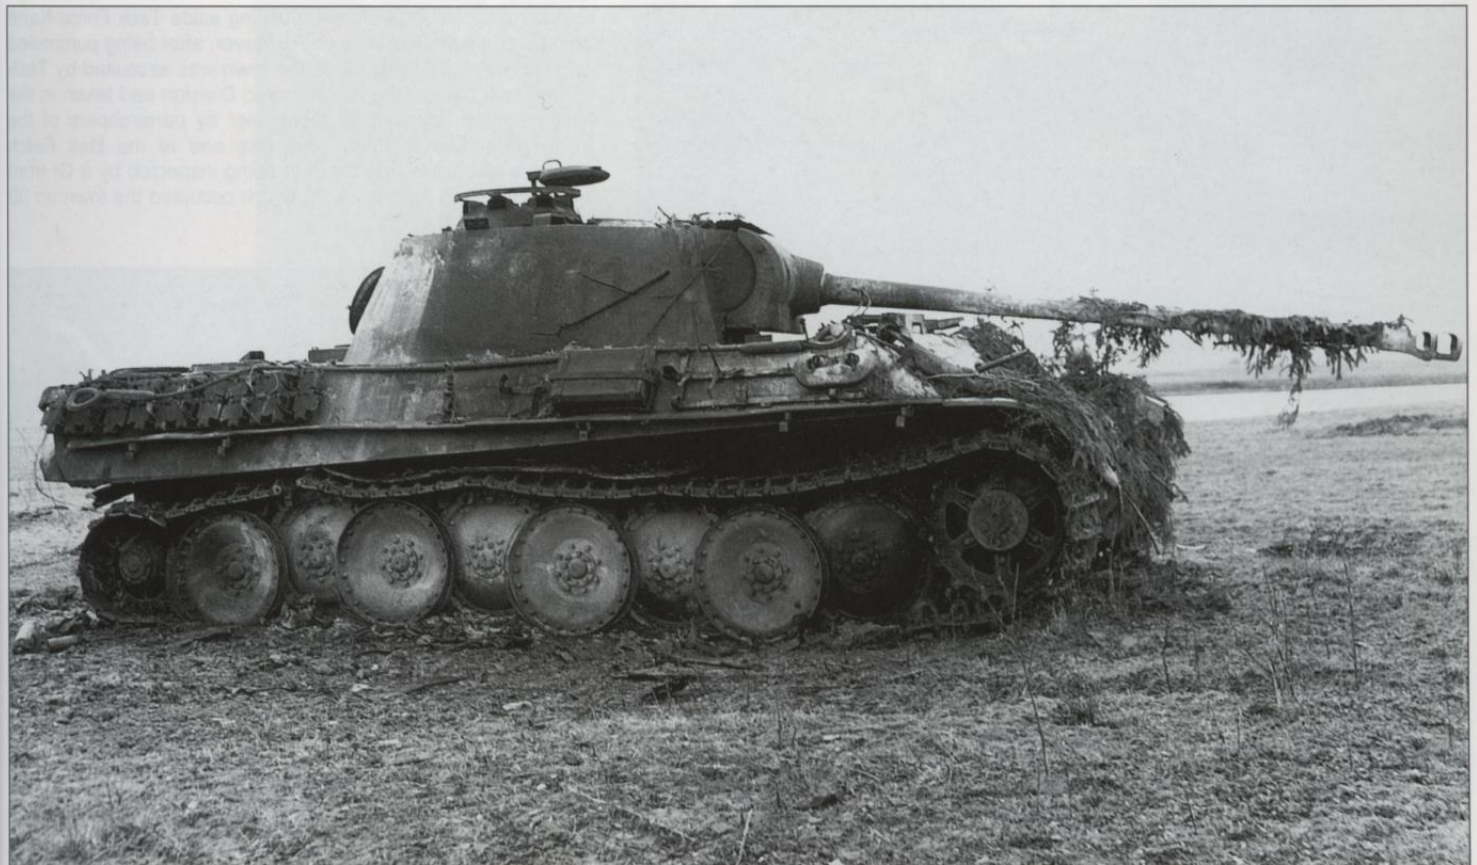
A Panther Ausf. G of the 1.SS-Panzer Division knocked out in the fighting near the Baugnez cross-roads where the infamous massacre took place. It has been burned out, but the tactical number 111 is barely evident on the turret side. This is a new production vehicle with the revised chin mantlet and crew heater.

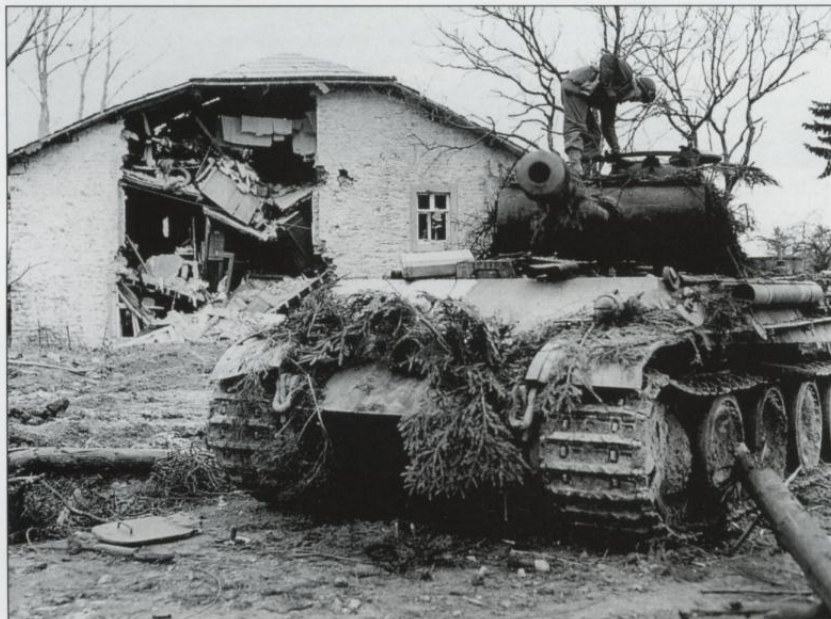
GIs inspect another of the Panther Ausf. G tanks of the 2.SS-Panzer Division knocked out during the fighting in Grandmenil with the 3rd Armored Division. This photo was taken several days after the battle on 4 January after snow had covered the area.

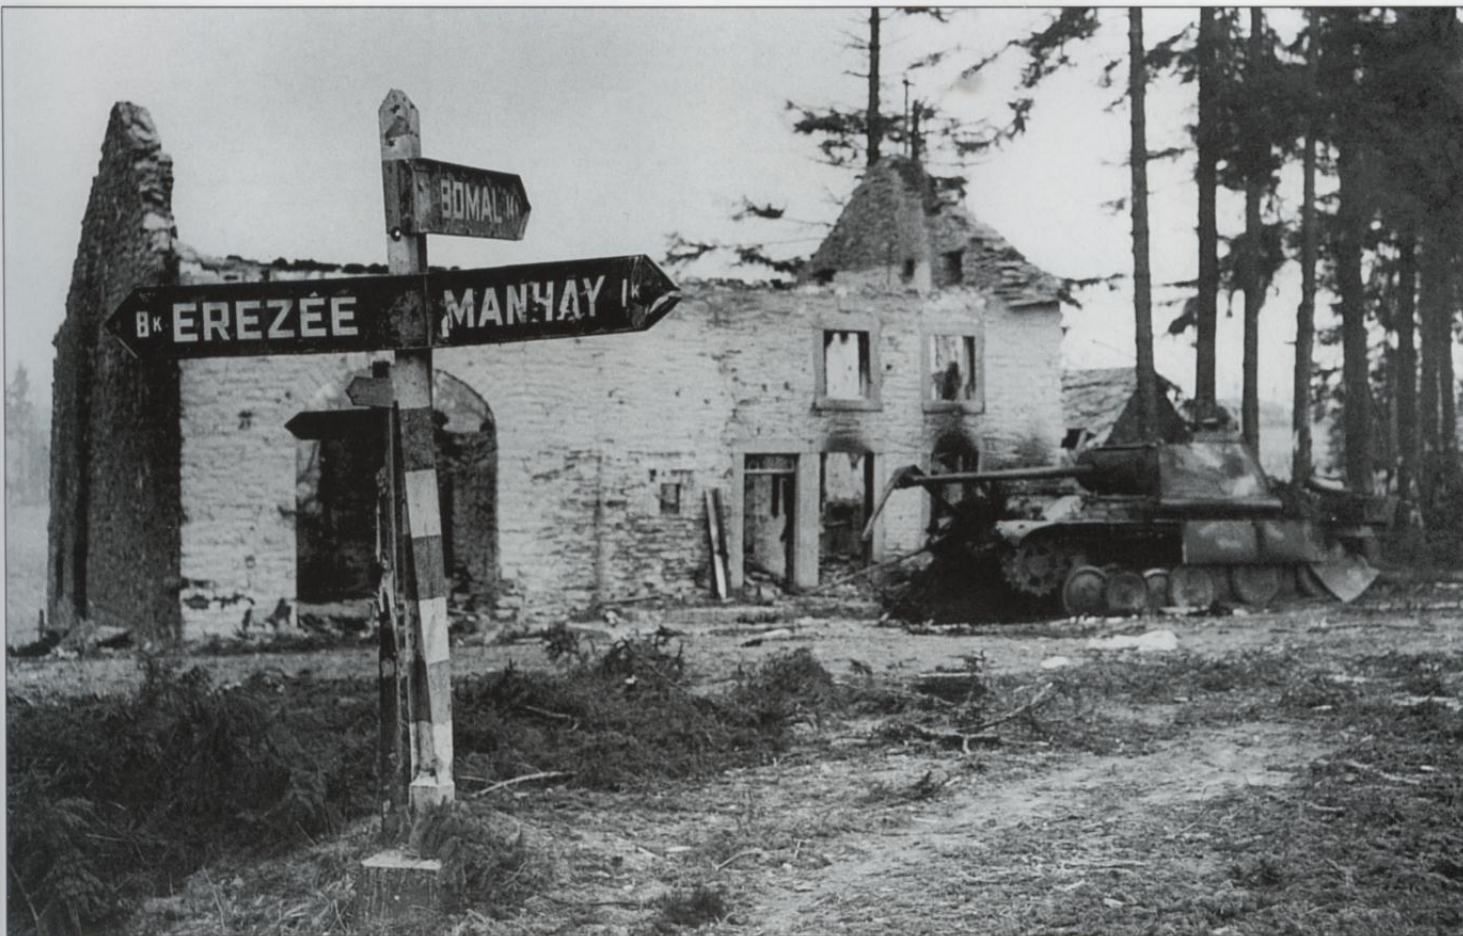
Another Panther Ausf. G of 2.SS-Panzer Division knocked out in a fork in the road between Manhay and Grandmenil during the fighting on 23 December 1944 with the 3rd Armored Division.

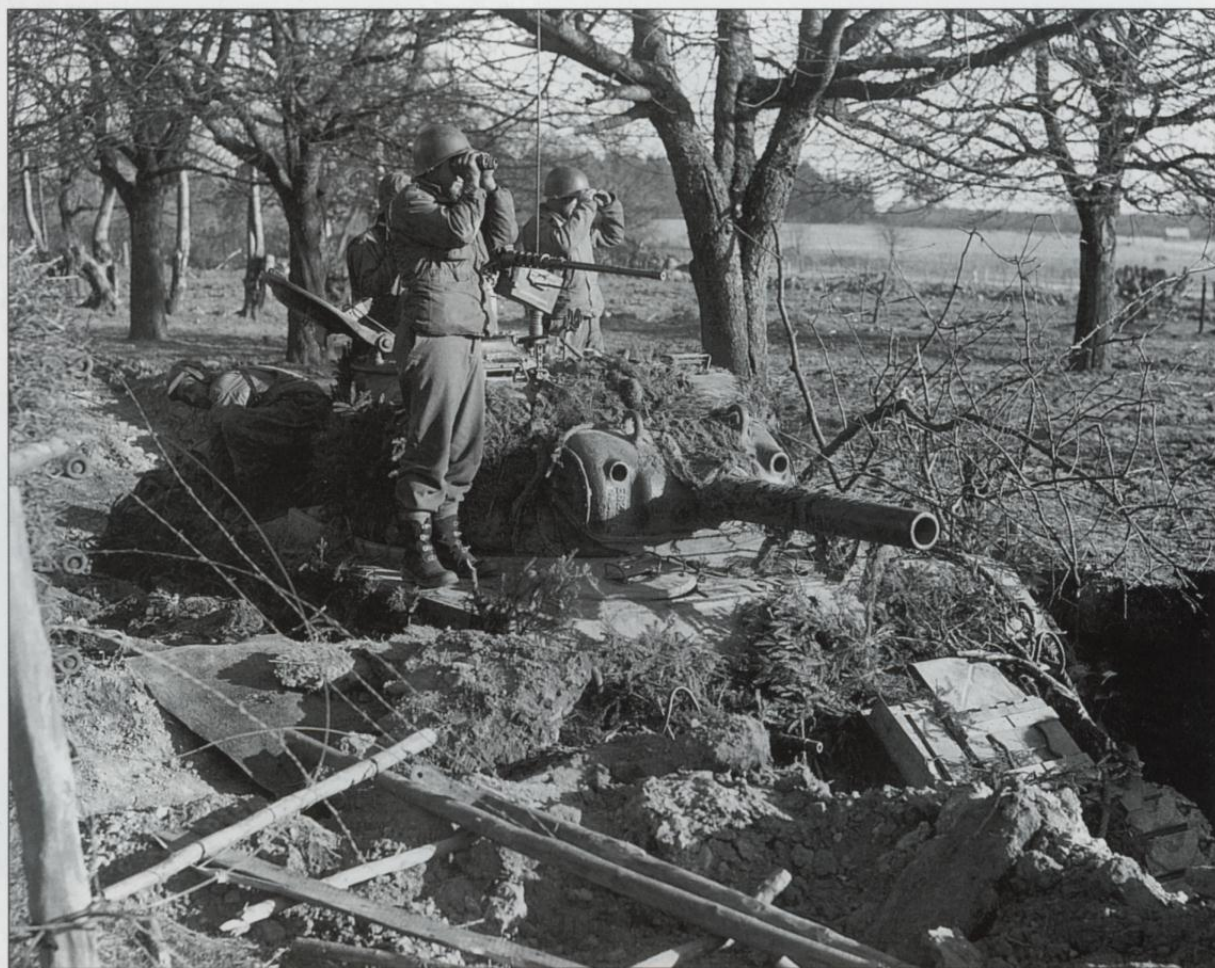
A M4 (105mm) assault gun of a headquarters company of the 7th Armored Division waits in hull down position near Manhay during the fighting there on 27 December with the 2.SS-Panzer Division "Das Reich". The tank is positioned in an entrenchment created by divisional engineers.

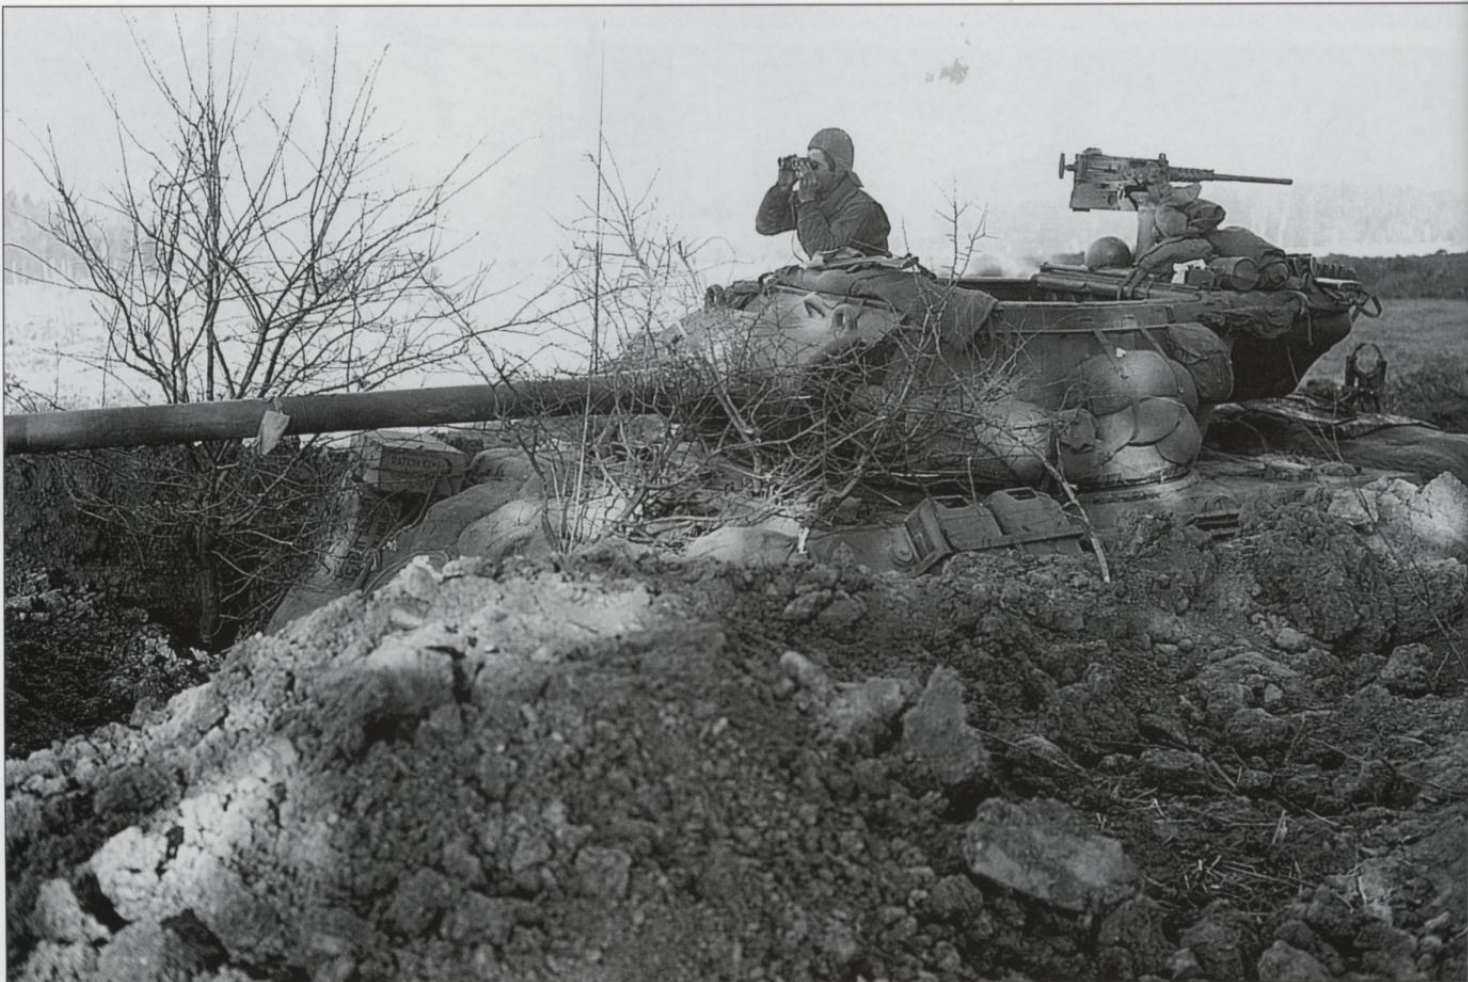
A well entrenched M36 90mm gun motor carriage of the 814th Tank Destroyer Battalion holds positions near Manhay on 27 December 1944 during the fighting with Das Reich.

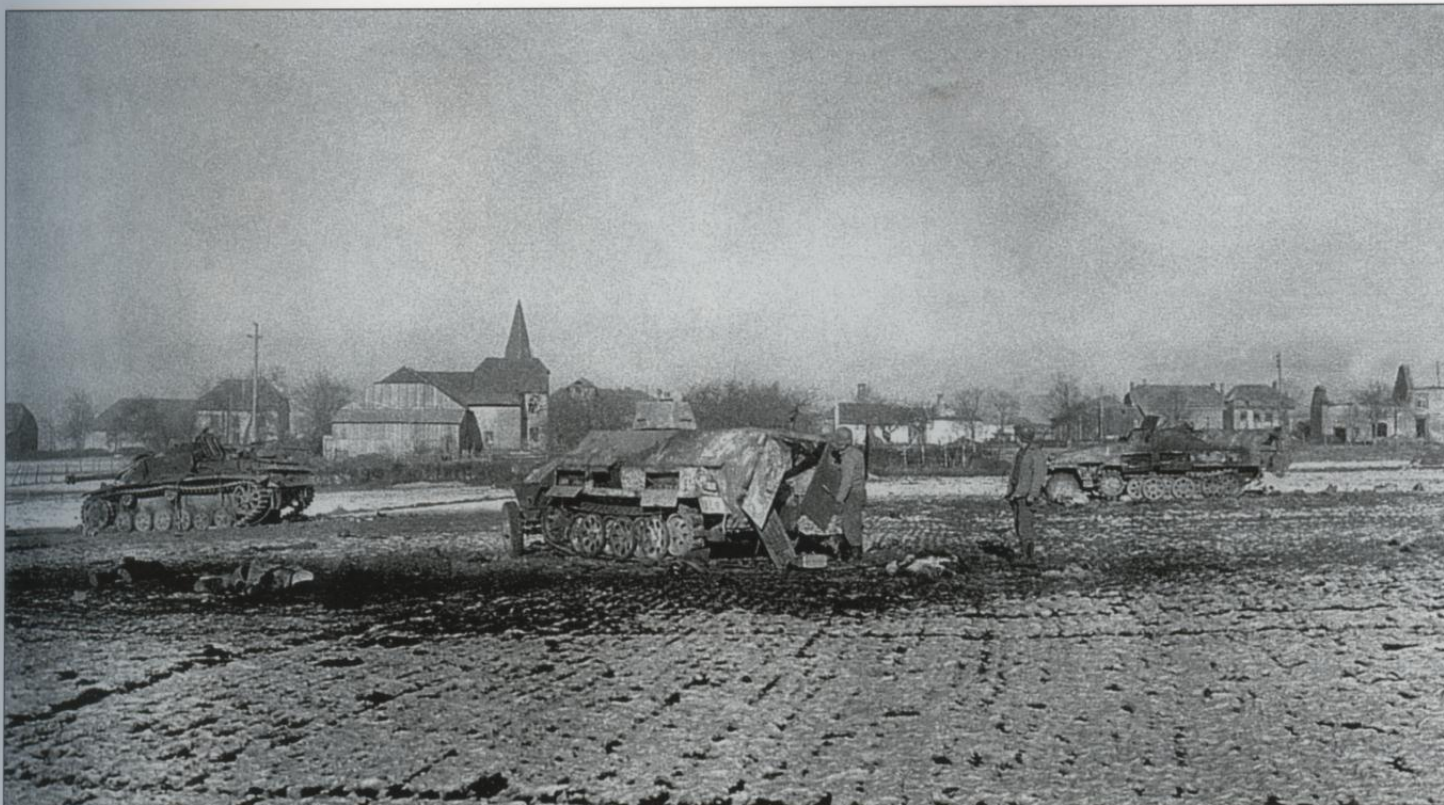
The Führer-Grenadier-Brigade was committed piecemeal to the fighting near Bastogne, and one of its kampfgroupe attacked the US 80th Division in Heiderscheid on Christmas Eve 1944. It suffered significant losses in the fighting, including the StuG III to the left and two SdKfz 251 half-tracks. The half-track in the center is one of the rare SdKfz 251/17 with a turret 2cm autocannon.

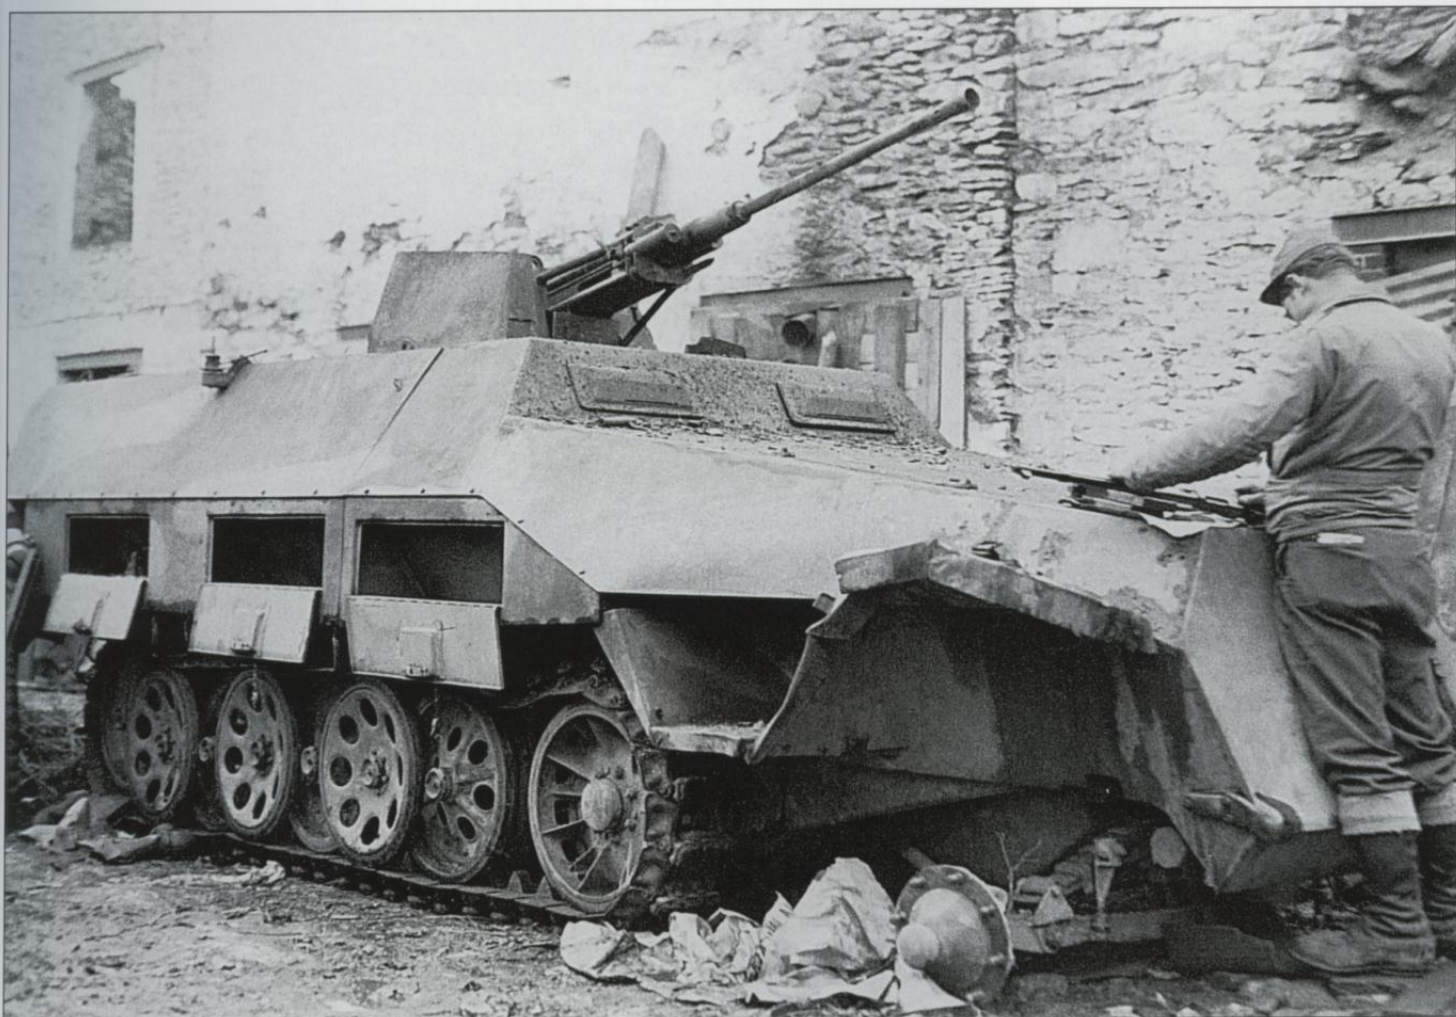
One of the captured SdKfz 251/17 half-tracks was recovered by ordnance units from Patton's Third Army for a technical evaluation. This is a view of it sometime after the fighting.

This is a close-up of the 20mm cannon on the SdKfz 251/17 taken from a technical report. The armored cover has been taken off to show details of the gun mounting.

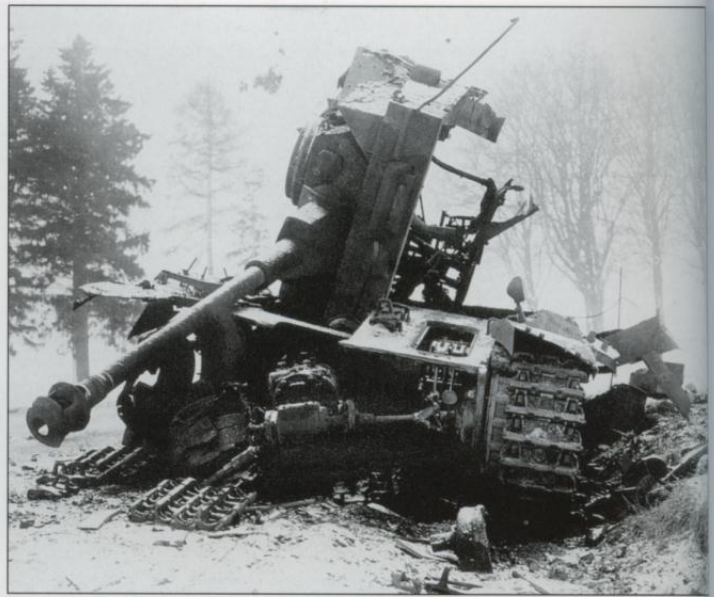
The catastrophic effects of an ammunition fire and the resultant explosion are all too evident from the shattered hulk of this PzKpfw IV of Kampfgruppe Maucke, 15. Panzergrenadier Division knocked out in the outskirts of Bastogne in late December 1944 during a fight with paratroopers from the 101st Airborne Division.

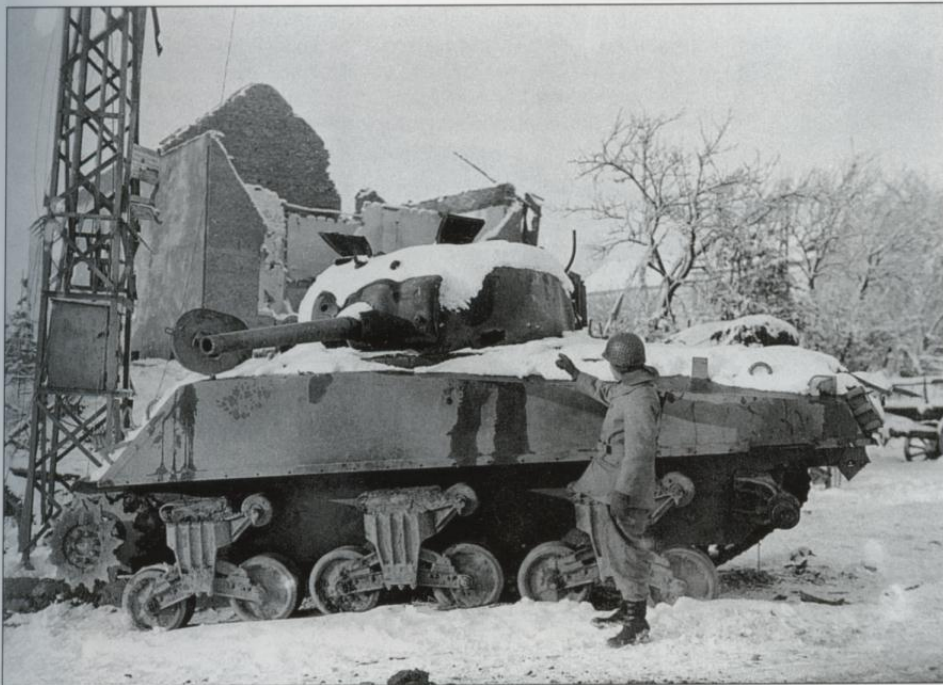
This M4A3 from the 6th Armored Division was knocked out in Hompre on the outskirts of Bastogne during the attempts to relieve the city in late December 1944. The GI is pointing to where a large caliber anti-tank gun round penetrated the base of the turret.

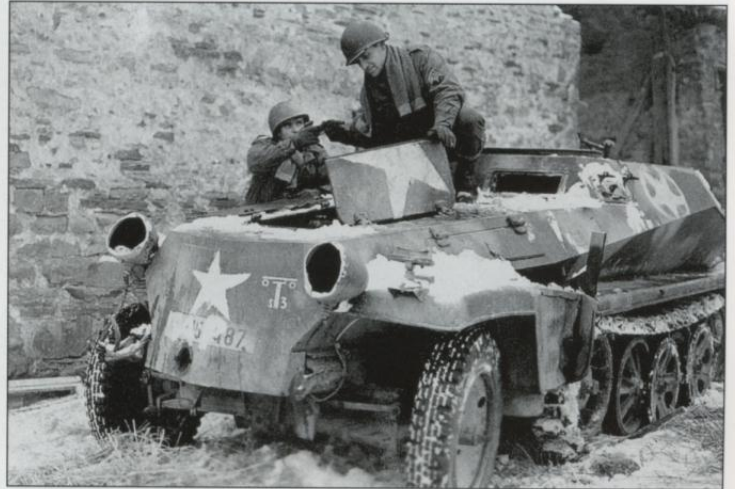
On 20 December, the 116.Panzer Division captured the fuel dump at Samree, but in subsequent fighting were pushed out by the 2nd Armored Division on 10 January. Here, some military police of the US 334th Infantry, 84th Division try to repair a SdKfz 250 half-track that had been left behind. The tactical insignia on the bow identifies it as belonging to the division's Pz.Jg.Abt. 146.

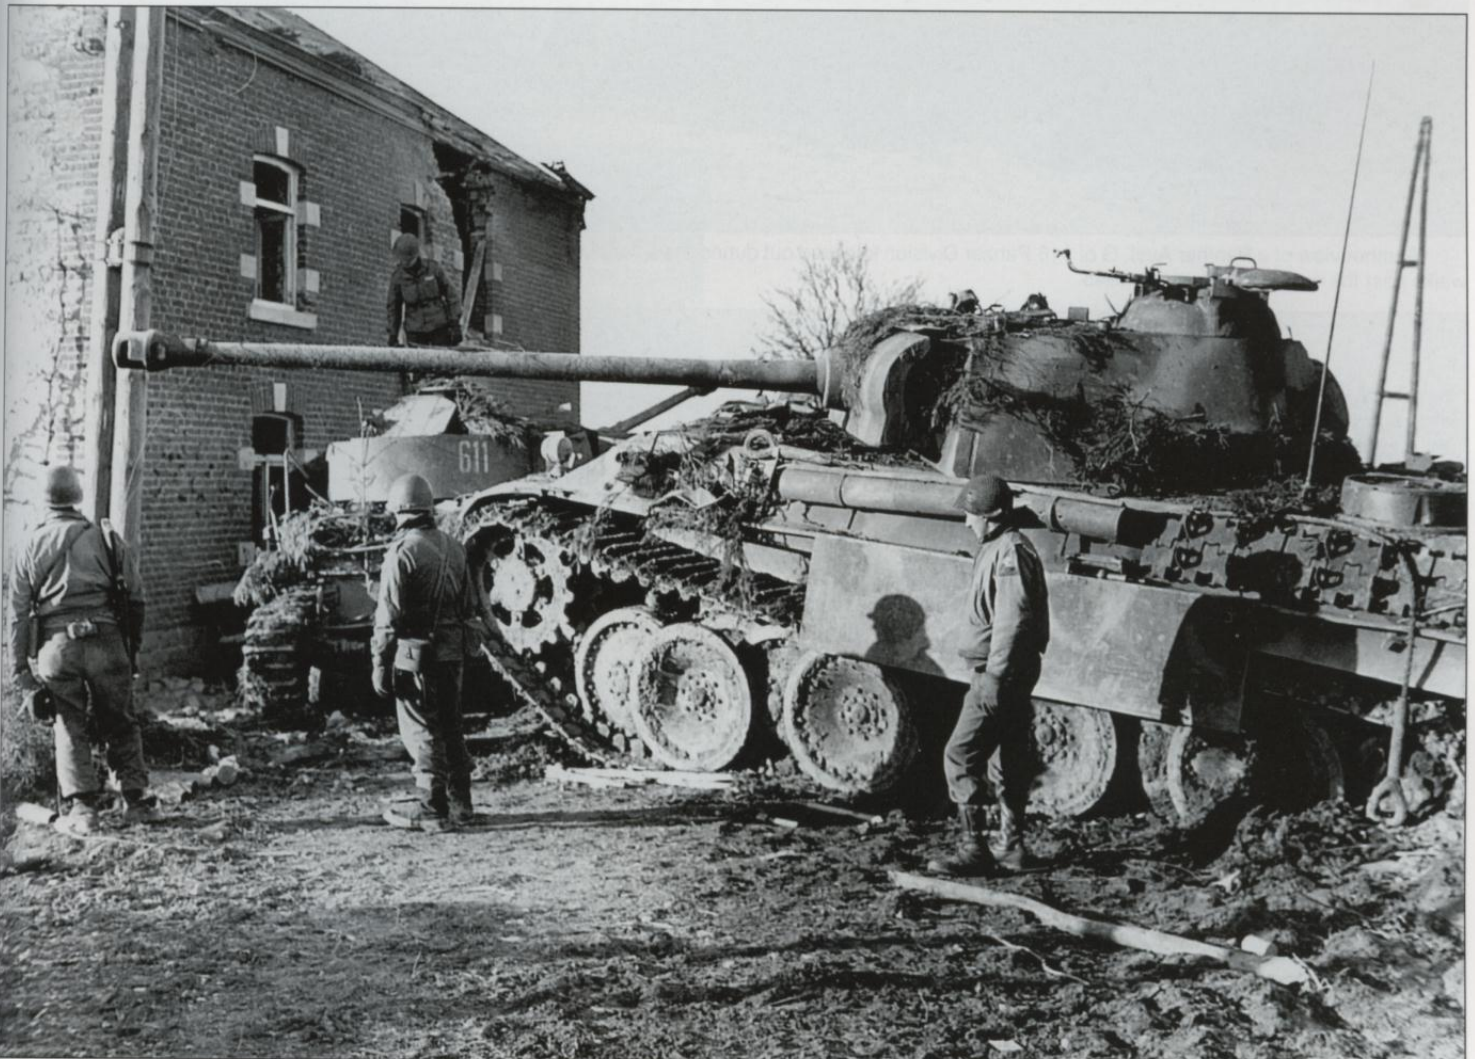
The furthest penetration by the 116.Panzer Division was Hotton, where hard fighting took place on Christmas and the following days with the 3rd Armored Division. This Panther from Kampfgruppe Bayer was one of a number left behind in the town after the fighting, with a PzKpfw IV evident in the background. This is a relatively late production Panther with the crew heater, and extended chin mantlet.

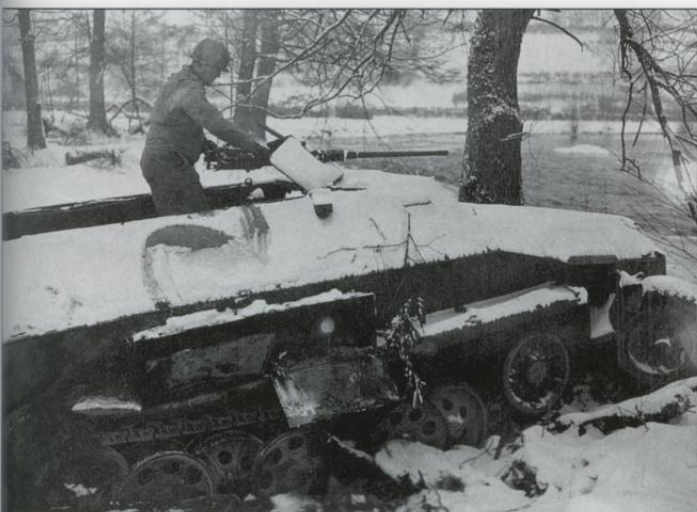
This SdKfz 251 half-track, probably from 116.Panzer Division was abandoned in Marcourt in early January 1945. Curiously enough, the crew had substituted a captured .50 cal Browning heavy machine gun for the usual MG42. It is being inspected by a GI from the 4th Cavalry Group on 13 January.

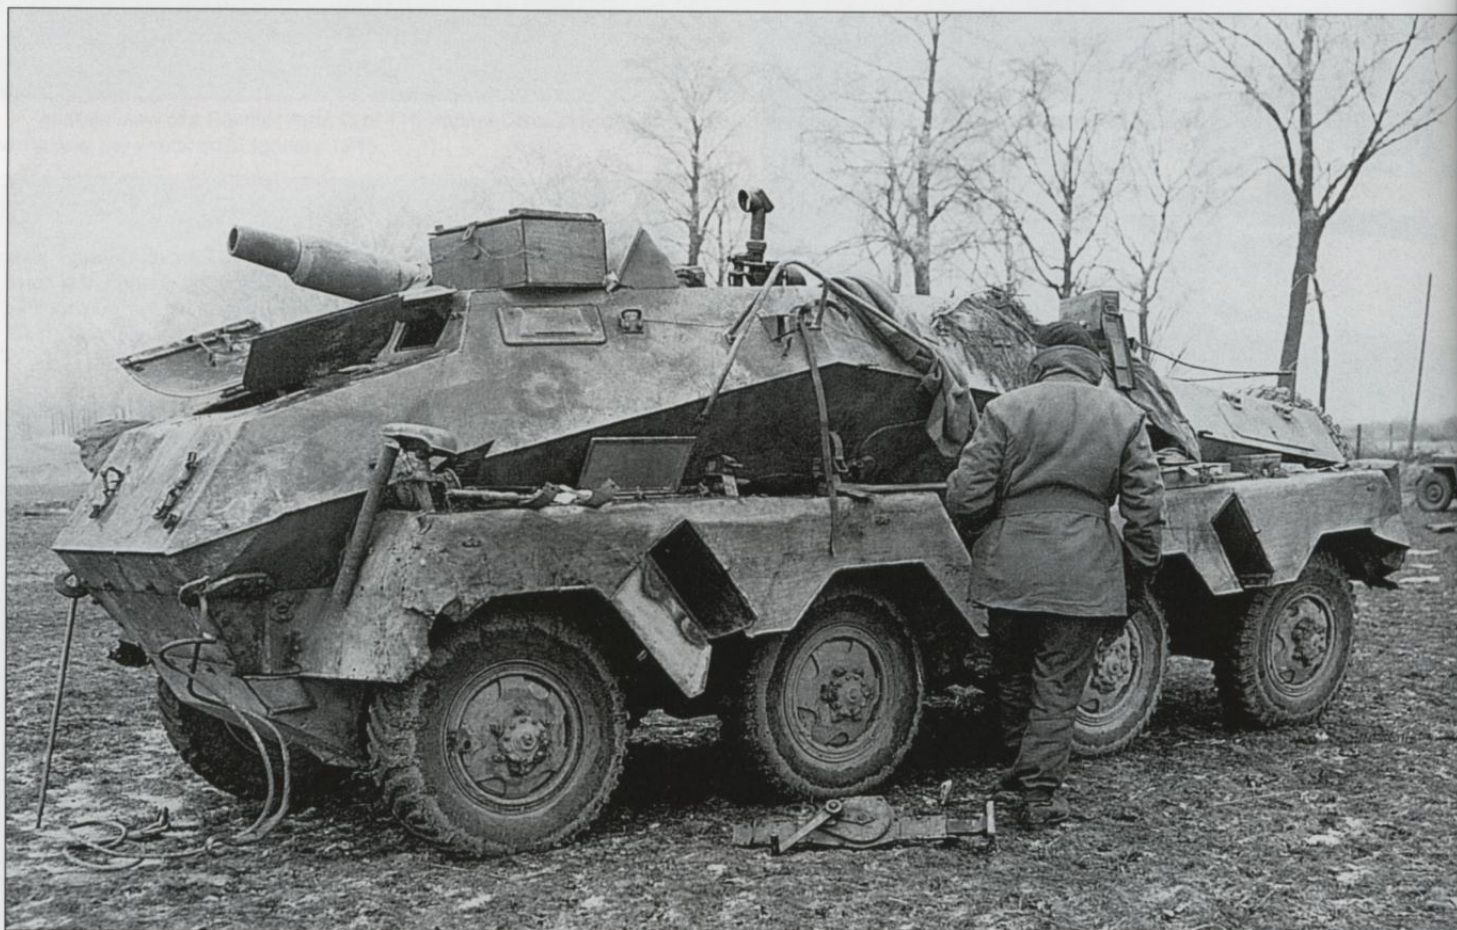
This old veteran, a SdKfz 233 s.Pz.Sp.Wg (7.5cm), was lost in the Celles pocket in late December 1944 in the fighting with the US 2nd Armored Division. The trident insignia on the bow identifies it as belonging to the 2. Panzer Division. This particular family of 8x8 armored cars had largely been superseded in 1944 by the newer SdKfz 234 series, but some old veterans like this one continued to serve until lost in combat.

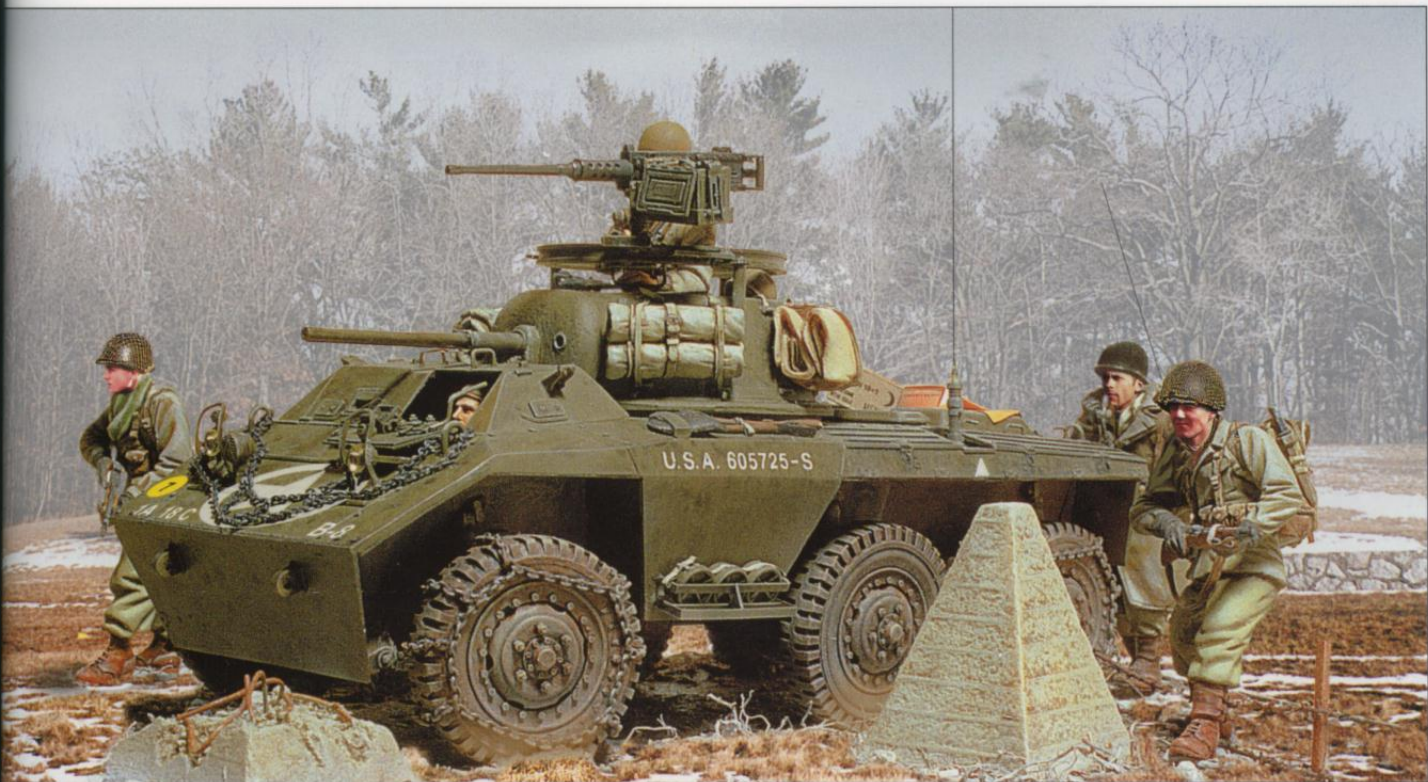
**M3 Armored Car, 18th Cavalry Squadron, 14th Cavalry Group, Losheim Gap**

The 18th Cavalry Squadron used fairly typical US Army markings. The white star was painted on the forward turret side, here obscured by the crew's gear, and on the hull side, seen only partially due to the missing side skirt. A star in a circle was painted in a larger size on the hull front. The bumper codes are 1A 18C for 1st Army, 18th Cavalry Recon. Sq., while the troop letter "B" is seen on the other side. There is also a yellow bridging circle with the vehicle weight 7 in black. The vehicle registration number is painted on the hull side in white. Much of this unit was lost as part of Task Force Mayes in the one-sided skirmish with SS-Pz.Gren.Reg't. 1 near Poteau-Recht on 18 December 1944.

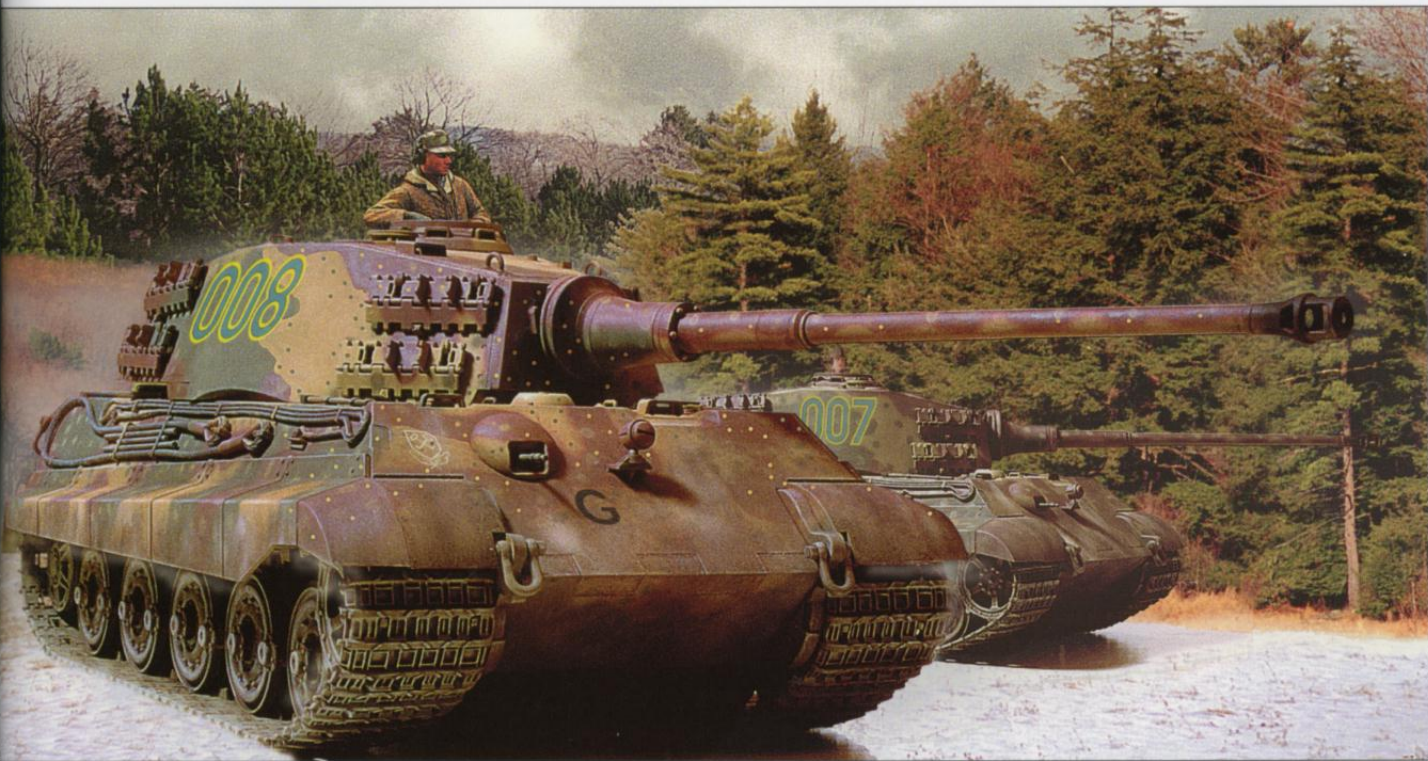
**King Tiger, s.SS-Pz.Abt. 501, Kampfgruppe Peiper**

The headquarters section of the unit had three King Tigers, numbered 007, 008 and 009. There is some dispute as to the colors of the numbers, some sources stating red with white outline and others blue with yellow. Some tanks of the unit carried the divisional insignia on the front hull front as seen here. The lead assault units were given letter codes to assist military police in directing traffic. Kampfgruppe Peiper was assigned "Rollbahn D", though trailing elements like this King Tiger unit were given the letter "G" as seen applied in black paint on the hull front. To conserve paint, in October 1944 the German plants left the tanks in the basic RAL 8012 red oxide primer, with sprayed-on patches of dark yellow RAL 7028 and dark green RAL 6003. The King Tigers used the "Hinterhalt" (ambush) scheme with small patches of contrasting color applied to create a dappling effect. On the King Tigers, this was a very sparse pattern of the small dots. This particular tank was abandoned near Born after its transmission failed.

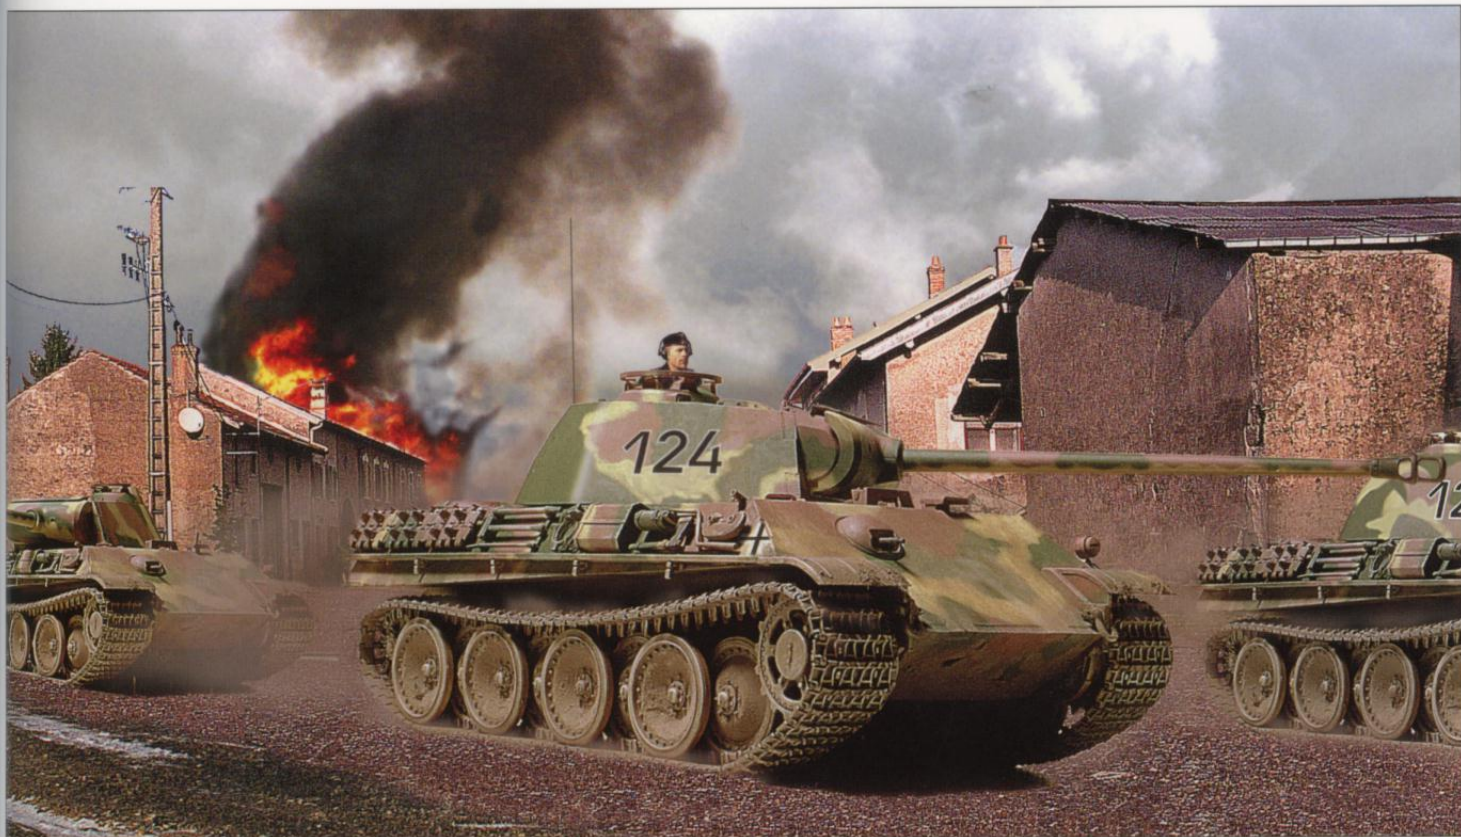
**Panther Ausf. G, 1/SS-Pz.Regt. 12, 12.SS-Panzer Division, Krinkelt-Rocherath, Belgium**

Most of the Panthers serving in the Ardennes were new production vehicles from the early autumn. The base color was RAL 8012 red oxide primer, with small sprayed patches of dark yellow and dark green. The Hinterhalt scheme does not appear to have been widely used at this time on Panthers. The 12.SS-Panzer Division used a distinctive style of tactical numbers, with elongated "1".

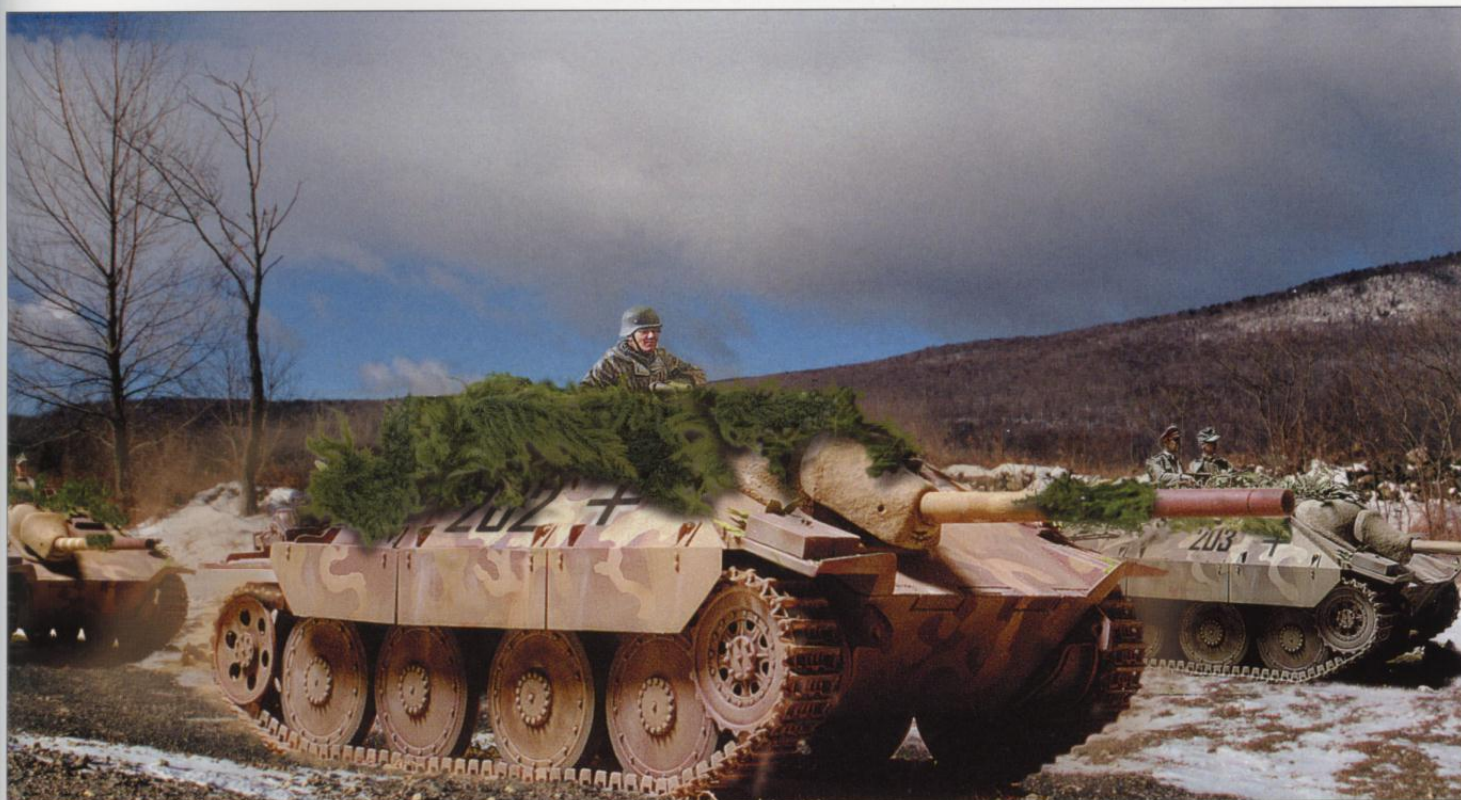
**Jagdpanzer 38(t) Hetzer, 1167.StuG Co., 167.Volksgrenadier Division, near Bastogne, 29 December 1944**

The Hetzer was the workhorse of the new Volksgrenadier division, providing their only armor support. The Battle of the Bulge was the first time that the Hetzer was used on the western front in any significant numbers, totaling about 170 vehicles by the end of the campaign. These vehicles are typical of December production batches at BMM. The scheme was the usual factory applied RAL 8012 red oxide primer with hard-edged patches of RAL 7028 dark yellow. However, instead of the usual dark green, bands of RAL 9002 white were applied. This scheme was sometimes seen on late production Panthers as well. The white was sometimes not very opaque, giving it a slightly ivory cast. The tactical markings are a simple set of numbers in black and the usual national insignia. Evergreen foliage was heavily used to provide camouflage cover against air attack.
