# The Battle of the Bulge

Steven Zaloga

# Introduction

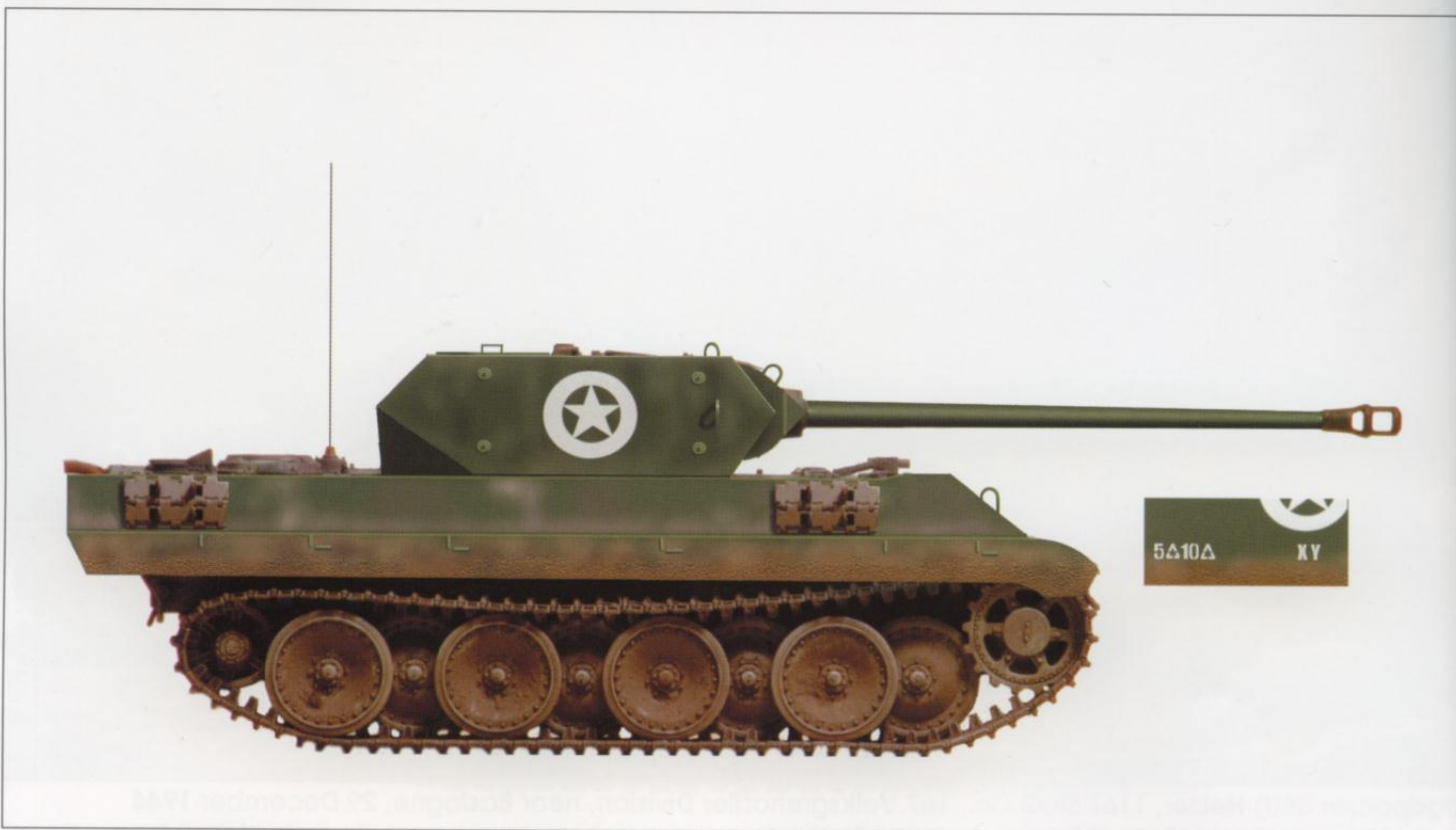
**Ersatz M10 (Panther), Kampfgruppe X, Panzer Brigade 150, Malmédy**

The Panther tanks of Pz.Brig. 150 were painted to resemble American tanks. In all likelihood, they were painted in German RAL 6003 dark olive green. They carried prominent white circled allied stars on either side of the turret, and on the center of the glacis plate. The US-style bumper codes on the bow showed the markings of B Company, 10th Tank Battalion, 5th Armored Division. In the center was a German code, XY which was used to identify vehicles of the unit to German traffic police. Most of these tanks were knocked out in the fighting in Malmédy on 21 December with the US 120th Infantry Regiment.

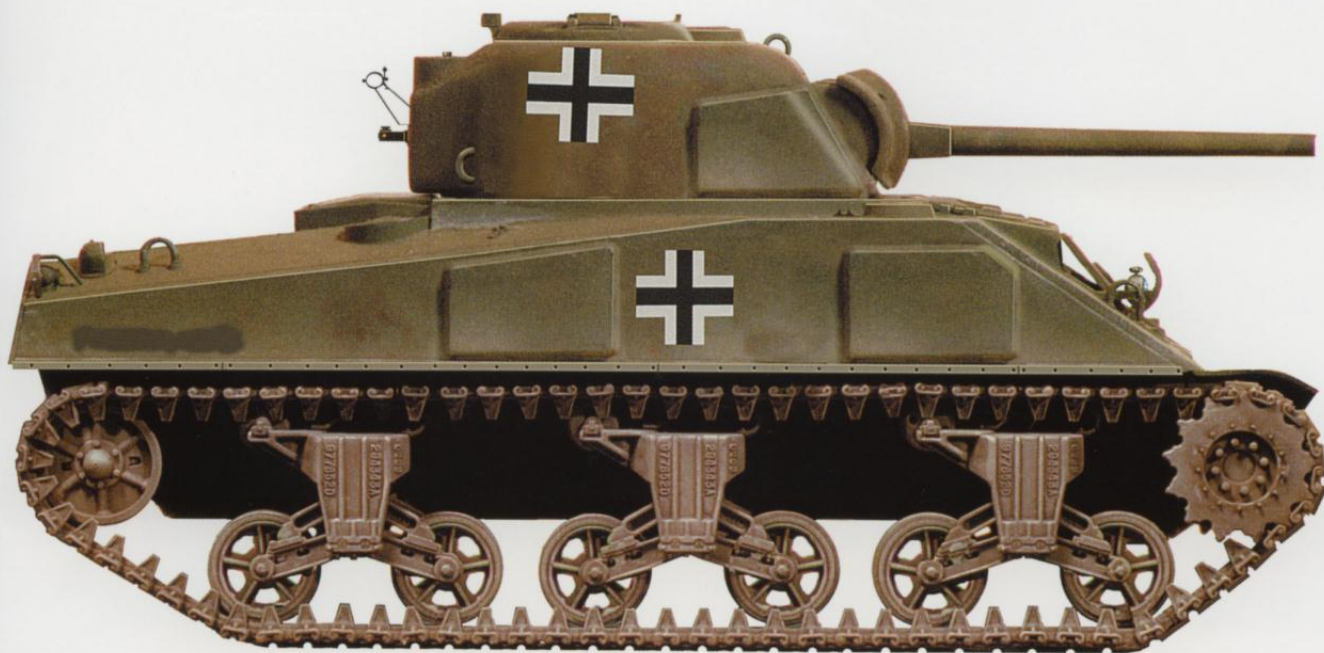
**M4 Medium Tank, Fallschirmjäger Regt. 15, 5.Fallschirmjäger Division, Esch-sur-Sure**

The German Seventh Army was particularly weak in tanks, and so tended to use any that they captured. The German paratroopers captured six M4 medium tanks during the fighting near Wiltz on 19 December, and after remarking them with German crosses, put them back in action. The crosses were painted larger than normal to prevent friendly fire incidents, and the US registration number was also painted out. The cross on the turret is a bit askew. This tank was lost during the fighting in mid-January 1945.

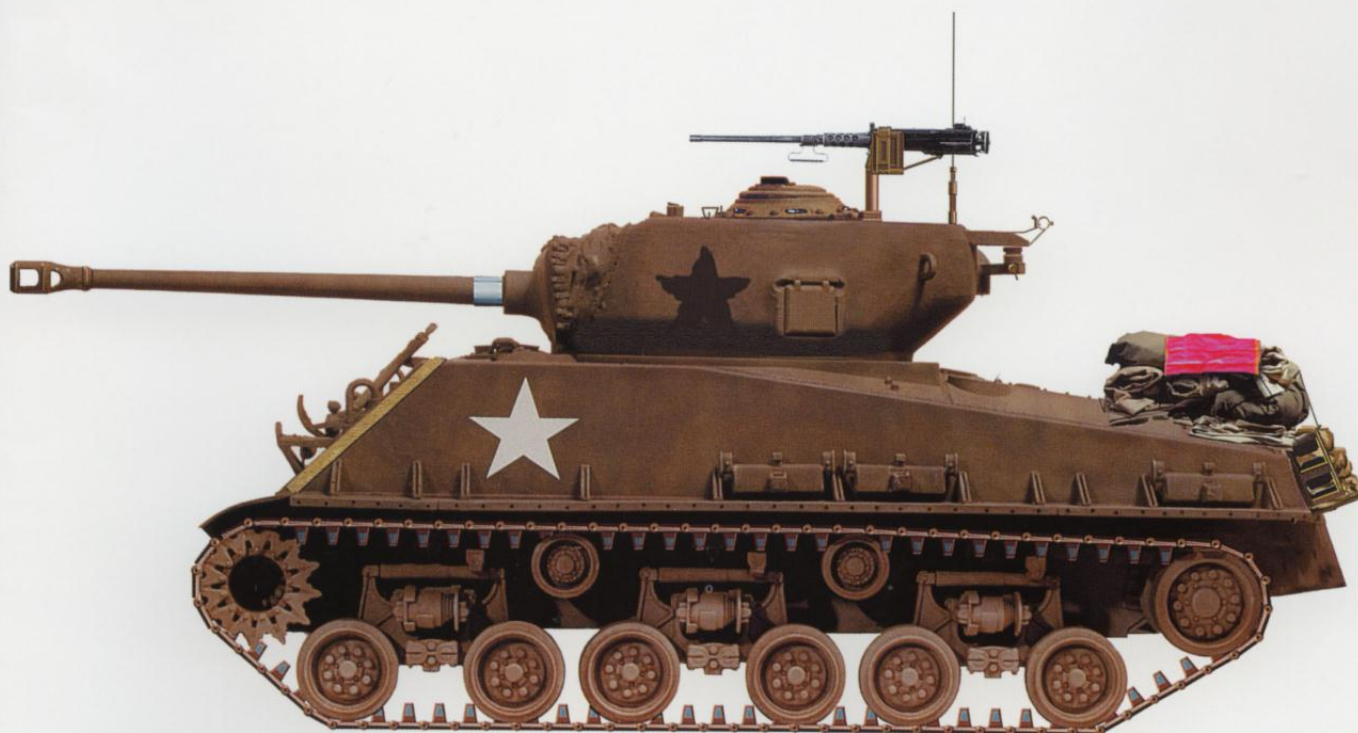
**M4A3E8, 35th Tank Battalion, 4th Armored Division, Bastogne, January 1945**

A small number of the new M4A3E8 tanks arrived in December as replacements and were quickly put into service. The mastic sealant used during shipping is still evident around the base of the turret. The 35th Tank Battalion usually painted out the star markings since they presented too visible a target to German anti-tank gunners. However, the white star is still untouched on the hull side. The tank is carrying the usual fluorescent cerise air identification panel.

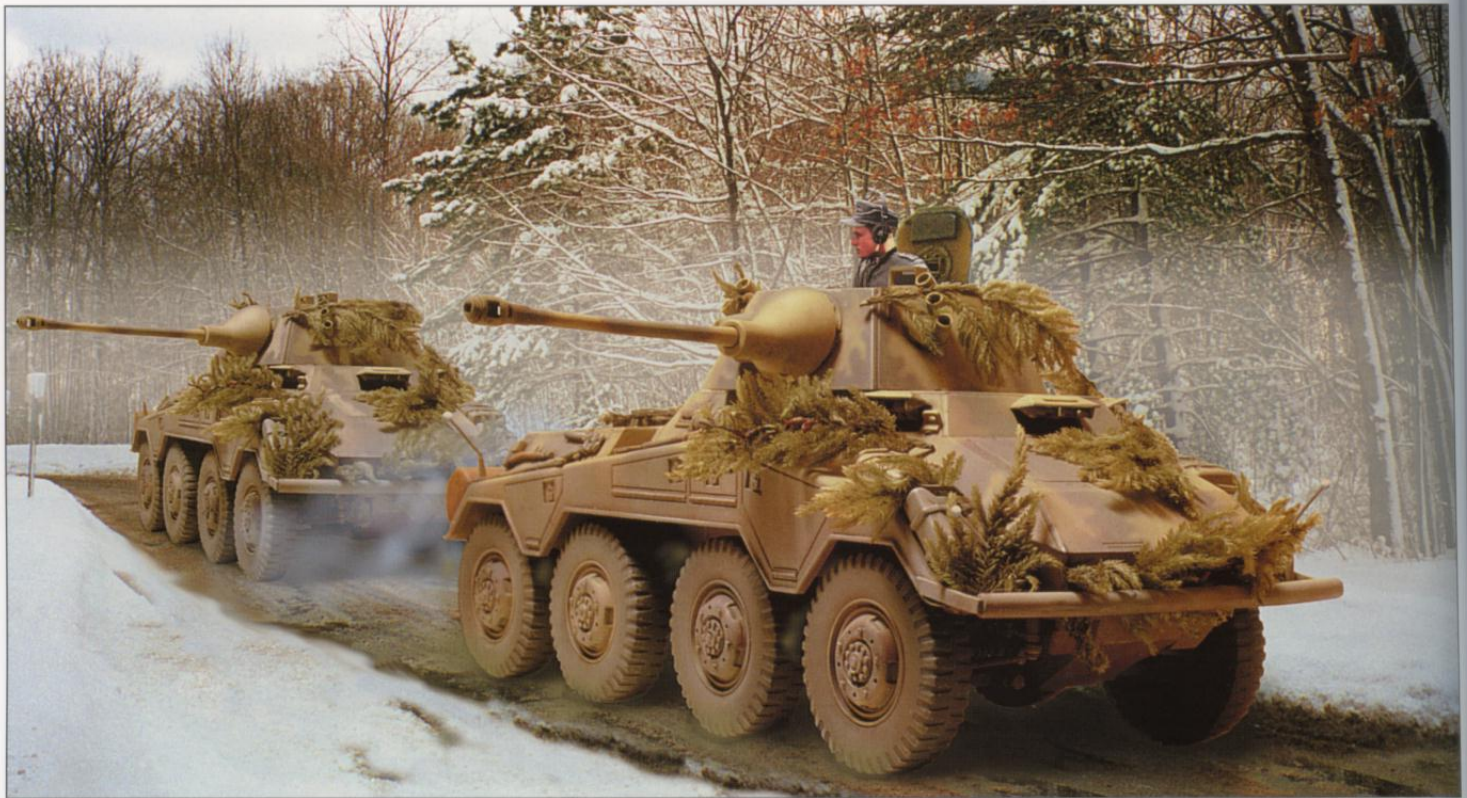
**SdKfz 234 Puma, Kampfgruppe von Bohn, Foy-Notre-Dame, 26 December 1944**

Kampfgruppe von Bohn was the reconnaissance element for the German push to the Meuse near Dinant in late December and this unit penetrated deeper than any other before finally being stopped in a short fire-fight with the British 3 RTR only a few miles short of the Meuse river. Their Puma armored cars were finished in the standard summer 1944 scheme of dark yellow with a diffuse pattern of dark brown and dark olive green applied at the whim of the crew. From existing photos of the unit, few markings were carried. Some Pumas had a simple black and white Balkan cross on the middle of the turret, but others had no tactical numbers or cross. The armored cars were heavily covered in pine boughs to provide camouflage against Allied fighter bombers.

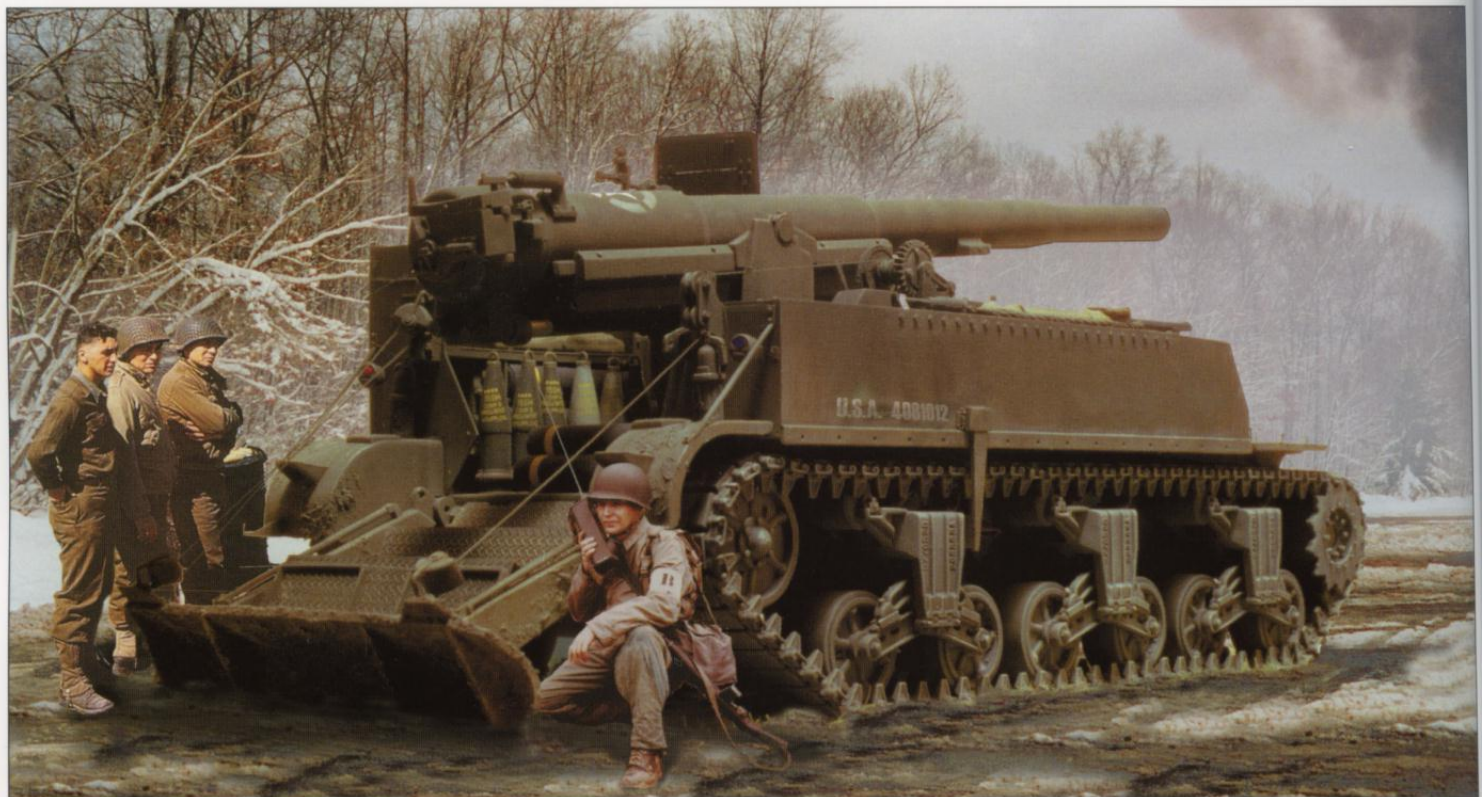
**M12 155mm GMC, Battery B, 991st Field Artillery Battalion, La Gleize, Marche-Belgium, December 1944**

The sound of doom for Kampfgruppe Peiper was a M12 155mm GMC seconded to the 740th Tank Battalion. It fired nearly two hundred rounds at point blank range into La Gleize, demoralizing the stalled panzer troops, and finally convincing Peiper to order a retreat. The unit's self-propelled guns were in the usual olive drab finish. During the fighting in France, the unit painted its regimental crest on the hull side, since it was a descendent of the Washington Grays. However, this practice was stopped in the autumn, and the insignia painted over. As a result, unit markings were very simple, only the registration number, and a white Allied recognition star on the top of the gun barrel.

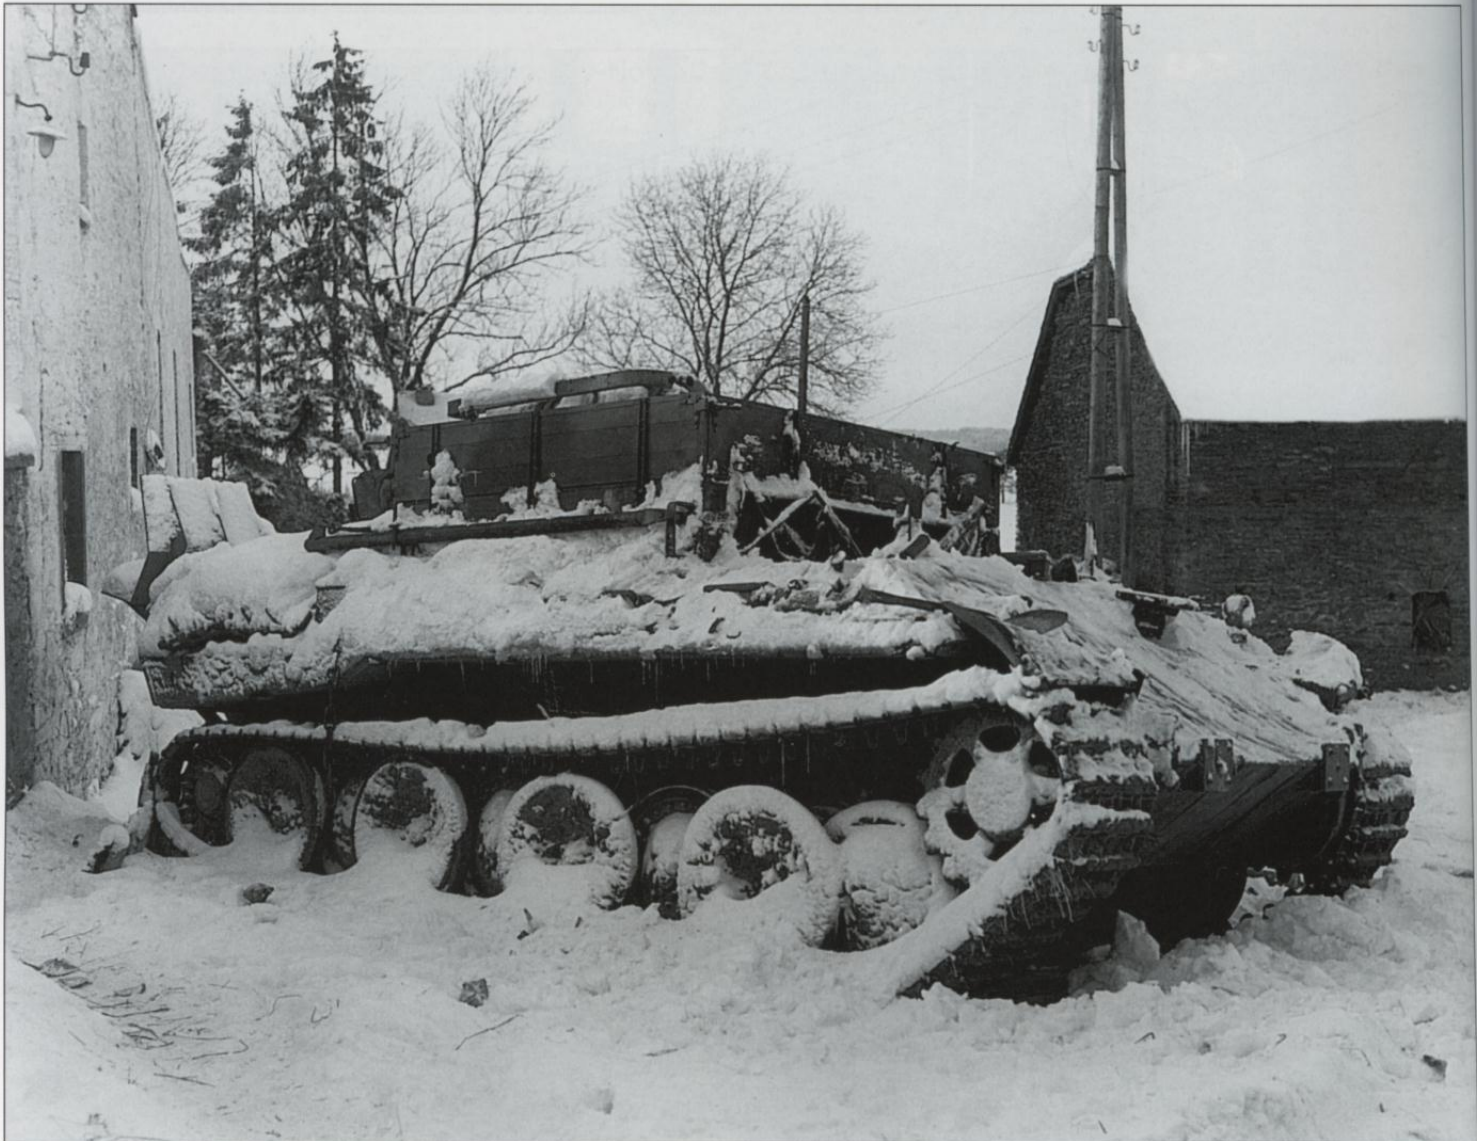
The Panzer Lehr Division left this Bergepanther recovery vehicle in the town of Morhet south west of Bastogne during the fighting there in mid-December 1944. This shows the vehicle nearly a month later after the January snowfalls and prior to it being packed up and shipped back to the United States for evaluation.

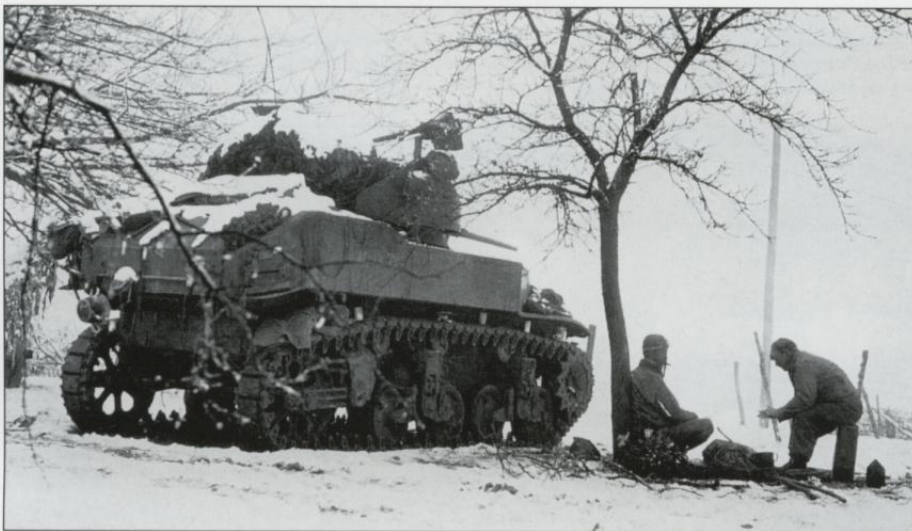
Tanks of the 2nd Armored Division support the 84th Division during the fighting near Amonines, Belgium on 2 January 1945. The lead tank appears to be a composite hull M4. It is fitted with the T54 metal chevron tracks with duck bill extenders. There was quite a bit of variation in the detail of the duck bills, as many were manufactured locally in shops in Belgium and France.

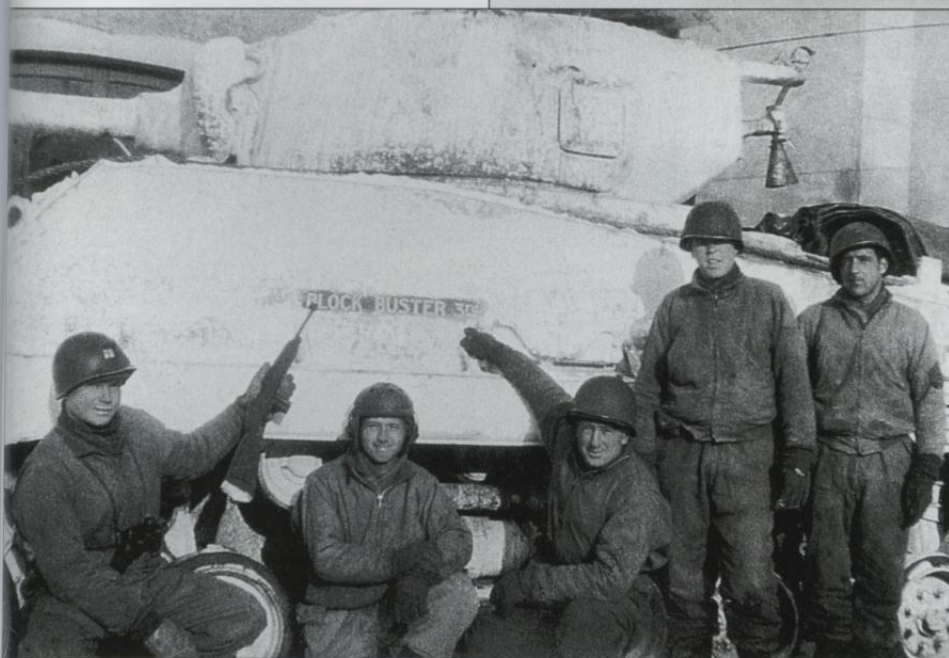
The Battle of the Bulge was the debut for the new M4A3 with HVSS suspension, called at the time by the tankers as the "M4A3 (76mm) with 23 inch track", and later as the M4A3E8. This is the tank of the Co. B commander, Capt. James Leach. (J. Leach)

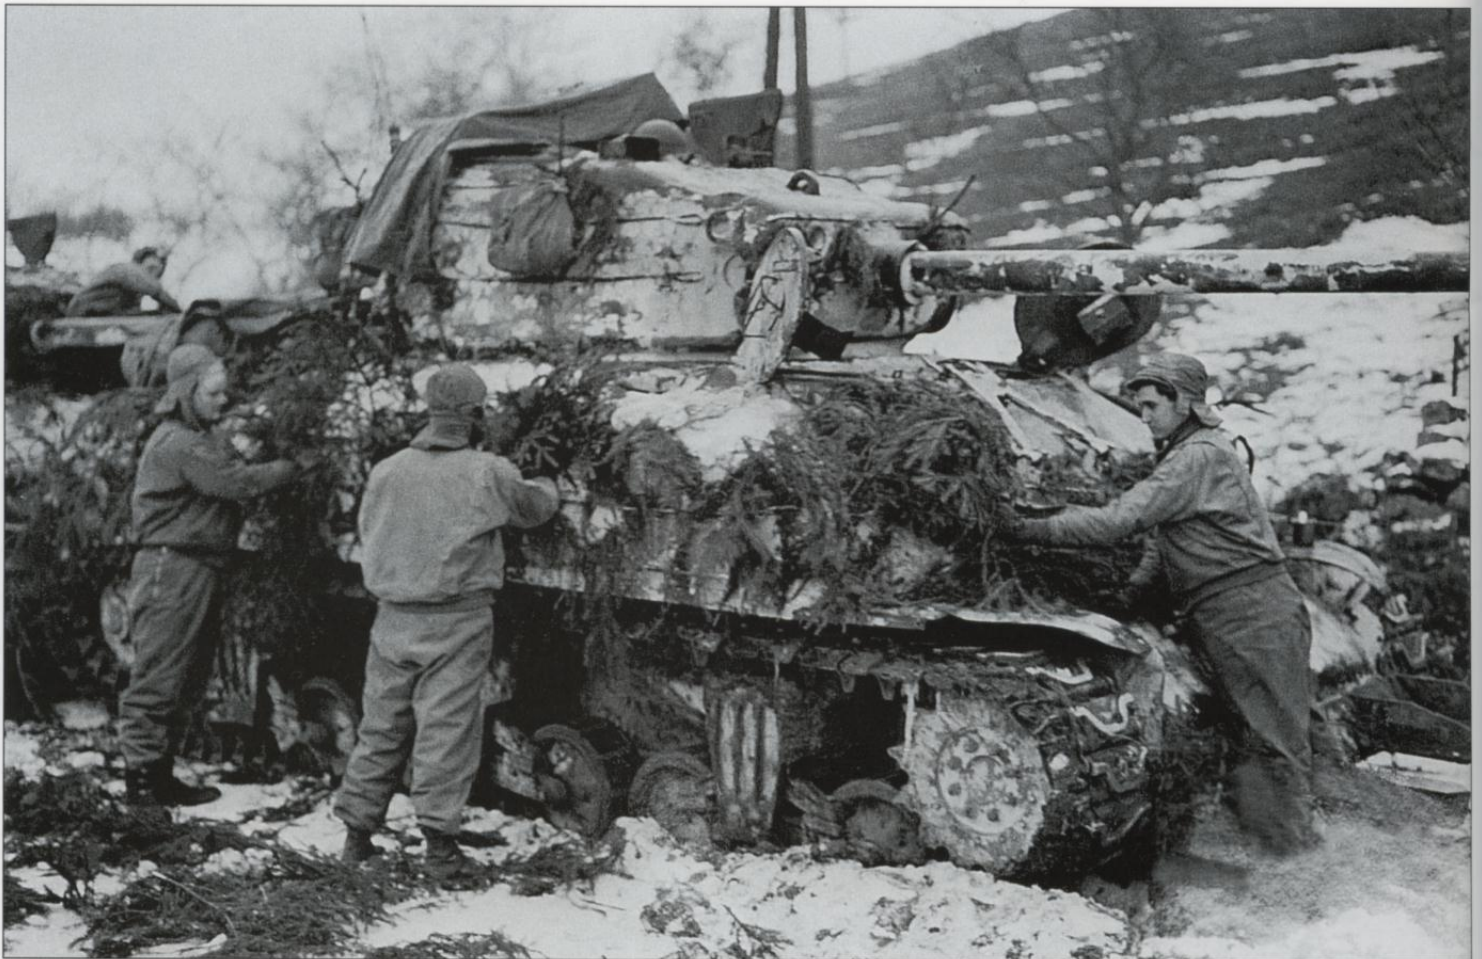
One of the new M4A3E8 medium tanks of the 35th Tank Battalion, 4th Armored Division during operations near Bastogne on 8 January 1945. This is evidently a very new vehicle as it was the usual practice to remove the sand skirts which interfered with suspension maintenance.

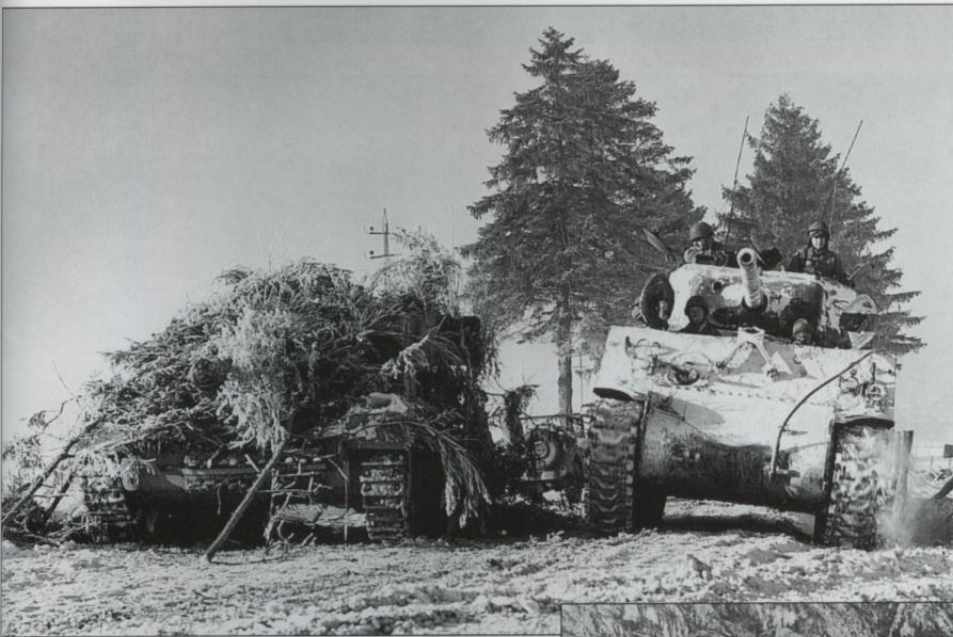
A M4A3 (76mm) of the 42nd Tank Battalion, 11th Armored Division passes by an abandoned German PzKpfw IV tank along the Houffalize road outside Bastogne on 15 January 1945. The 11th Armored Division had been one of the units used to widen the corridor into Bastogne at the end of December, then it took part in efforts to break out of the encirclement on the eastern side of the town.

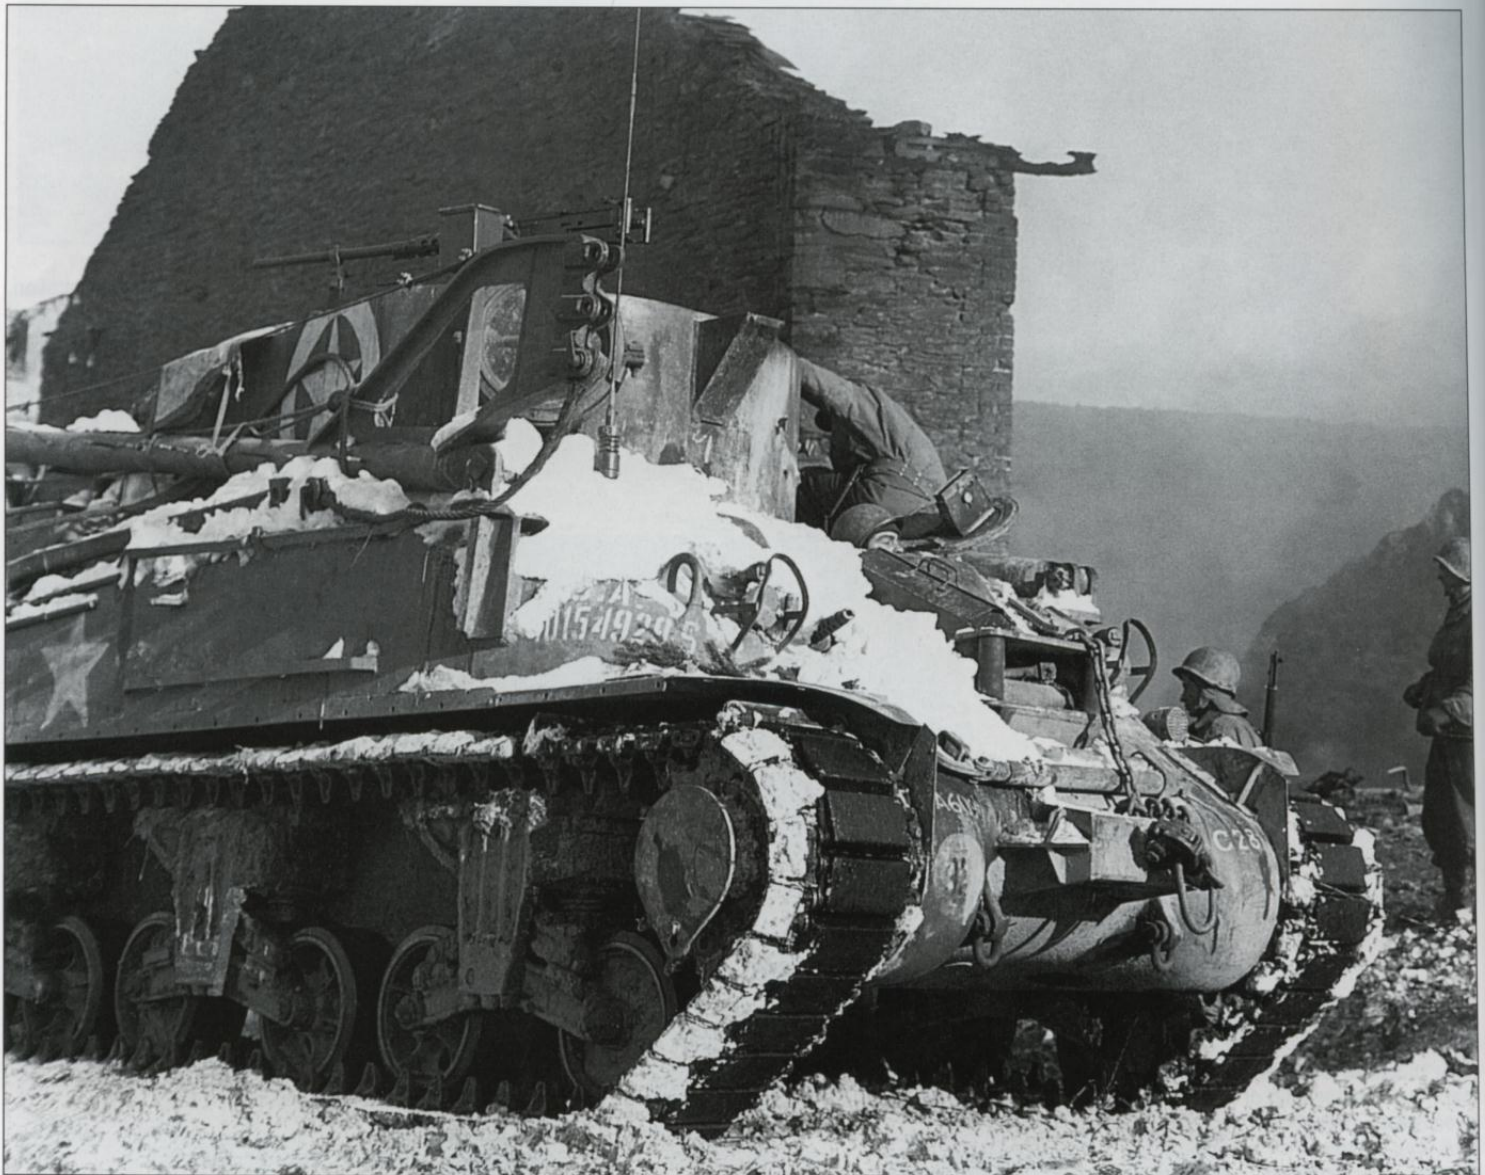
A M32B1 armored recovery vehicle of the 6th Armored Division moves to the outskirts of Bastogne on 14 January 1945 in anticipation of the push to break out of the pocket. The M32B1 was an armored recovery vehicle based on the hull of the M4A1 tank, fitted with a new turret, a winch, and an A-frame crane.

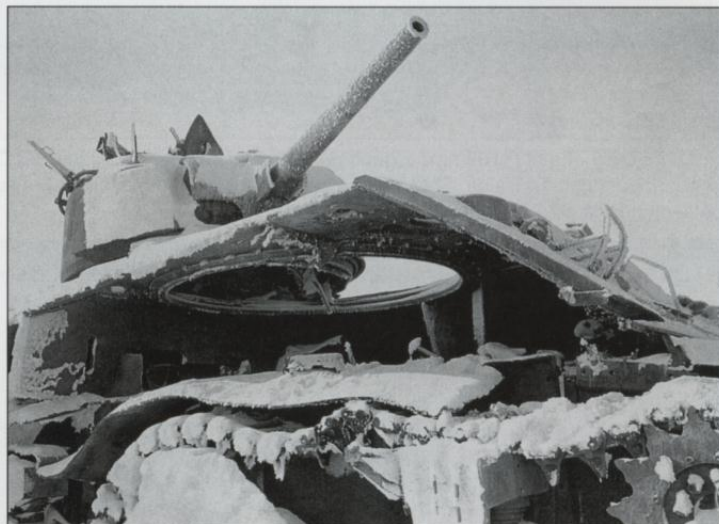
This close-up of the M4 to the left in one of the previous photos, tactical number 73, shows the results of a massive internal ammunition explosion that has peeled the right side armor back and blown the turret off the turret race.

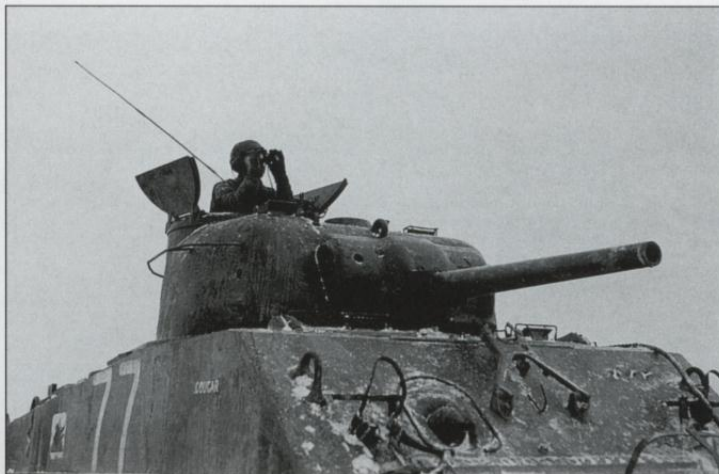
A M4A3 of Co. C, 15th Tank Battalion, 6th Armored Division during the push to the north-east of Bastogne in mid-January 1945. This tank, named Cougar, carries the tactical number 77, also its radio call-sign. This attack was part of a broader push by Patton's Third Army from Bastogne, towards "Skyline Drive" at the northern eastern end of the Bulge. (Patton Museum)

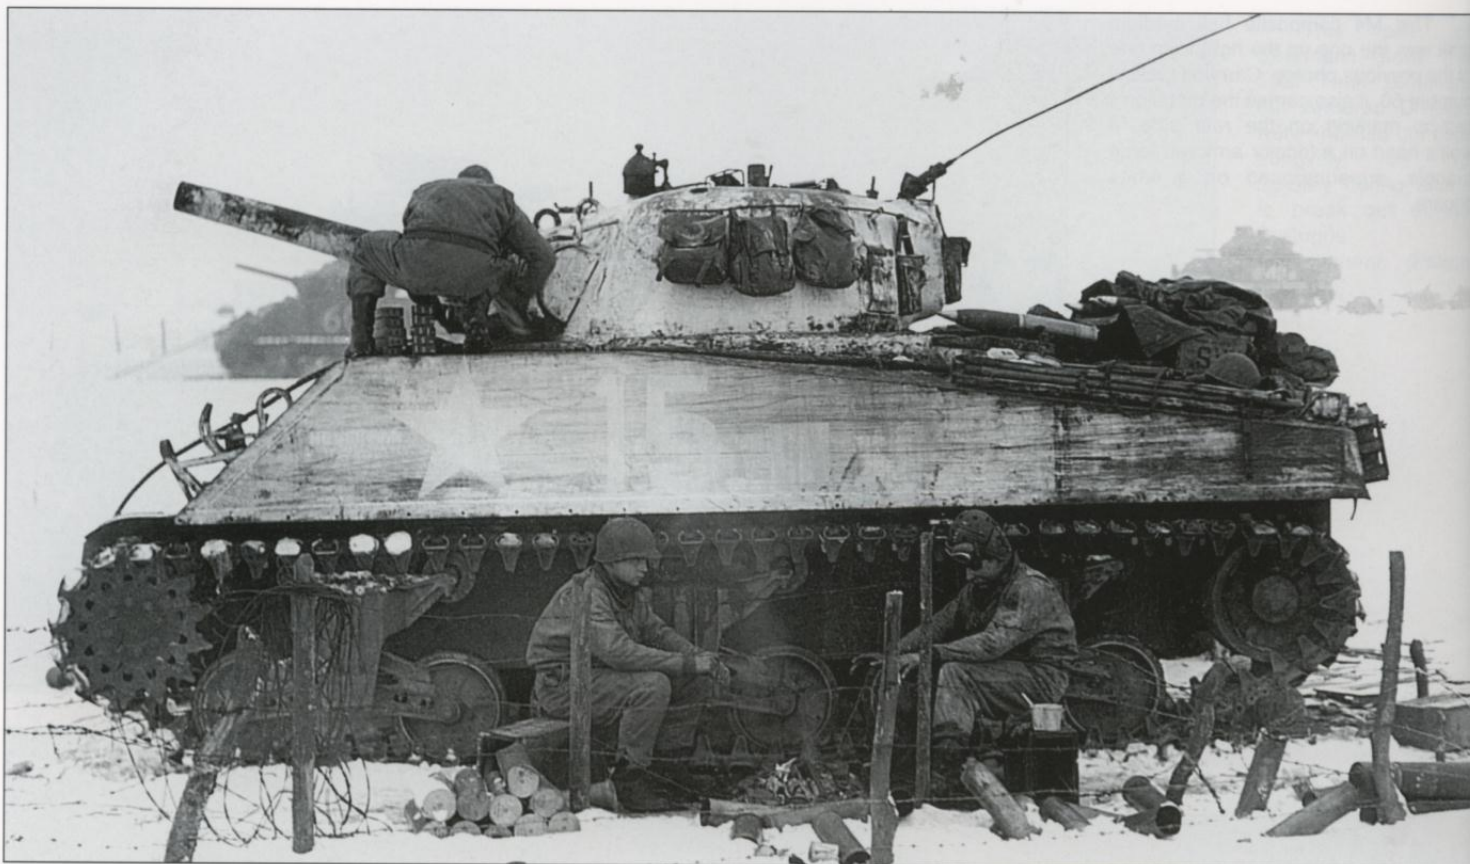
The crew of a M4 (105mm) assault gun, tactical number 15, of the HQ Co., 15th Tank Battalion, 6th Armored Division warm up over a fire while waiting for another support mission. These tanks were used to provide indirect fire support for the regular medium tanks of the battalion, and expended casings can be seen scattered around the tank.

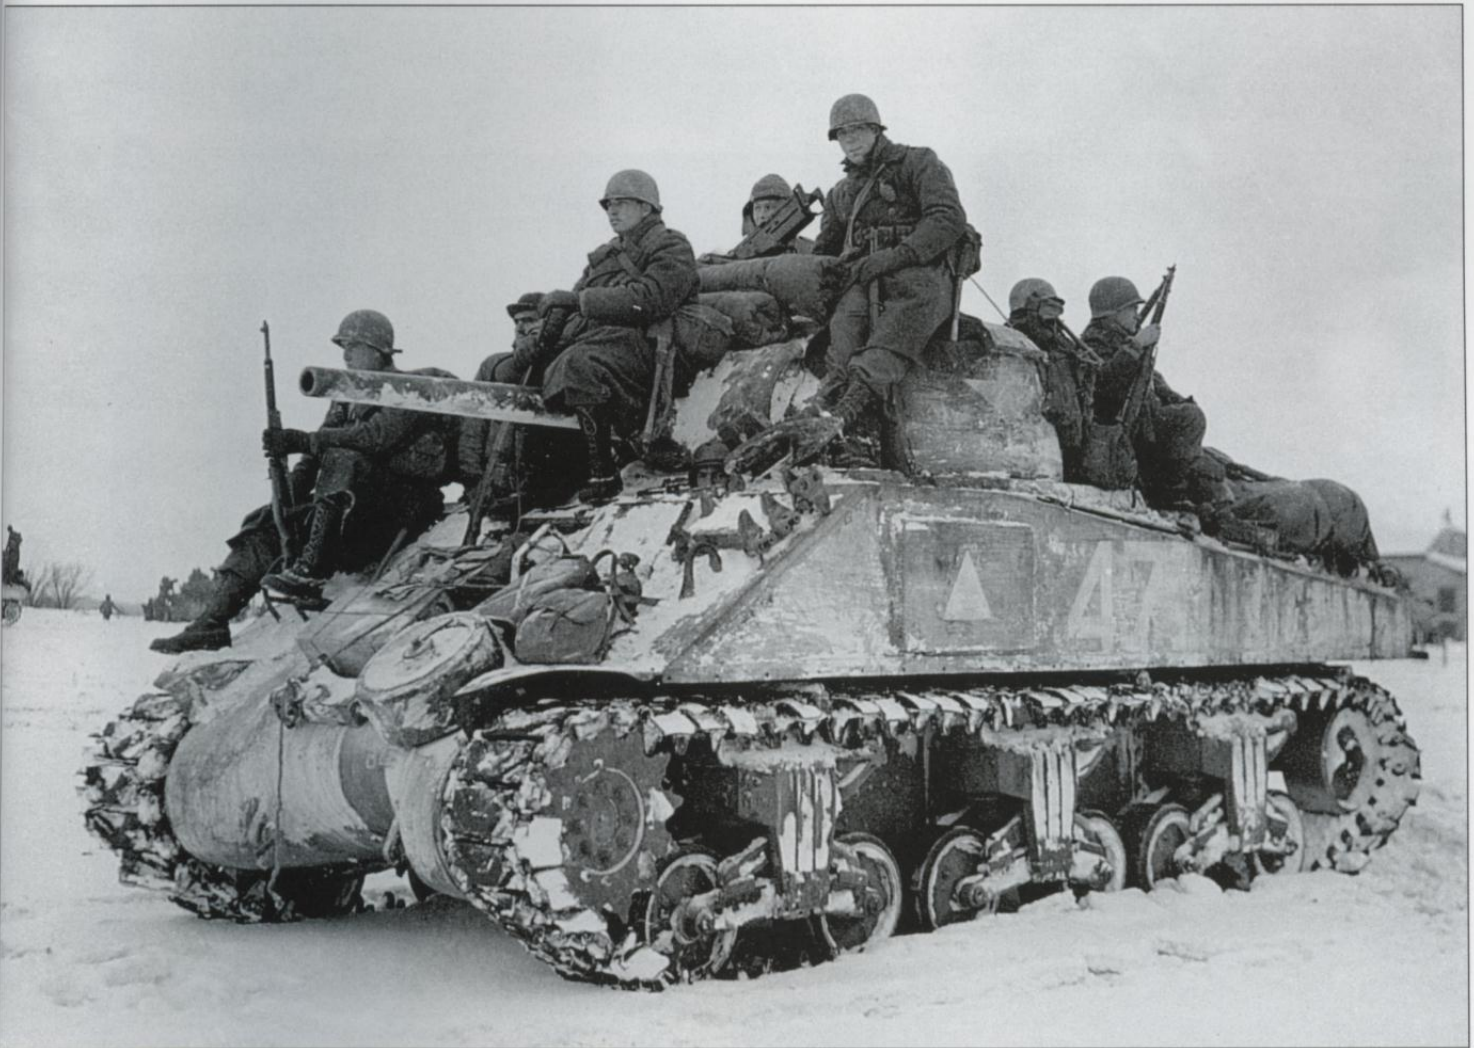
A M4 of the 68th Tank Battalion, 6th Armored Division carries infantry forward during the fighting in mid-January 1945. Its tactical number is 47 and it carries the white triangle typical of this battalion.

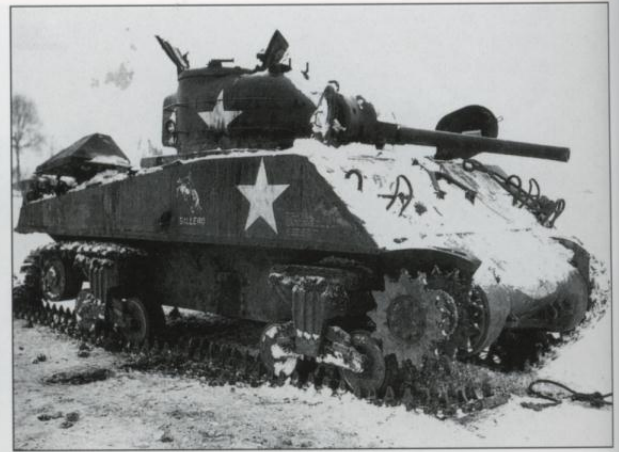
"Ballero," another M4A3 tank of the 69th Tank Battalion, 6th Armored Division being repaired after the fighting to push out of Bastogne in mid January 1945. A hit can be seen to the immediate left of the vehicle name on the side.

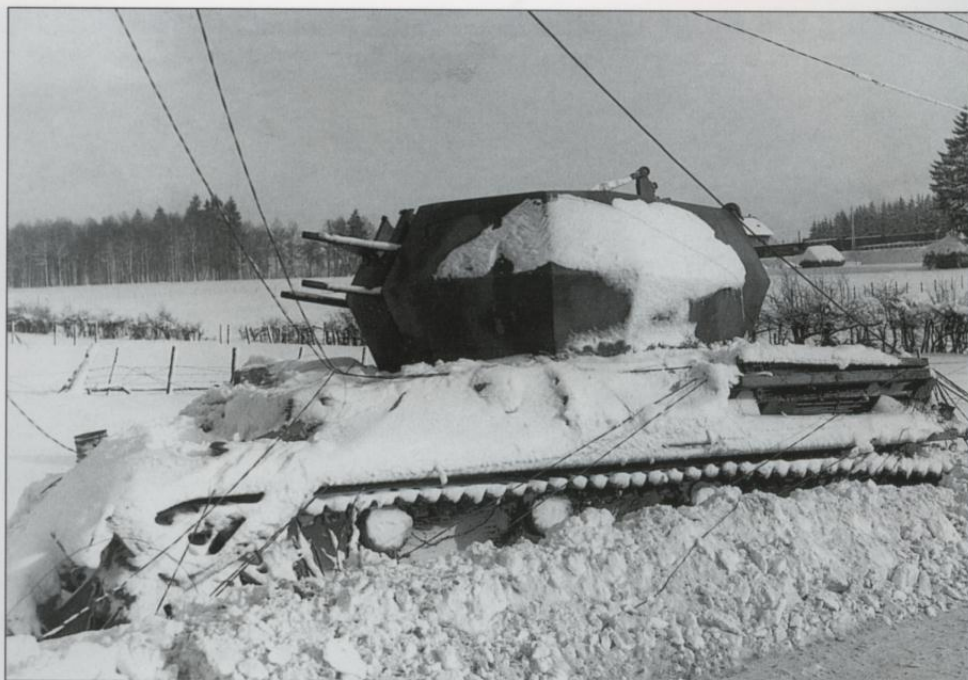
US infantry moves up north of Bastogne near Compogne, Belgium on 15 January past a disabled Flakpanzer IV Wirbelwind. This anti-aircraft version of the PzKpfw IV tank was armed with a four-barrel 20mm Flak 38 anti-aircraft cannon.

This Flakpanzer IV Wirbelwind was abandoned in Patton's Third Army sector near Bastogne where it was photographed on 23 January under a cover of snow and communication wire. It was earmarked for shipment back to the United States for technical evaluation.

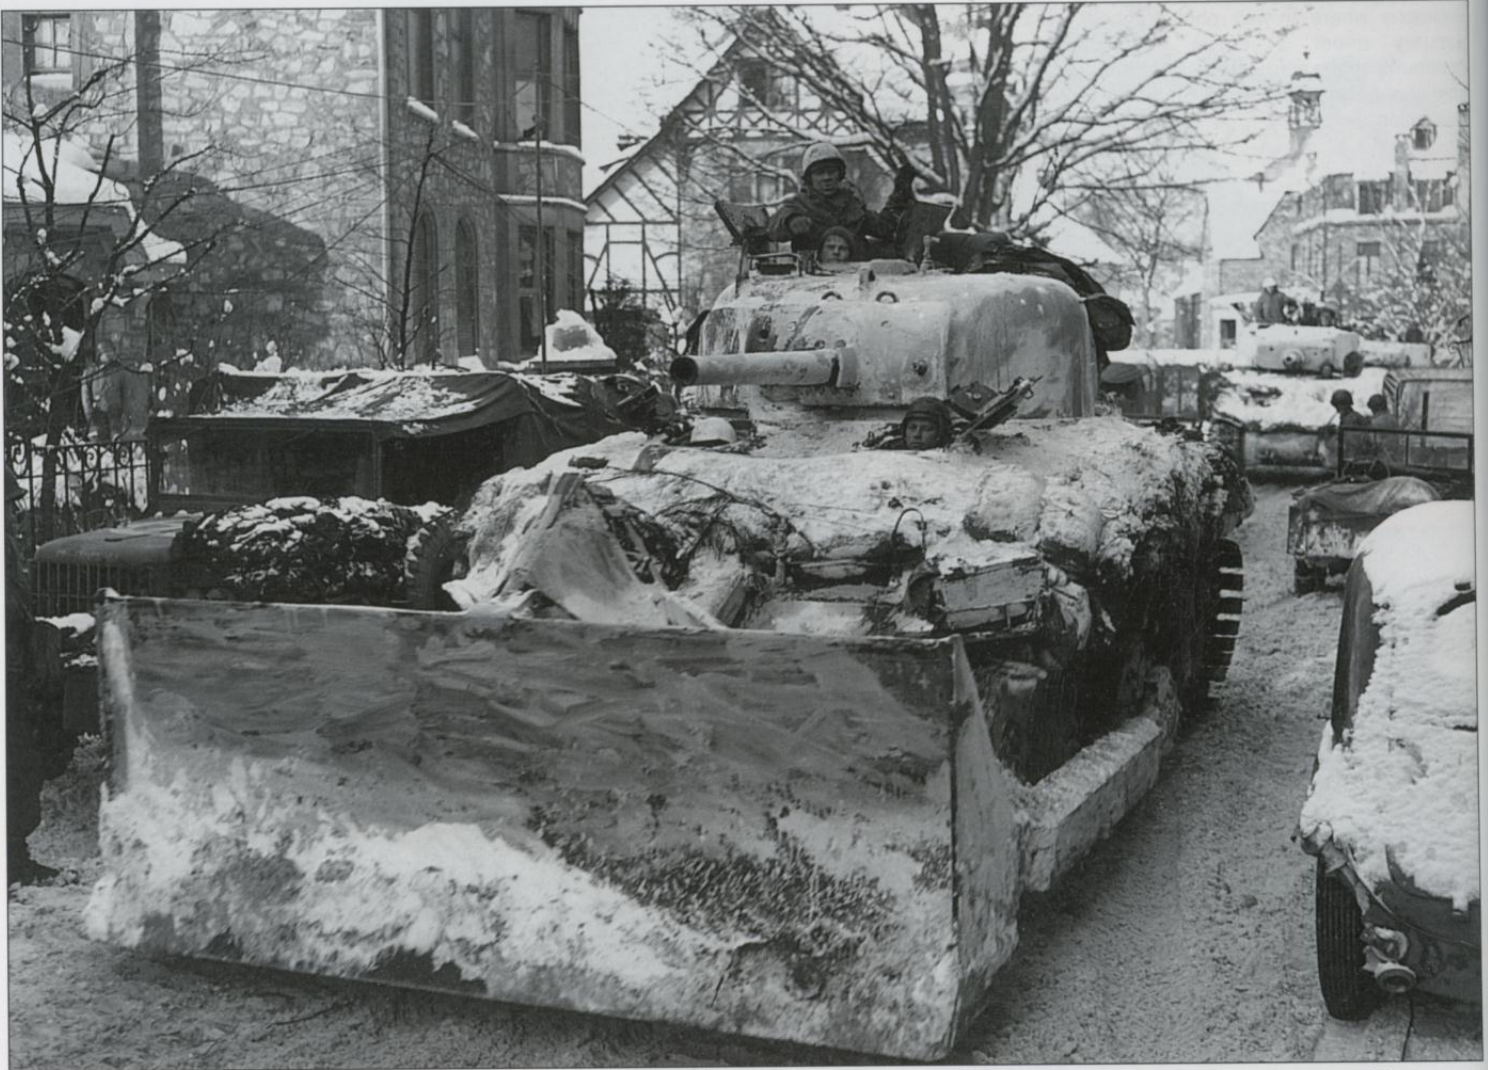
A M4A1 medium tank of the 743rd Tank Battalion fitted with a M1 dozer blade leads a column through Malmédy to help clear away snow. The second tank in the column is one of the rare M4A3E2 Jumbo assault tanks. At the time, this battalion was supporting the 38th Division in efforts to reduce the Bulge.

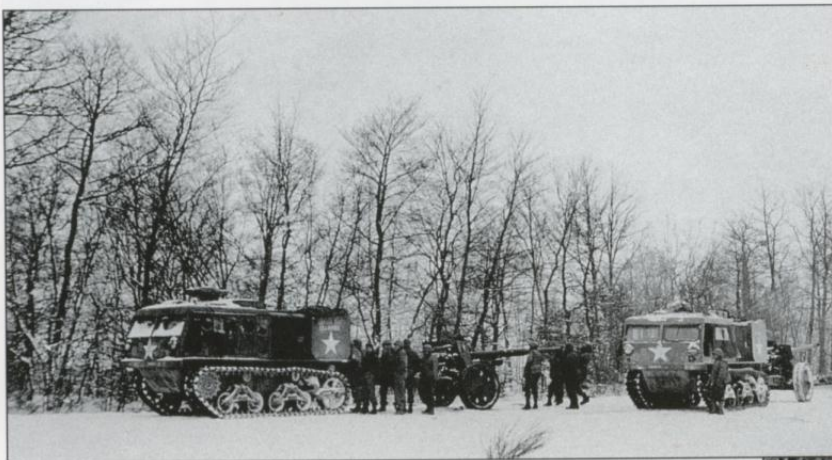
On occasion, captured German artillery was employed if ammunition was available. Here, a couple of M4 high speed tractors are towing a pair of German 88mm PaK 43/41 heavy anti-tank guns while supporting operations by the 90th Division in Luxembourg on 11 January 1945. These massive guns were appropriately nicknamed the *Scheunentor* (Barn door) by their German crews due to their massive size.

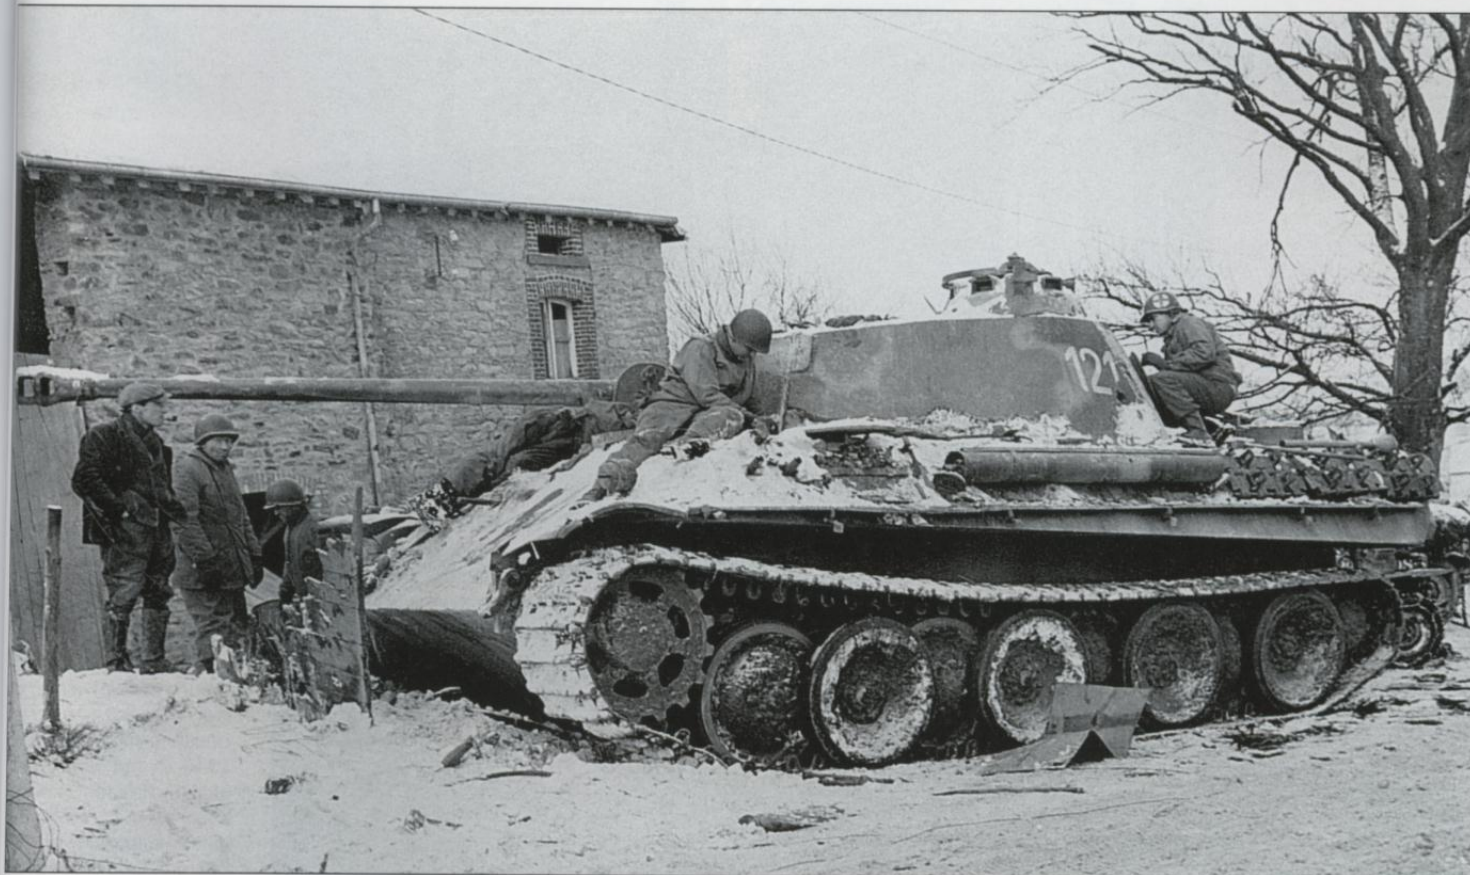
A Panther Ausf. G, tactical number 121 of the 9.Panzer Division, knocked out by a 57mm anti-tank gun during the fighting for Langlir, to the north-east of Houfallize, on 13 January 1945. Although the 57mm anti-tank gun was ineffective against the Panther's thick frontal armor, it could penetrate the side armor. Note the penetration in the turret side in the lower rear corner of the tactical number. The 9.Panzer Division typically painted its tactical numbers in plain white on the rear side of the turret.
