# The Battle of the Bulge

Steven Zaloga

# Introduction

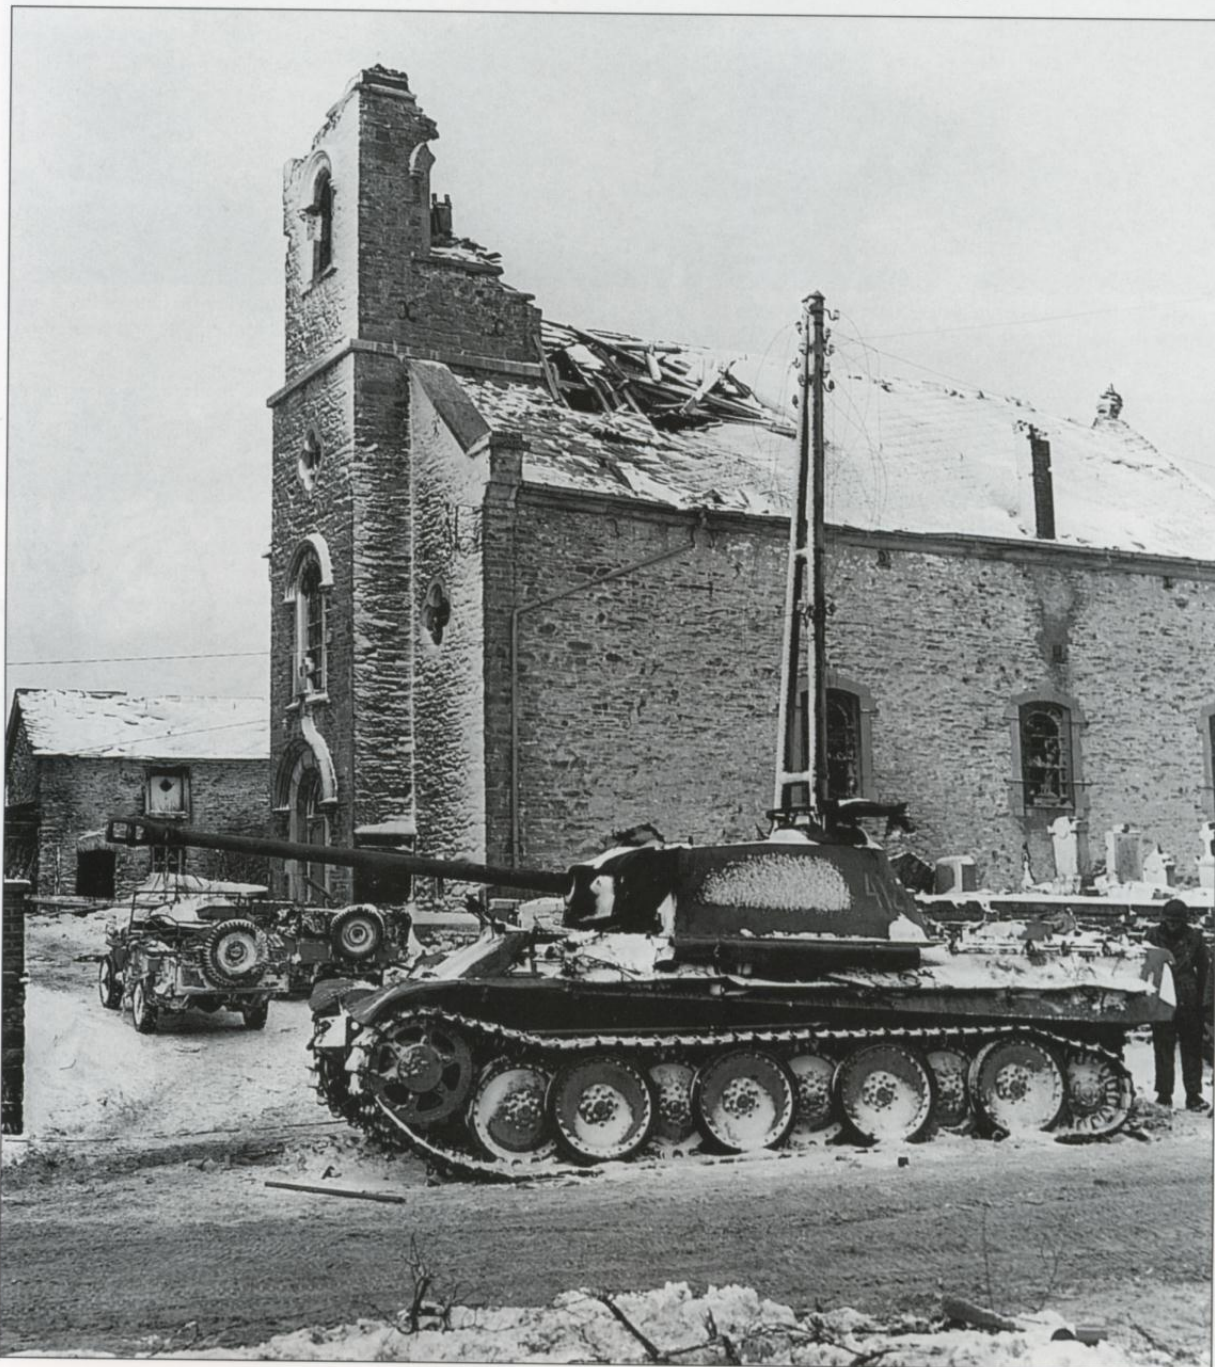
A Panther Ausf. G tank, tactical number 412, from the 9.Panzer Division, knocked out near the village church in Sterpigny, Belgium. This village is to the south of Langlir, the site of the other Panther photo here. This tank took part in attempts by the 9.Panzer Division to rebuff the advance of the US 3rd Armored Division on 17 January 1945 to the north-east of Houffalize. It was knocked out by a trio of tank destroyers of the 703rd Tank Destroyer Battalion which pumped three rounds into the rear engine compartment.

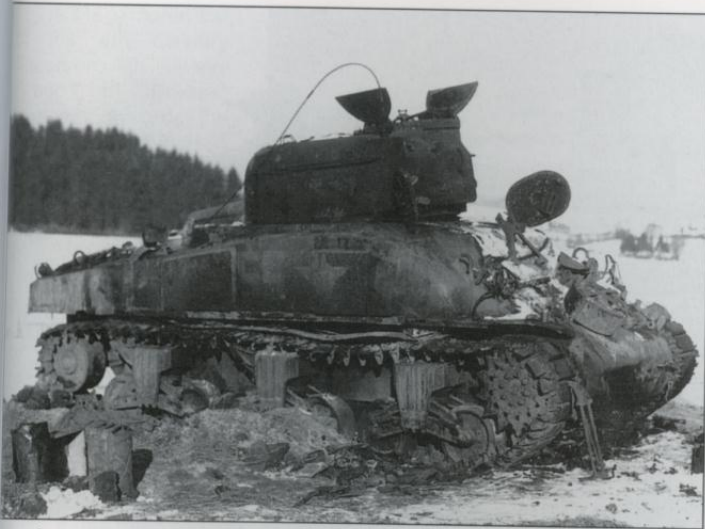
A composite hull M4 medium tank of the 69th Tank Battalion, 6th Armored Division, knocked out during the fighting around Wardin. This may have been one of the tanks knocked out in an unexpected encounter with a King Tiger on 11 January.

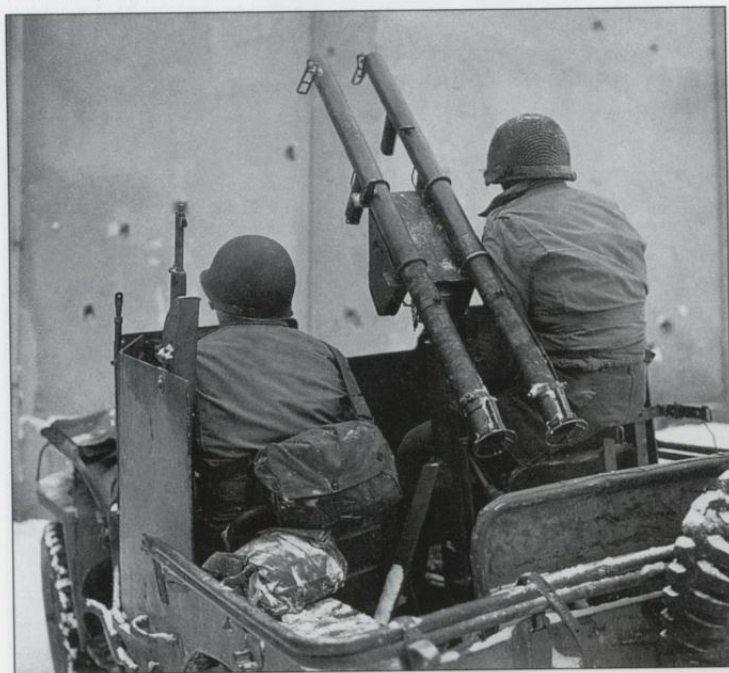
An intelligence and reconnaissance (I&R) platoon from the 60th Infantry, 9th Division developed this improvised mounting for a pair of 2.35 inch bazookas using the normal .50 cal heavy machine gun pedestal in a jeep. This vehicle was photographed in Belgium on 16 January 1945.

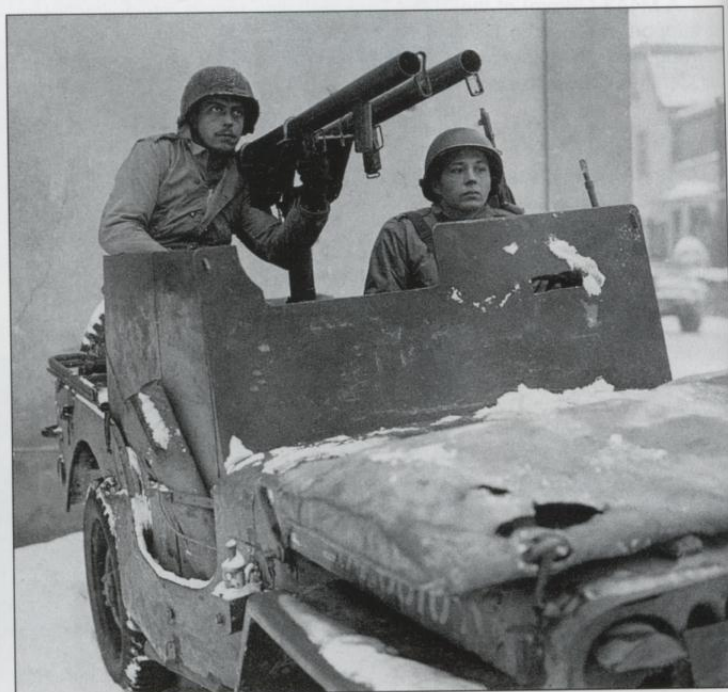
This other view of the bazooka armed jeep from a 60th Infantry I&R platoon also shows how the crew has added a partial armored shield around the front of the vehicle from plate steel.
